F.R. Note No. 101  
Research programme  
Objective: A2/1

FIRE AND EXPLOSION AT THE PREMISES OF  
MESSRS. OSBORNE STEVENS & CO. LTD., UXBRIDGE.

F. E. T. Kingman and K. N. Palmer

February, 1954.

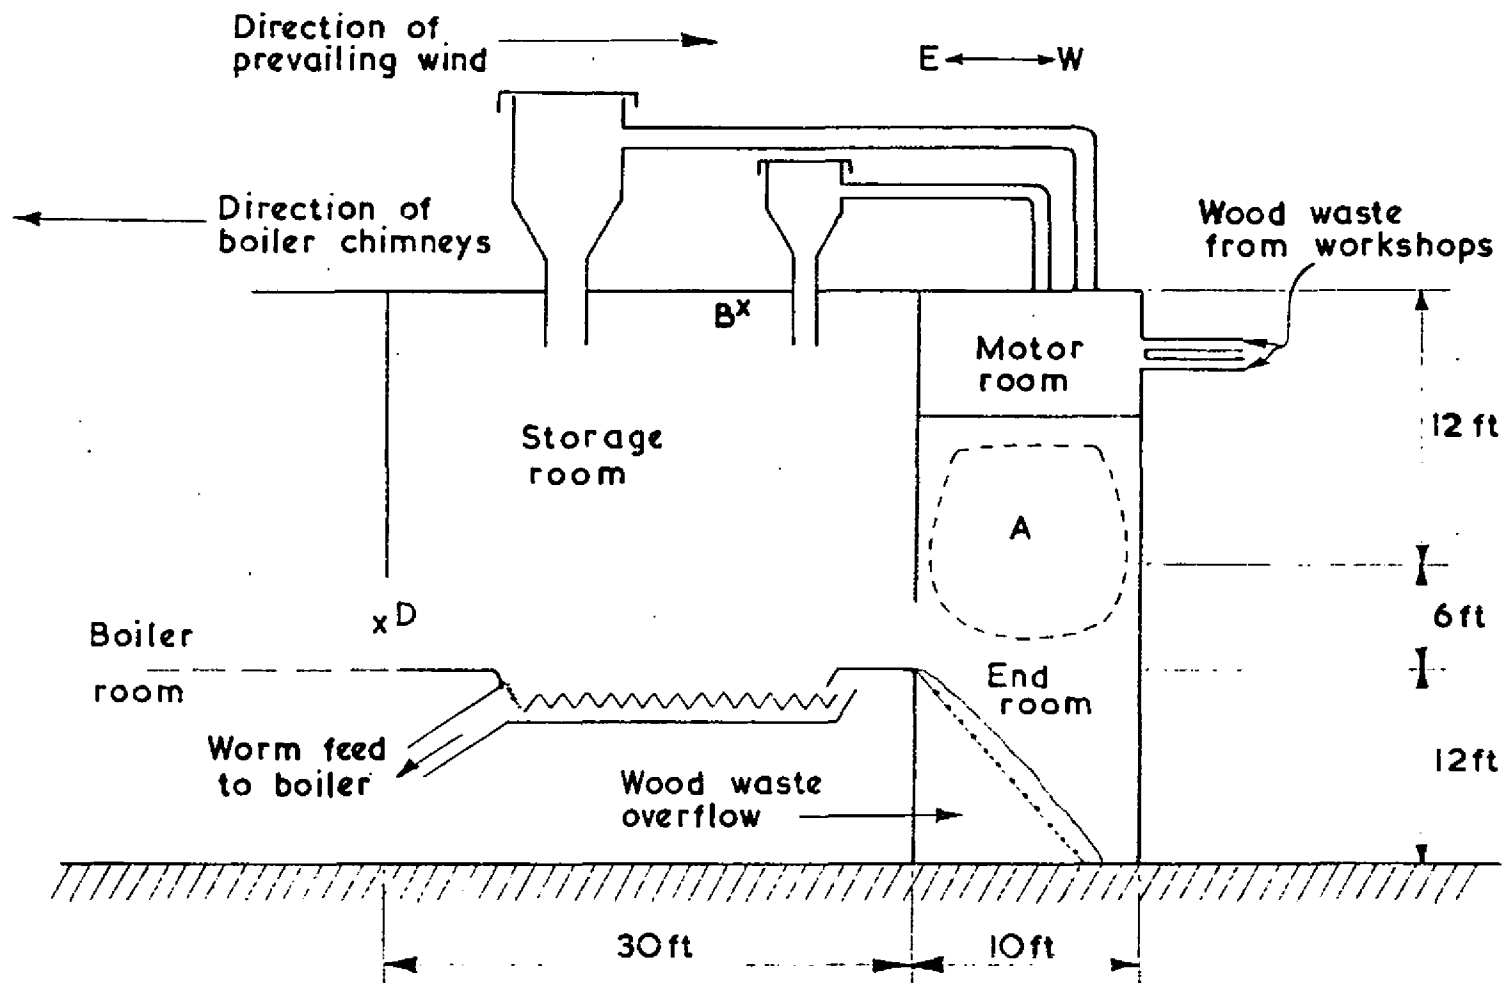
FIG. 1. SECTIONAL SKETCH OF BUILDING IN WHICH EXPLOSION OCCURRED

Building - This was of a steel frame construction divided into a boiler room, storage room for wood waste, motor room, and an end room providing direct access to the storage room (Fig. 1). The storage room was lined internally with corrugated iron sheeting, the dividing walls between it and the boiler and end rooms were also of corrugated iron. The entire building before the explosion was lined externally with corrugated asbestos supported by wooden battens attached to the vertical steel members. There was thus a cavity about 6 in. wide between the inner and outer walls of the storage room on the rear (South) side of the building. The end room had no internal lining and there was a connection between this room and the rear cavity wall of the storage room. The roof was of corrugated iron, sloping slightly, and above it were two cyclones which fed the wood waste into the storage room.

The primary explosion appears to have occurred in the cavity in the south wall of the building: as already stated, this occurred just as the fireman started to loosen the asbestos sheeting preparatory to dealing with the burning dust in the cavity. This explosion could have been a gas explosion (back draught) due to an explosive mixture formed by heating of the dust in the confined space in the cavity. Alternatively there may have been some dust disturbance, such as dust falling down from the ledges in the cavity setting up an explosive concentration in the space, which was fired by burning dust. It is not possible to decide between these two alternatives. The probable sequence of events then is as follows:

The primary explosion, whatever its cause, travelled through the cavity into the front (North) compartment of the end room, where further dust was stirred up, the resultant explosion venting partially through the asbestos covering of the end room (area A, Fig. 1), but also through the storage room injuring the Fire Officer standing on the far side (point D, Fig. 1).

Hazards of the structure - This incident has demonstrated the hazard which may arise when buildings for processes involving combustible dust are constructed with unsealed cavity walls. This type of wall acts as a trap for very fine dust fractions, which tend to separate out from the main bulk when moved, and cannot be subjected to regular cleaning operations. In the present incident, deposits of fine dust several inches in depth had been observed on some horizontal members when the asbestos covering was removed. It is thus possible to have a fire in the dust not easily

1. The cavity formed by the double walls of the storage room should be sealed off or, better still, eliminated entirely.
2. The storage room itself should be altered so that the dust is collected without falling through the air from a height, and fed into a sealed hopper without internal ledges, girders etc. on which dust can collect. With the present construction, even if the cavity is eliminated, a dust explosion may occur in the storage chamber itself.
3. It should be emphasized that the actual dust explosion in this incident was a relatively mild one, due probably to the facts that the first explosion was in a narrow space only, and the secondary one was vented easily - under slightly different conditions the explosion might have been much more destructive.
