F.R. Note No. 138/1954

DEPARTMENT OF SCIENTIFIC AND INDUSTRIAL RESEARCH AND FIRE OFFICES' COMMITTEE
JOINT FIRE RESEARCH ORGANIZATION

REPORT ON A VISIT TO THE GENERAL POST OFFICE, MOUNT
PLEASANT, LONDON, E.C.1.

L. A. Ashton and D. Hird

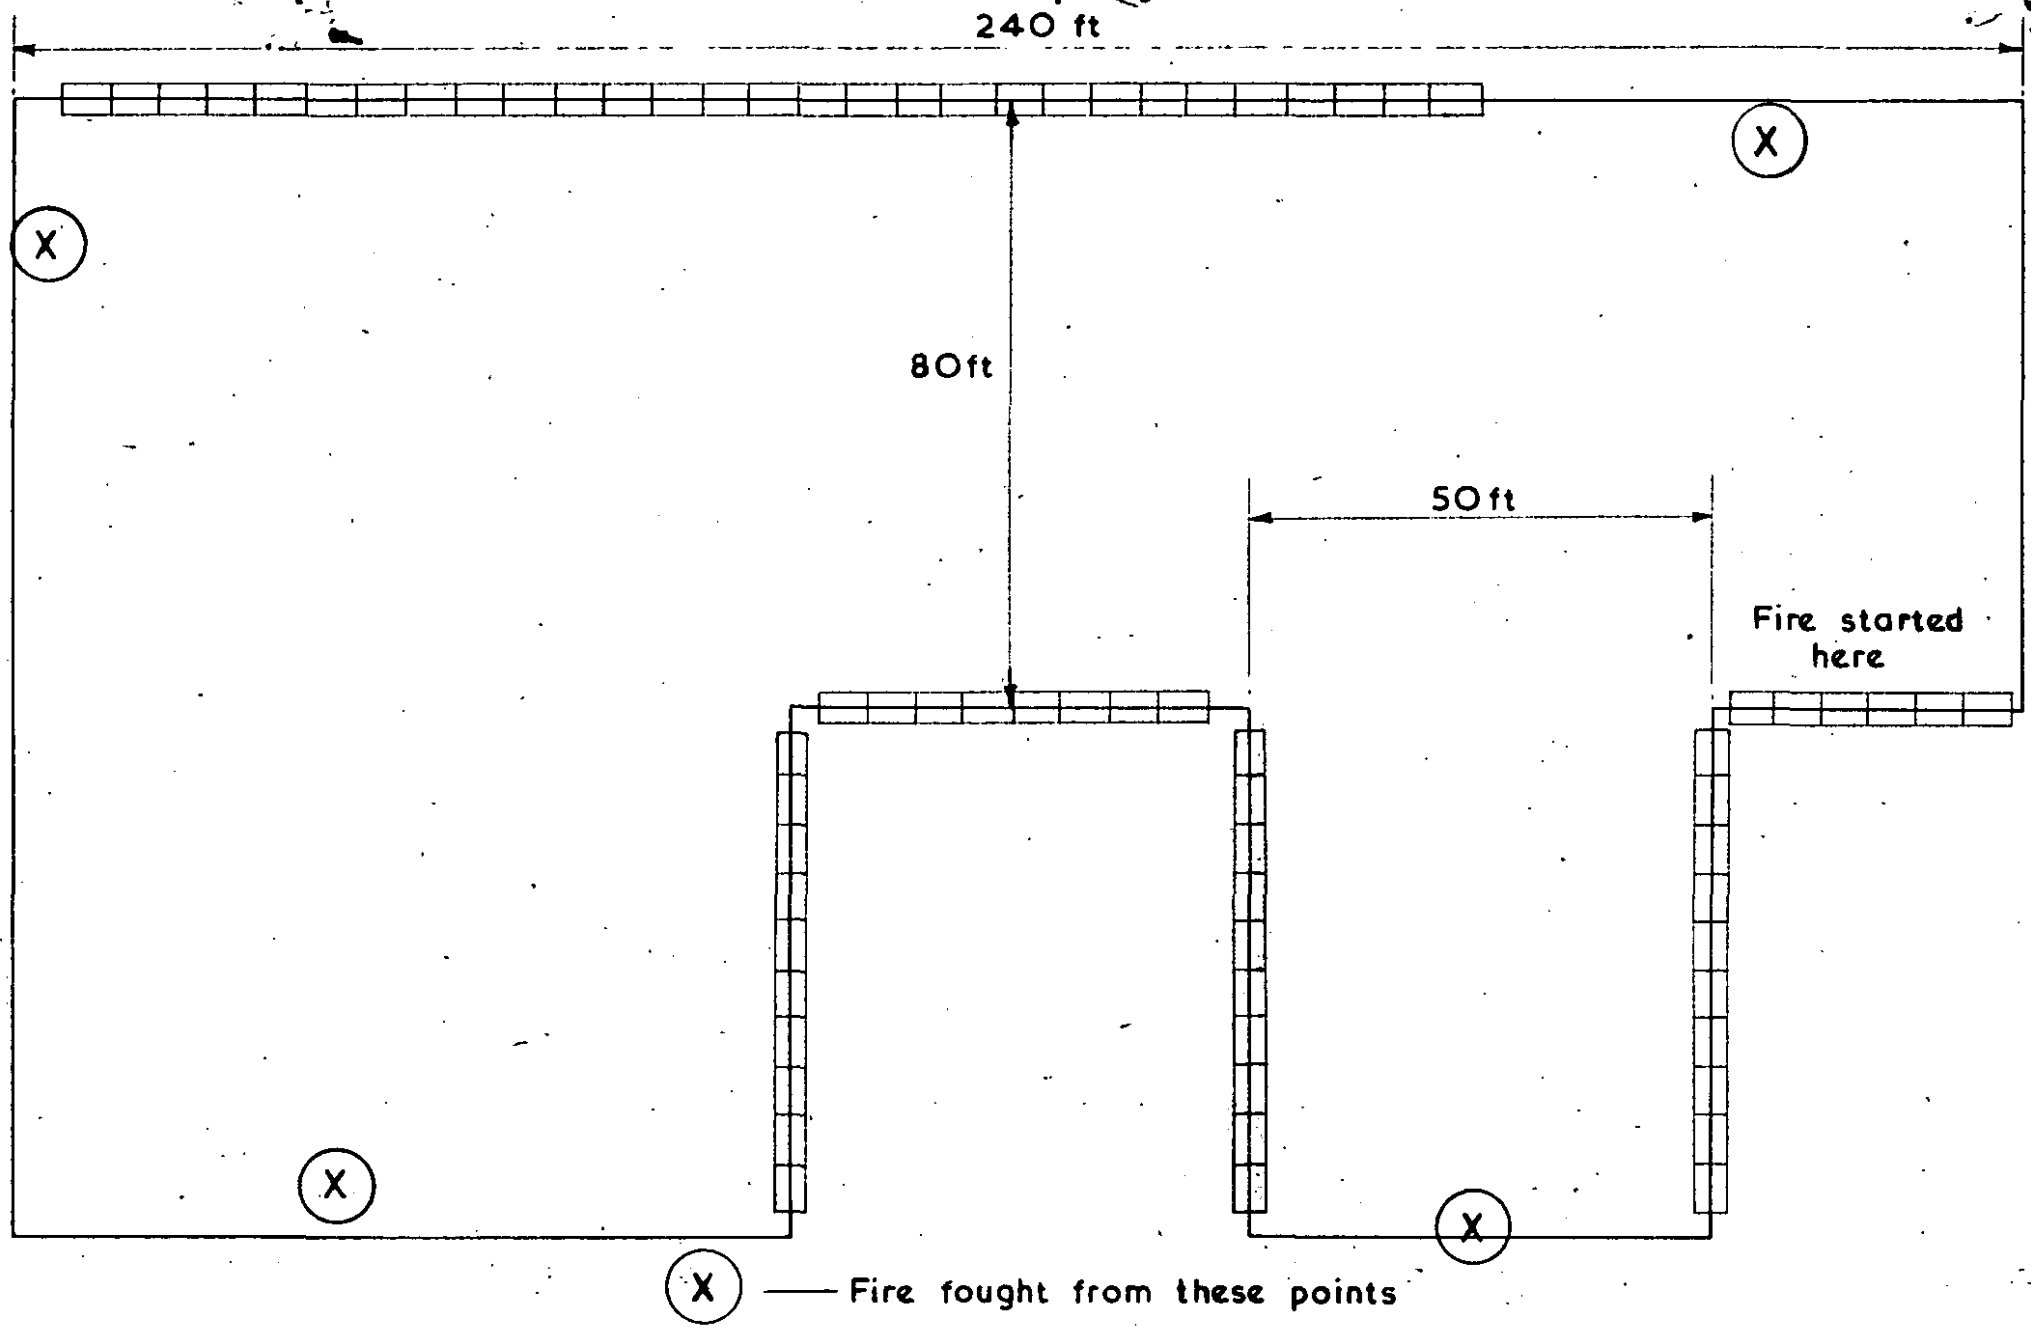
FIG. I. PLAN OF STORE WITH APPROXIMATE DIMENSIONS

The fire occurred on the top floor of a three storey building, in a large undivided room (Figure 1) used as a stationery store. It was discovered soon after 10 a.m. on the 5th October at the point shown in Figure 1, and the cause will probably be returned as unknown. There was a delay in calling the Fire Brigade, and they did not arrive until about half-an-hour after the discovery of the fire. By this time it was not possible to approach the seat of the fire because of very dense smoke. Once the whole contents were involved the fire burnt for 2-3 hours before it was extinguished.
