FIRE IN PAINT SPRAY BOOTH DUCTING

P. C. Bowes and G. W. V. Stark

Summary

November, 1954.

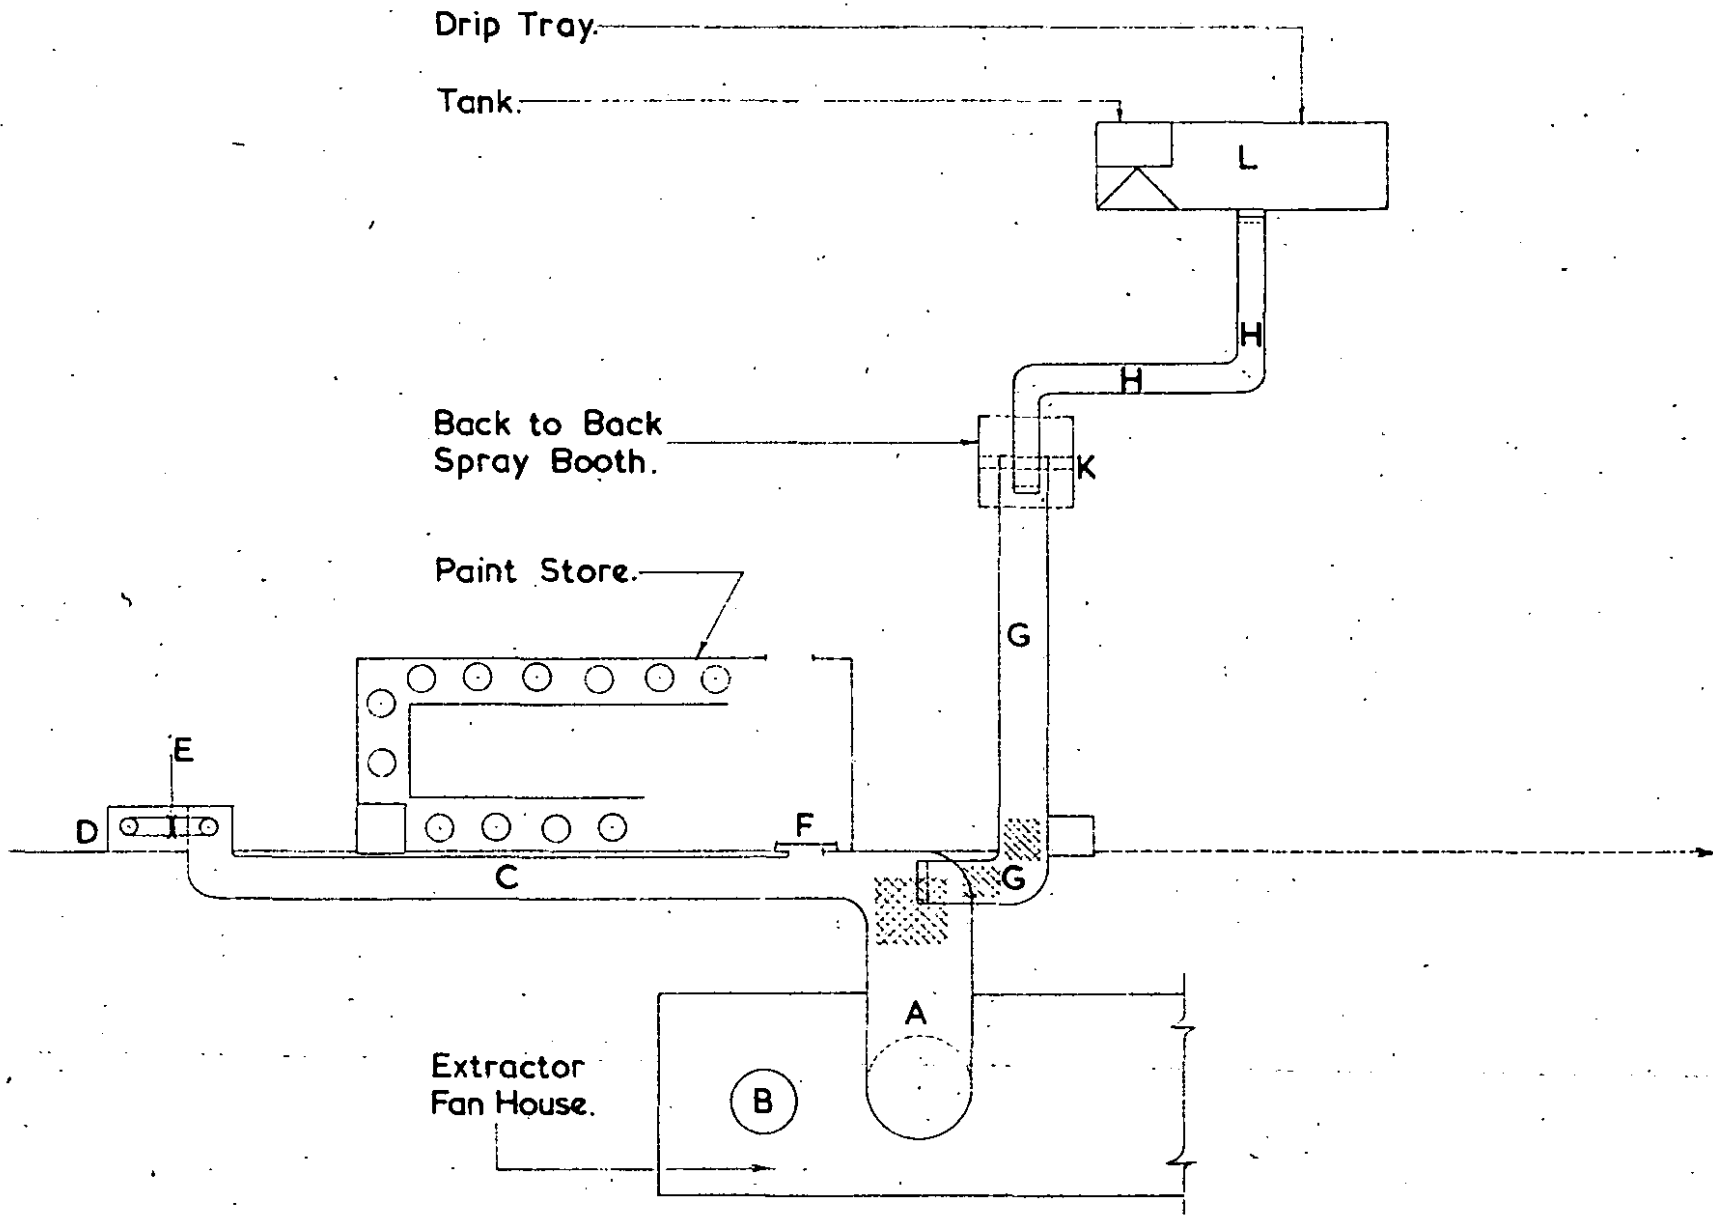
FIG. 1. SKETCH PLAN - LAYOUT OF DUCTING.

A sketch plan of the ducting is shown in Figure 1. The rectangular ducts C and G, (Section 24 x 15 in., and 24 x 9 in. respectively), outside the first floor of the steel frame factory building were suspended close to the glazing, which was of wired glass. There were no means of entering this external ducting for cleaning purposes. The part of ducting G that was inside the factory building was provided with a number of sliding shutters for this purpose, but none were apparent in the length of ducting H (section 12 in. x 4 in.). A hand operated shutter, E, was provided for isolating the solvent wash tank from the ducting, but no further shutters were fitted to the system. The paint in the dip tank, and the tunnel above the drip tray, were said to be heated above 90°F.

The discoloration of the areas of ducting marked by cross hatching in the sketch plan indicated that they had been heated strongly, while that on the underside of ducting C showed that the fire in this section had followed a zig-zag path. Soot blackening was noticed at a joint between the sections of the large trunking A, and at the sliding shutters on ducting G. The bottom panes of wired glass in the paint store, adjacent to the external ducting C, had been crazed. The wall behind the solvent wash tank D was somewhat soot blackened. The small section ducting H did not appear to have been involved.

It is not possible to say where the fire started, but it is unlikely that the heavy paint residue in ducting C was primarily involved, unless the fire was initiated by a cigarette end, because the residue was said to consist of nitrocellulose based aluminium paint, which is not liable to spontaneous heating from ordinary temperatures. Also this ducting was last used to extract paint over spray about four years ago, and, after such a lapse of time, spontaneous ignition would be very unlikely to occur, even if some oil-based paint had been used. On the other hand paint residues from the spraying booth K could be expected to collect at the junction of the smaller ducts with the main, large diameter, extraction trunking where the air velocity would be suddenly reduced, and it was at this point that the fire appeared to have been most intense.

Mr. Halstead said that he proposed to recommend that means be provided for the cleaning of all ducting, inside and outside the factory buildings, together with the installation of automatic shutters operated by fusible links, to isolate any section of ducting affected by fire. It is thought that this system would not give protection against vapour explosion, and a system such as a pressure operated device that would operate more rapidly, would appear to be more appropriate.
