F.R. Note No. 15/1952

FIRE IN RIVER BANK AT BRENT CRESCENT, WEMBLEY, 19th AND 21st APRIL, 1952

P. C. Bowes and
F. E. T. Kingman

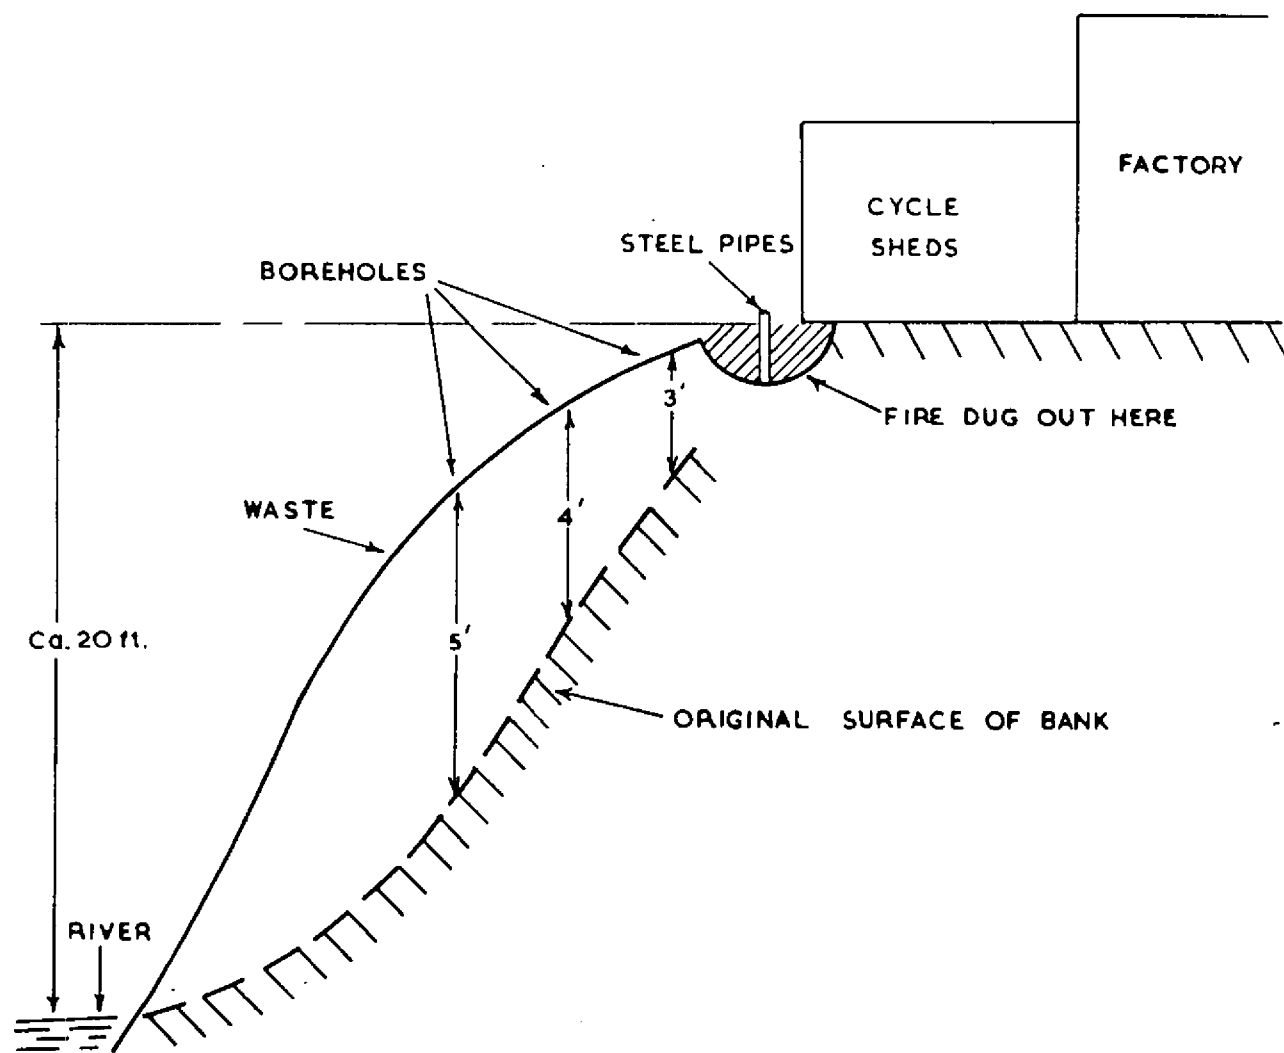
FIG. I. PROBABLE CROSS SECTION OF SITE.

The site consisted of made-up ground on the banks of the river Brent; Fig. 1 is a sketch of the site in vertical section, as far as this can be deduced from observations and information given. It was understood that the ground had been made up about 18 years previously and that the course of the river had been altered at the same time. The present ground level was about 20 ft. above the river level. The depth of made-up ground was not known but the opposite bank appeared to be virgin soil and was about 10 ft. above the river. The composition of the made-up ground was not known but would presumably have been approved by the Borough Council responsible.

The bank of the river was steep and had been used, evidently for a number of years, for dumping factory waste. At the site of the fire this consisted mainly of steel swarf and scrap; coal and coke were present and rags were embedded in the mass. The mass was closely consolidated on the surface but was loose below. A row of vertical steel pipes, parallel to the bank, was disclosed during digging-out operations; this had probably formed a retaining fence and suggested that the refuse extended for a considerable distance beyond the original line of the bank.

It appeared likely that the combustible material was confined to the layer of refuse on that part of the site between the river and the factory and that the made-up ground on which the factory was built might be considered as not being liable to 'take fire. This was supported by evidence (communicated later by 'phone by Mr. Squires) from bore-holes made by engineers on behalf of the Schori Metallising Company. These bore-holes, which were drilled at intervals of 3 ft. down the bank, indicated that the depth of the layer containing combustible material became thinner near the top of the bank. A bed of clay was struck at the depth indicated in Fig. 1 below this layer of rubbish.

As the fire was small and might well burn out naturally without causing any immediate hazard it was recommended that it should be watched; preferably it should be dug out cautiously and the hole sealed with lime or cement slurry. The position should be kept under close observation in case the layer of combustible material extended further and into the made-up ground underneath the factory. If, therefore, the fire showed signs of extension towards the factory it would be necessary to start injecting slurry into the ground between the fire and the factory to prevent its extension in this direction.

Finally, the tipping and burning of combustible refuse in the land between the factory and the river should be stopped.
