INSPECTION OF A STOVE-ENAMELLING OVEN  
AT MESSRS. HOOVER, LTD.,  
HIGH WYCOMBE, BUCKS.

E. H. Coleman and G. W. V. Stark

January, 1955.

File No. F.1000/32/30

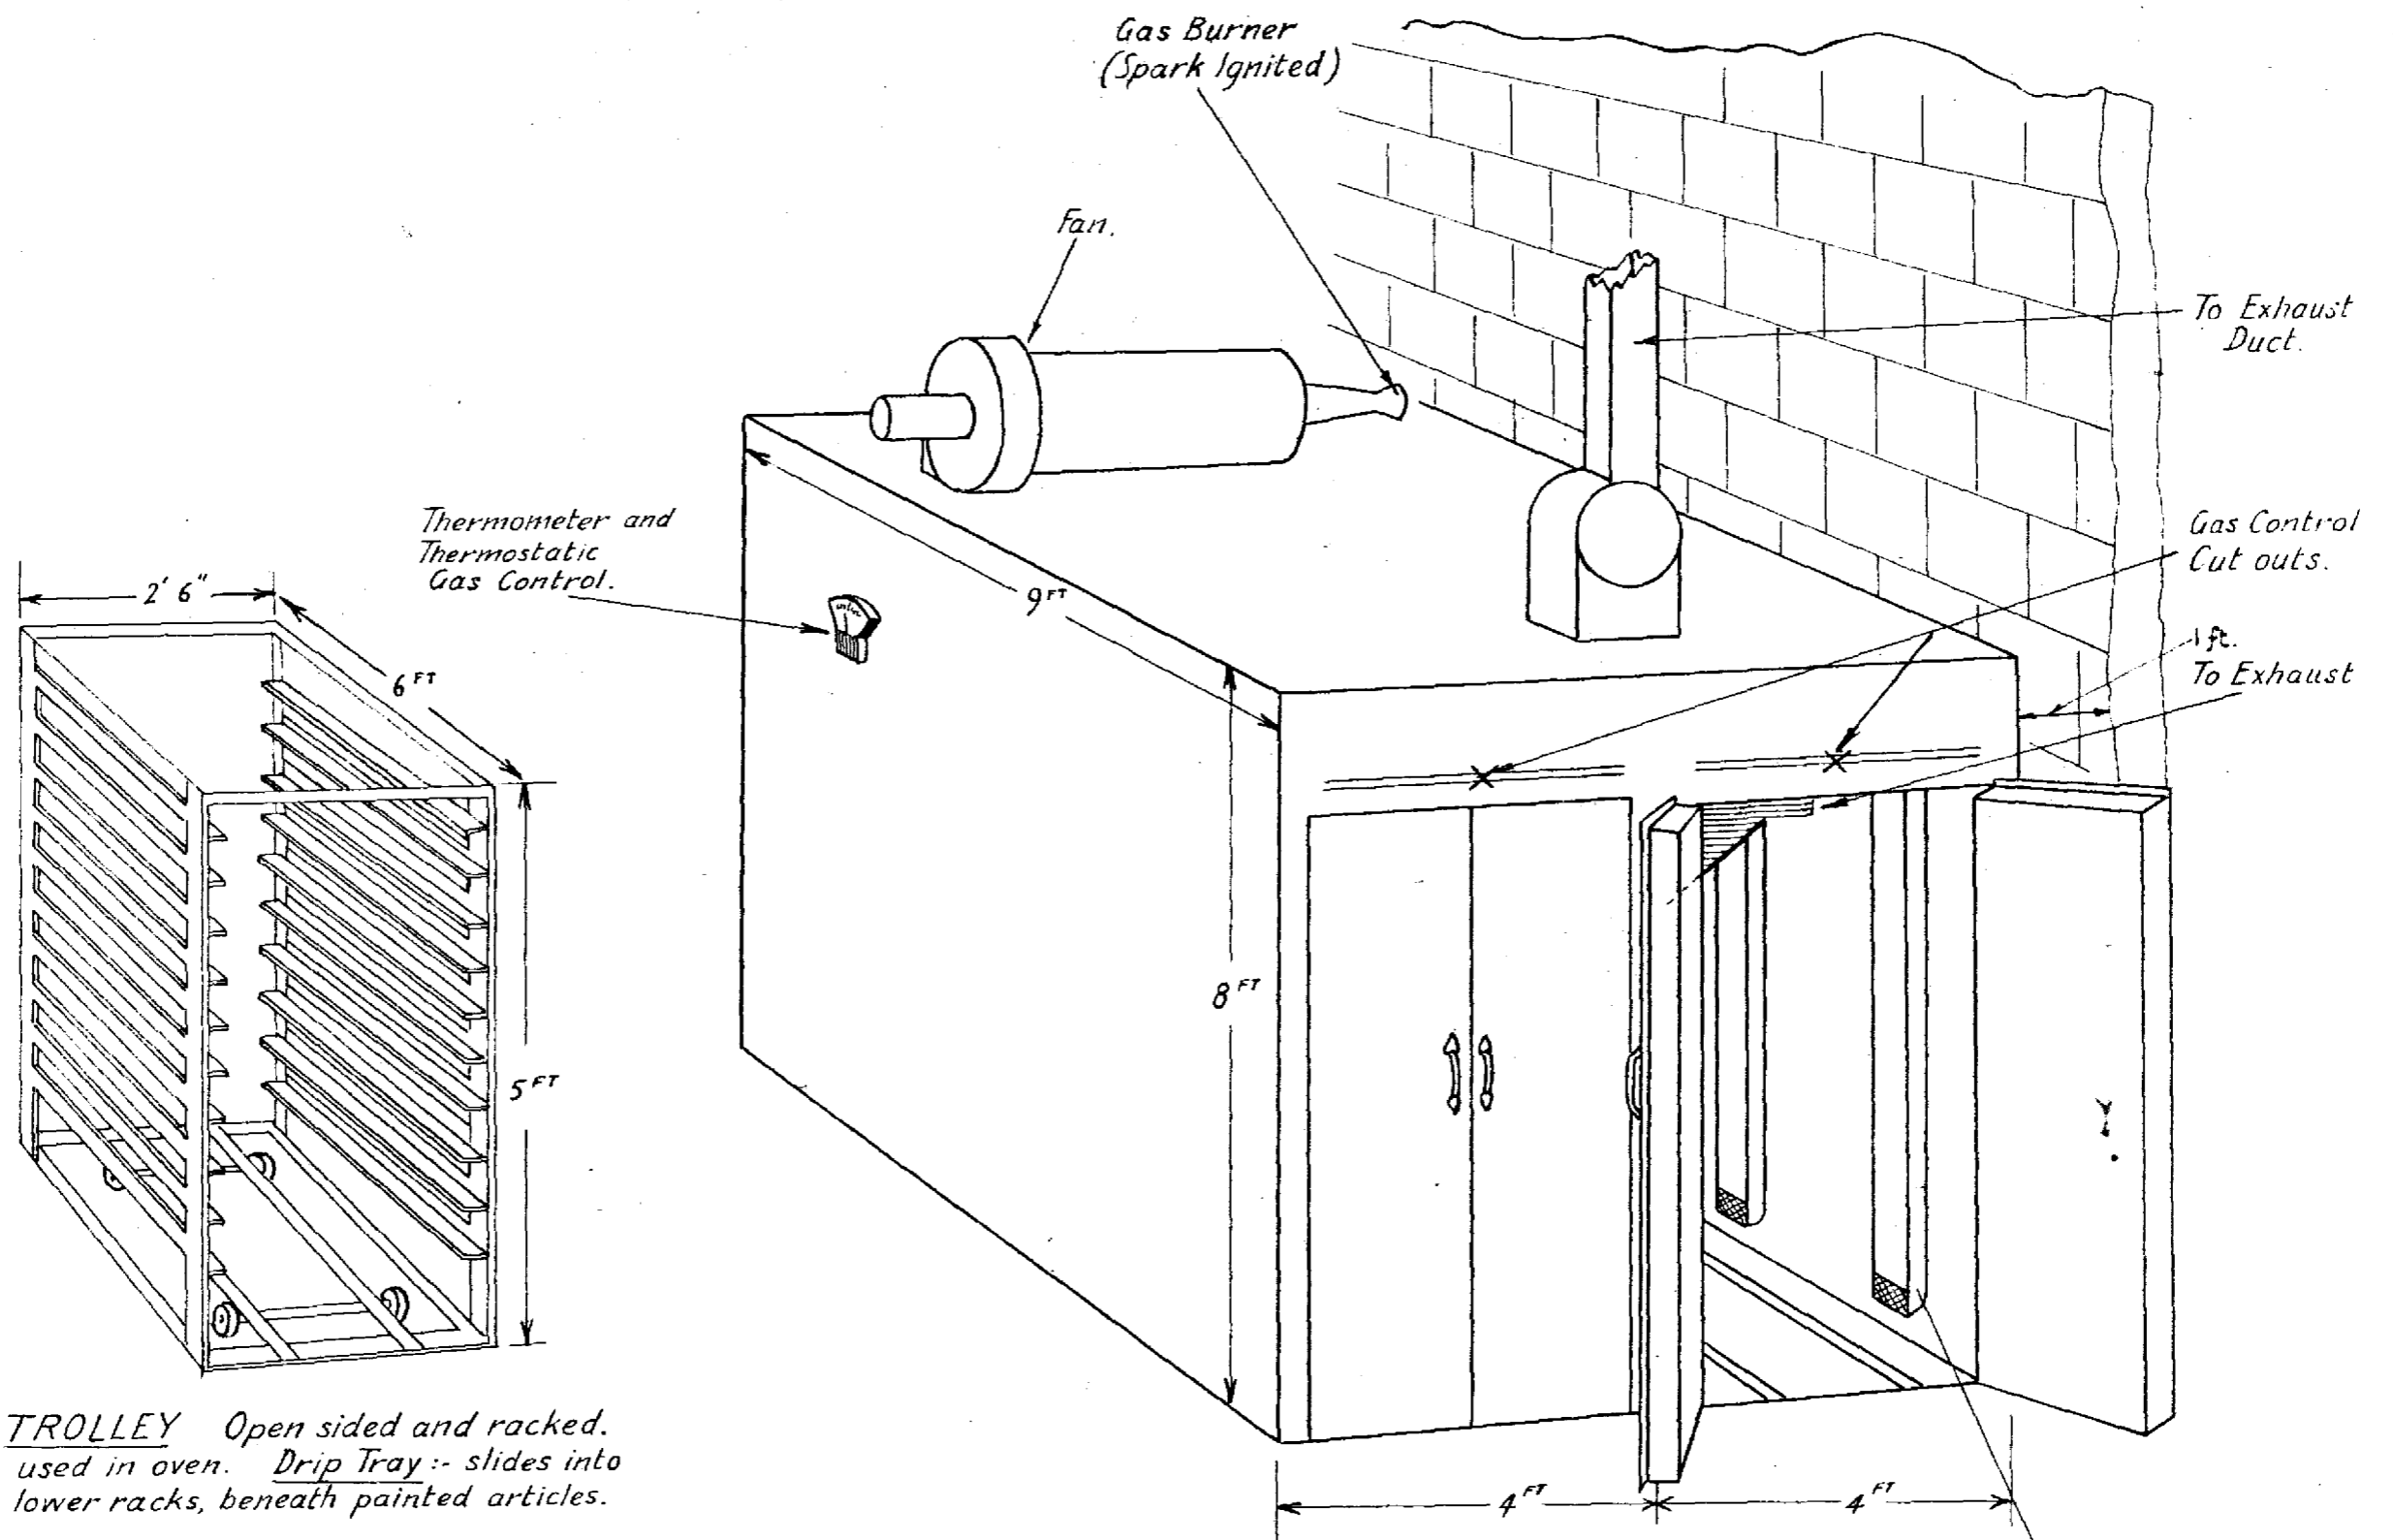
BATCH OVEN. HOOVER LTD, HIGH WYCOMBE.

A sketch of the oven is given in Figure 1. The oven, made by Messrs. Maehler, Ltd., is of sheet steel, approximately 9 ft. x 9 ft. by 8 ft. high, and is divided longitudinally into two compartments, each with its entry and exhaust flues and separate double doors.

On the day of the fire about one hour after the rack of goods had been inserted, the operator noticed a red glow at the base of the right-hand oven. He immediately operated the CO<sub>2</sub> apparatus and 180 lb of the gas was discharged, and the fire was controlled. When the oven was opened the fire was seen to be at the front end of the drip tray and underneath the hot air inlet. The tray was removed and the fire was extinguished with a further 120 lb CO<sub>2</sub>.

The tray contained a layer about  $\frac{1}{2}$  in. thick of solid paint residues. The residues could be ignited with a match and burned readily, and the gas burner was pitted and showed signs of burning and corrosion.

It was considered that the fire could have been initiated by incandive particles of soot, or of hot iron oxide. These could have been carried from the burner and have fallen on to the heated paint drippings and ignited them.

It is suggested that paint residues should not be allowed to accumulate in the drip tray, and therefore the drip tray should be changed immediately before inserting the trolley in the oven.

The discharge of hot particles should be prevented by regular and frequent cleaning of the flues. A further precaution would be the insertion of baffles or a wire mesh screen in the inlet duct at the point where the hot gases enter the oven. It would be advisable to consult the makers of the oven about this.
