P.R. Note No. 172/1955

DEPARTMENT OF SCIENTIFIC AND INDUSTRIAL RESEARCH AND FIRE OFFICES' COMMITTEE
JOINT FIRE RESEARCH ORGANIZATION

REPORT ON AN EXPLOSION IN A PETROL TANK AT THE
IRONBRIDGE SERVICE STATION, SOUTHWALL

D. J. Rasbash and Z. W. Rogowski

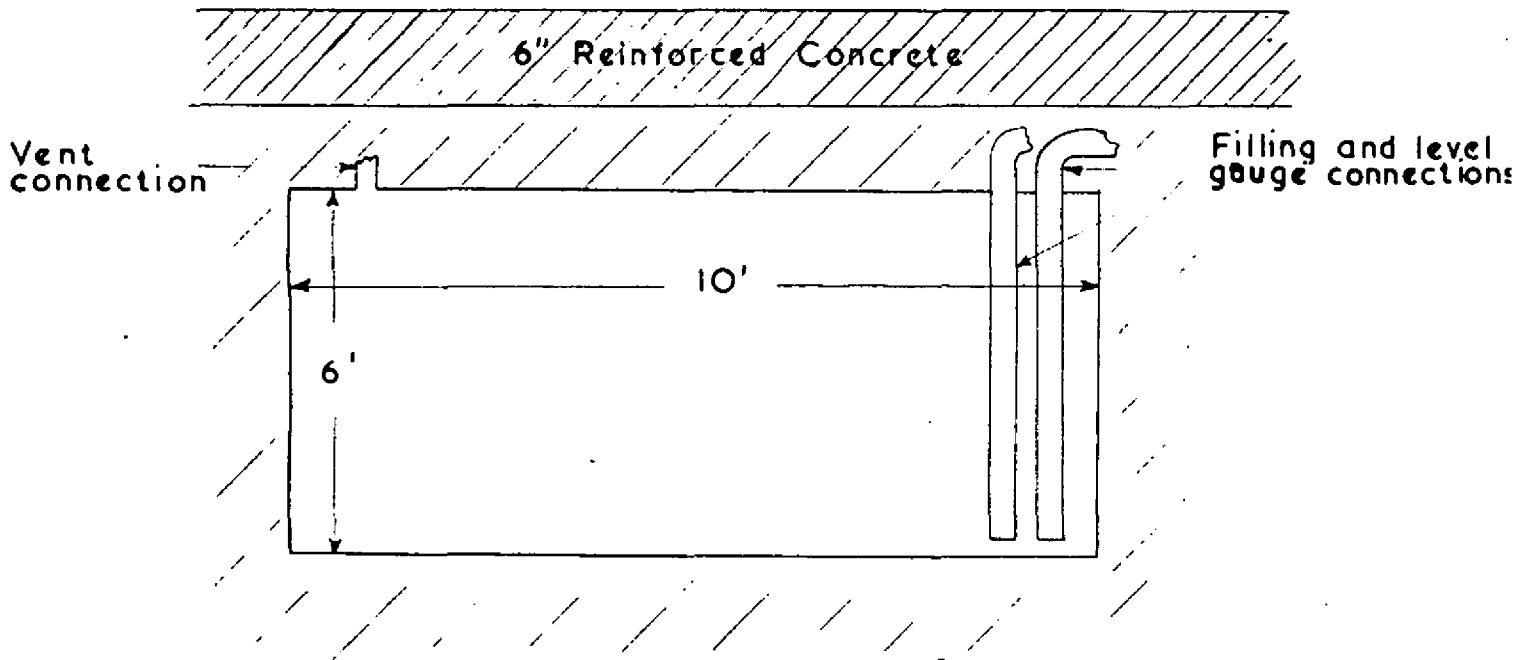
FIG. 1. PROBABLE LAYOUT OF THE TANK BEFORE THE EXPLOSION.

The tank, which was sunk in the ground, had been shattered by the explosion but an examination of the wreckage indicated that prior to the explosion the design of the tank was as shown in figure 1. It was a cylindrical steel shell 6 ft. in diameter and 10 ft. long and its capacity was given as 1,000 gallons. The thickness of the metal was $\frac{1}{2}$ in. and the sheets were butt welded. Two pipes, about $1\frac{1}{2}$ in. internal diameter reached down to the bottom of the tank at one end. Presumably these pipes were used for filling and determining the level of the liquid in the tank. At the top of the other end was a vent hole attached to a length of venting pipe 1 in. internal diameter.

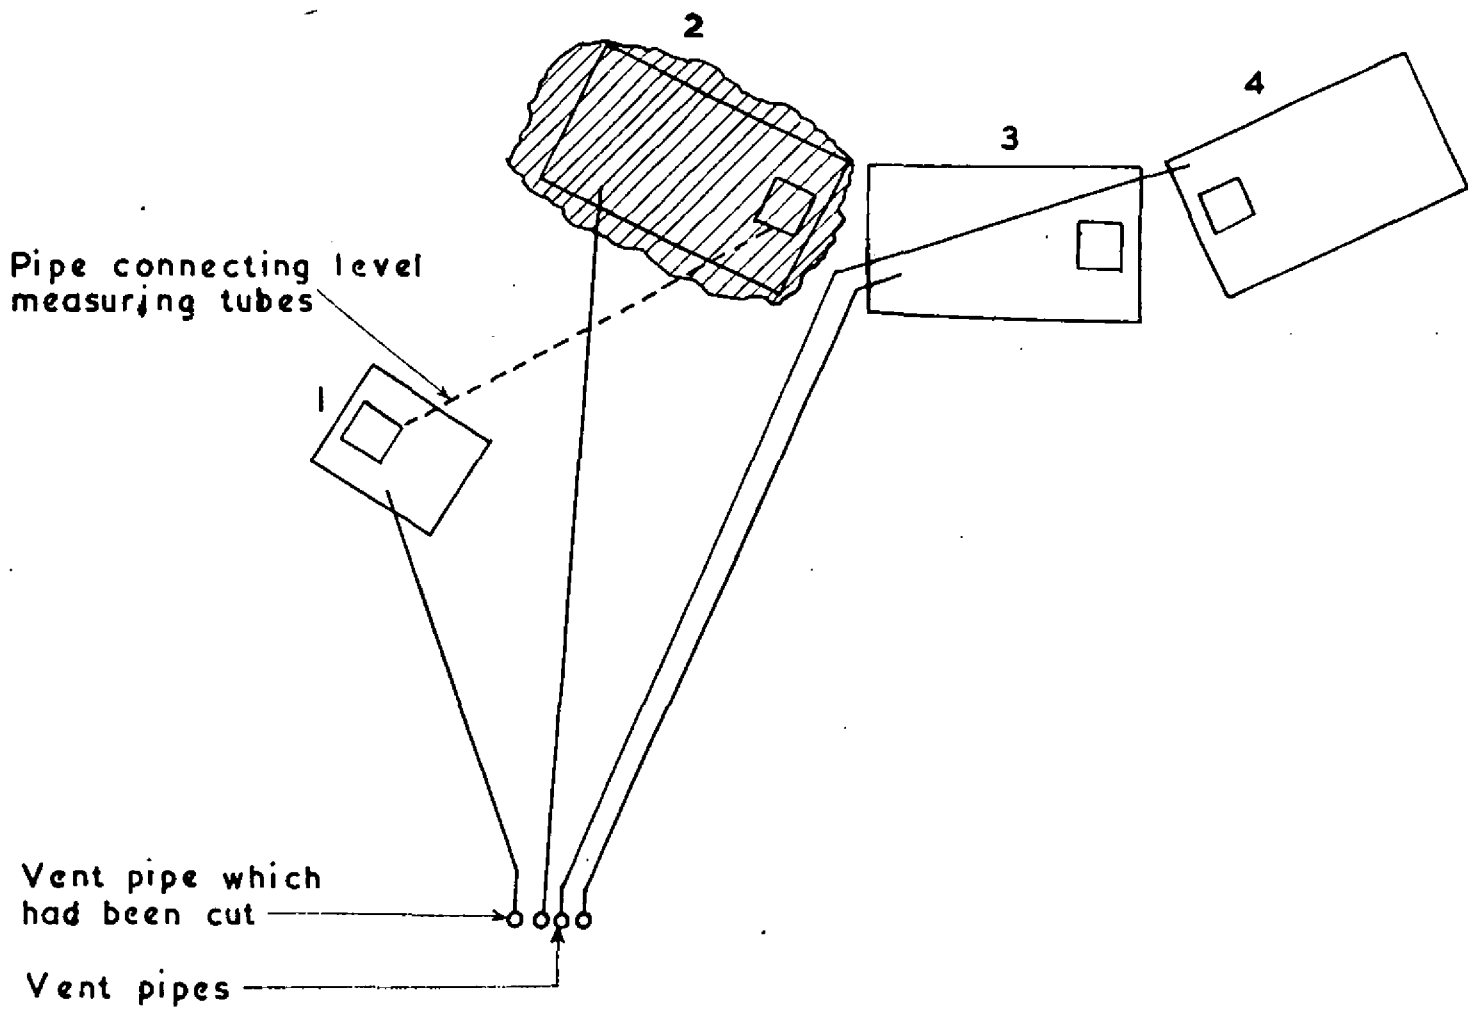
FIG. 2. RELATIVE POSITION OF TANKS ON THE SITE.

The tank was one of a group of four, three of a 1,000 gallon capacity and one of 500 gallons. The relative positions of these tanks are shown in figure 2, which was obtained from information provided by Mr. Squire after our visit to the scene of the explosion. The tank which exploded is marked as tank 2. The vent pipes from each of the four tanks ran underground for a distance of some 20 to 30 ft. before rising vertically to a height of 7 ft. There was a connection between the level measuring tubes of the 500 gallon tank (tank 1) and tank 2. The tanks were stated to have been installed in concrete chambers with a 9 in. base and 6 in. sides and top and packed with puddled clay.

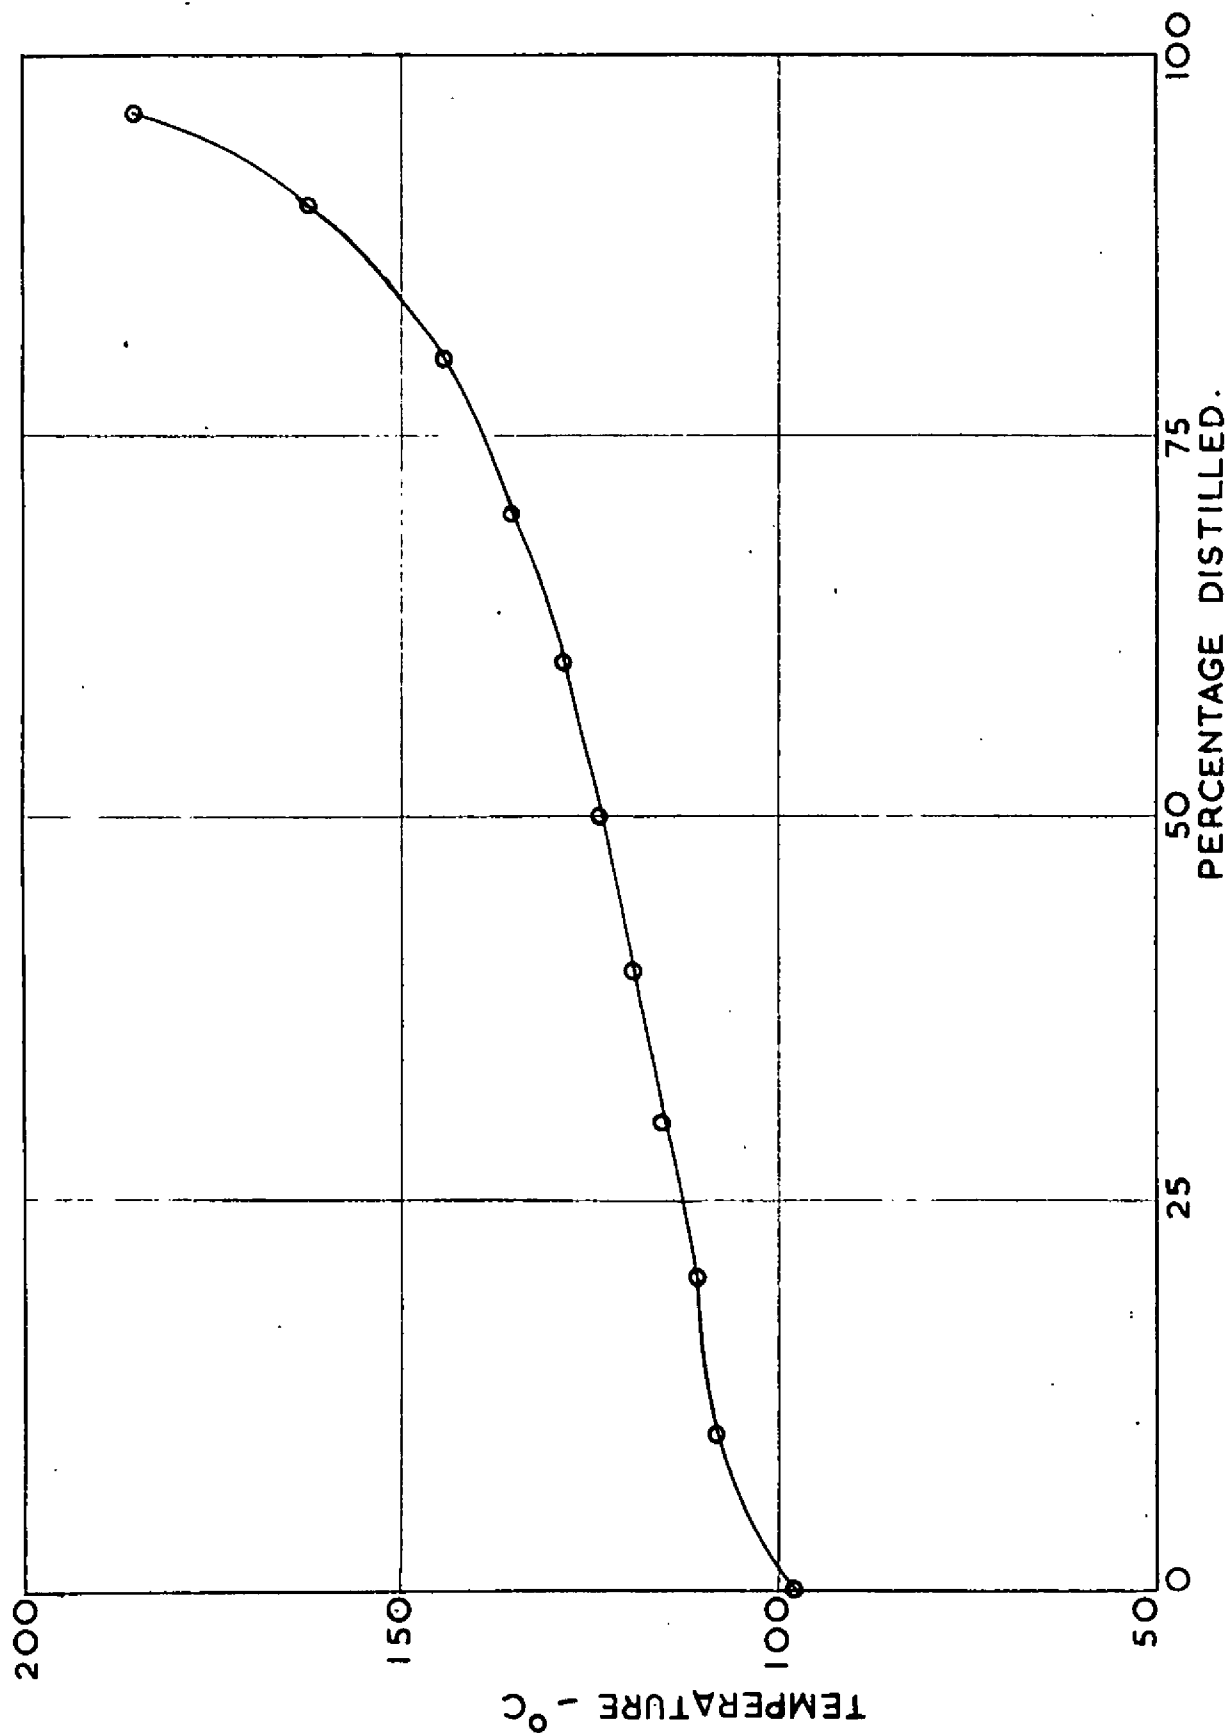
FIG. 3. DISTILLATION CURVE FOR THE LIQUID COLLECTED FROM THE TANK

Small quantities of petrol were found in the foam. A sample collected for examination gave the distillation curve shown in figure 3. The curve indicates a normal petrol, except for the fact that the initial boiling point is somewhat higher than usual. This indicates, as might be expected, that some of the lighter fractions had evaporated from the original liquid. The liquid was easily ignited at room temperature by a small gas flame.
