F.R. Note No. 192/1955
Research Programme
Objective

REPORT OF A VISIT TO THE SCENE OF A FIRE AT METAL COLOURS (SLOUGH) LTD.

D. J. Rasbash and E. H. Coleman

June, 1955.

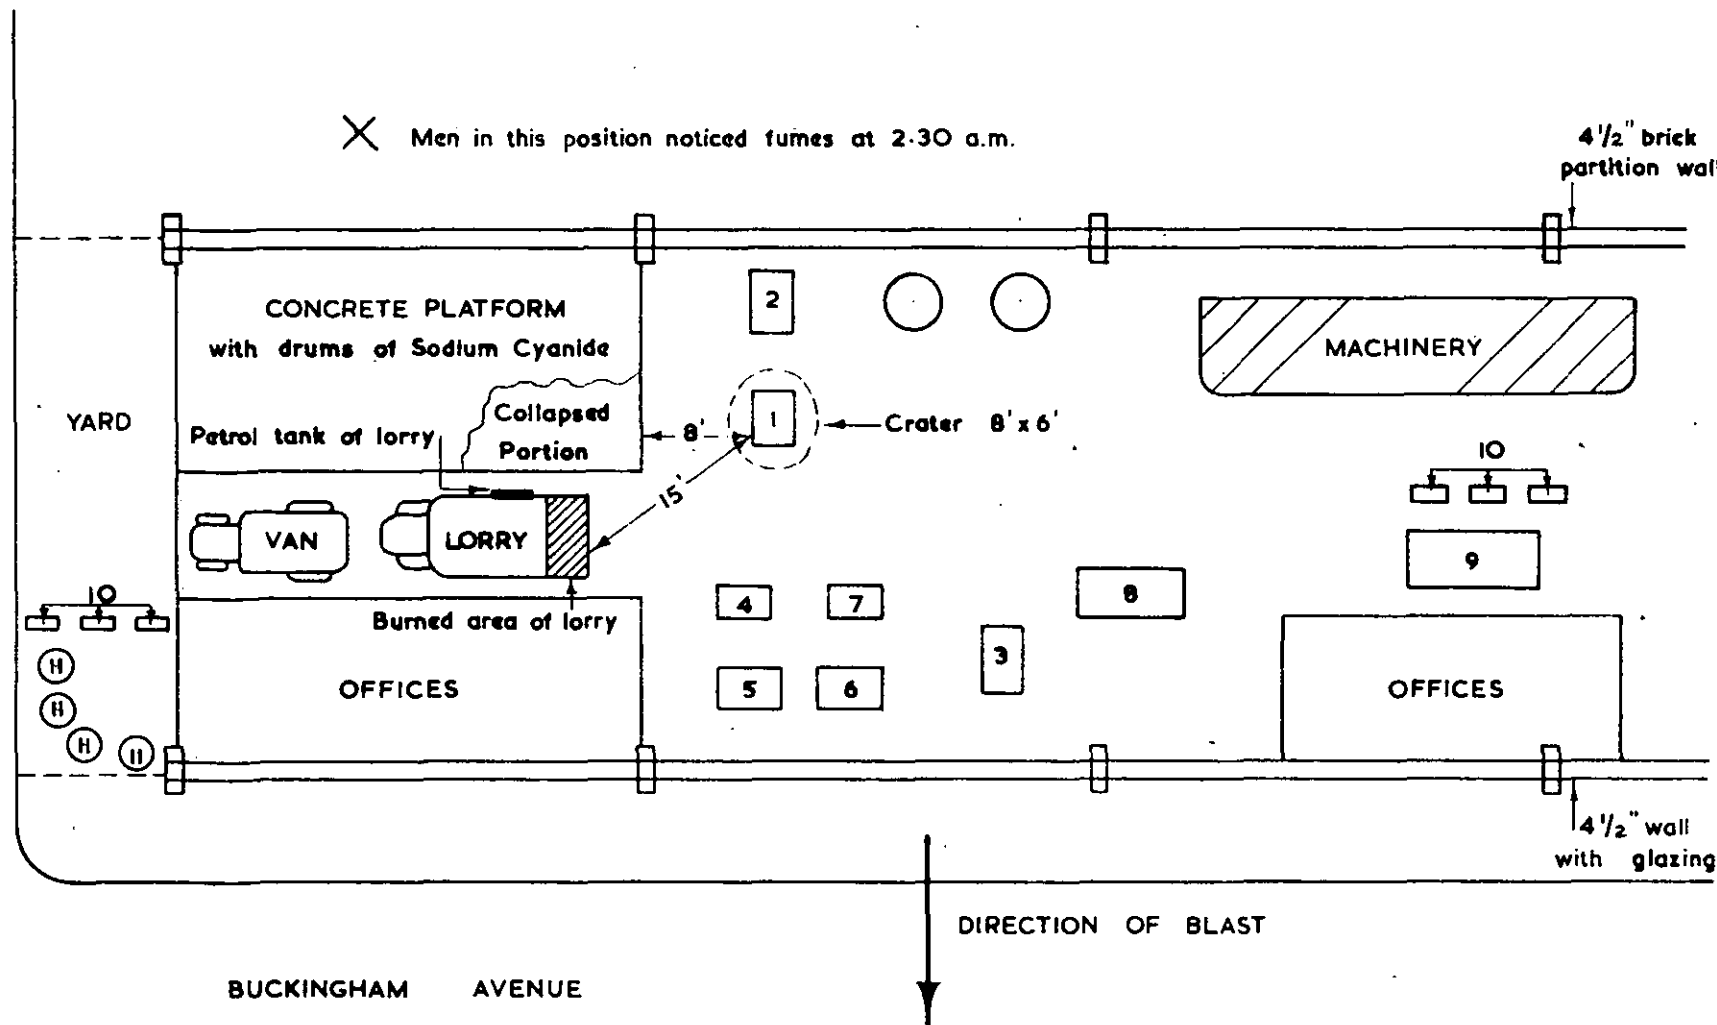
FIG. 1. SKETCH PLAN OF WORKS OF MESSERS METAL COLOURS (SLOUGH) LTD.

The explosion blew out the walls and removed the asbestos cement roof. Debris was scattered over a wide area. The main force of the blast was in the direction shown by the arrow on the plan (Fig. 1). Asbestos roofing and glass windows at Messrs. Mars Ltd. were broken and a portion of the metal end of the bath was found about $\frac{1}{2}$ mile away. The works next door to Messrs. Metal Colours (Slough) Ltd. was gutted by fire.

Inside the works, No. 1 nitrate bath had disappeared leaving a crater about 8 ft. x 6 ft. Bath No. 2 had been torn apart. The outer casing of $\frac{1}{4}$ in. steel was bent inwards, and the inner pot of $\frac{1}{2}$ in. mild steel torn open. Bath No. 3 was not damaged.

Fragments had punctured the oil pipes on the transformer (No. 4 Fig.1). The rear of the lorry was burnt away, and the heat had been sufficiently intense to soften the rear road springs. The previous evening the lorry had been loaded with wooden barrels containing lead nitrate, and the petrol tank had been filled ready for starting in the morning. Some of the barrels had rolled out and were charred. In spite of the intensity of the fire at the rear of the lorry the petrol tank was not affected and contained its full amount of petrol.

It is considered that the explosion was due to the over-heating of No. 1 nitrate bath. The hot fragments scattered by the explosion initiated the fires which were intensified by oil leaking from the fractured transformer.
