FIRE IN WOOD CHIP INSULATION

P. C. Bowes

This note describes an investigation into the cause of a fire that is believed to have started in wood chip insulation surrounding a warm air duct above a veneer drying kiln.

F.1015/10/60
October, 1955.

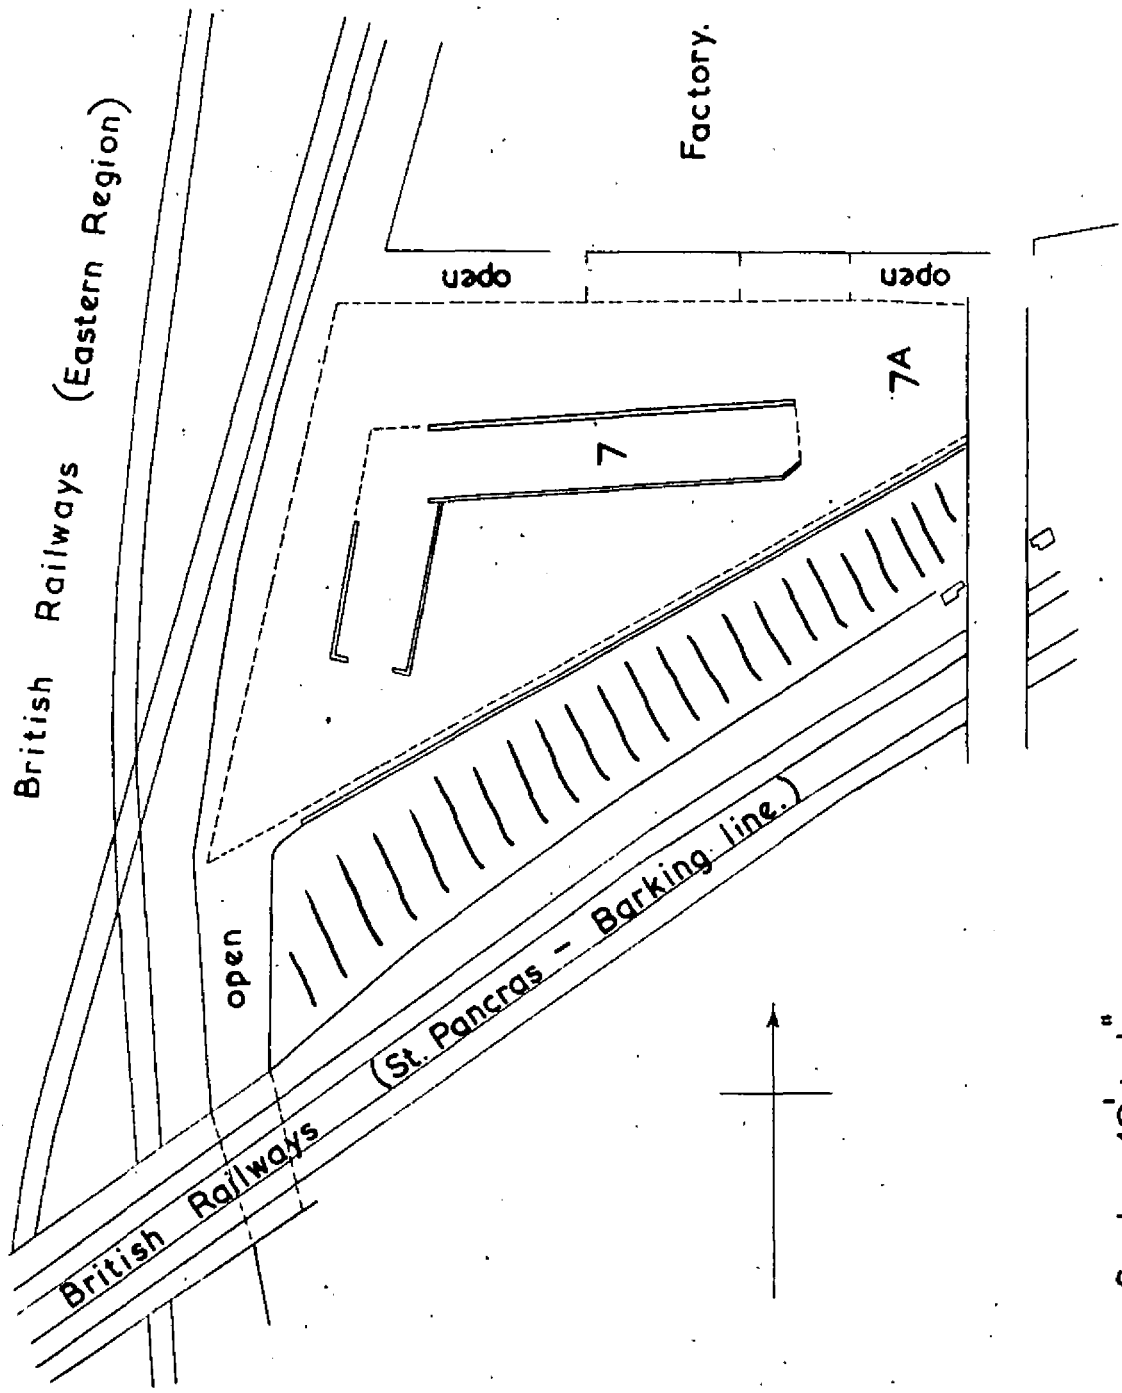
FIG. I. PLAN OF SITE.

In the troughs of the corrugated roof of the building 7A (Fig. 1) surrounding the kiln, and in corners elsewhere, there were deposits of fine wood dust of up to about an inch in thickness. It was learnt that these deposits were known to smoulder. It is, perhaps, possible that a similar deposit leading into the ventilator above the header had been ignited by a spark from the railway, and that some of the smouldering dust had fallen into the wood chips and so set up smouldering that eventually developed into the fire.

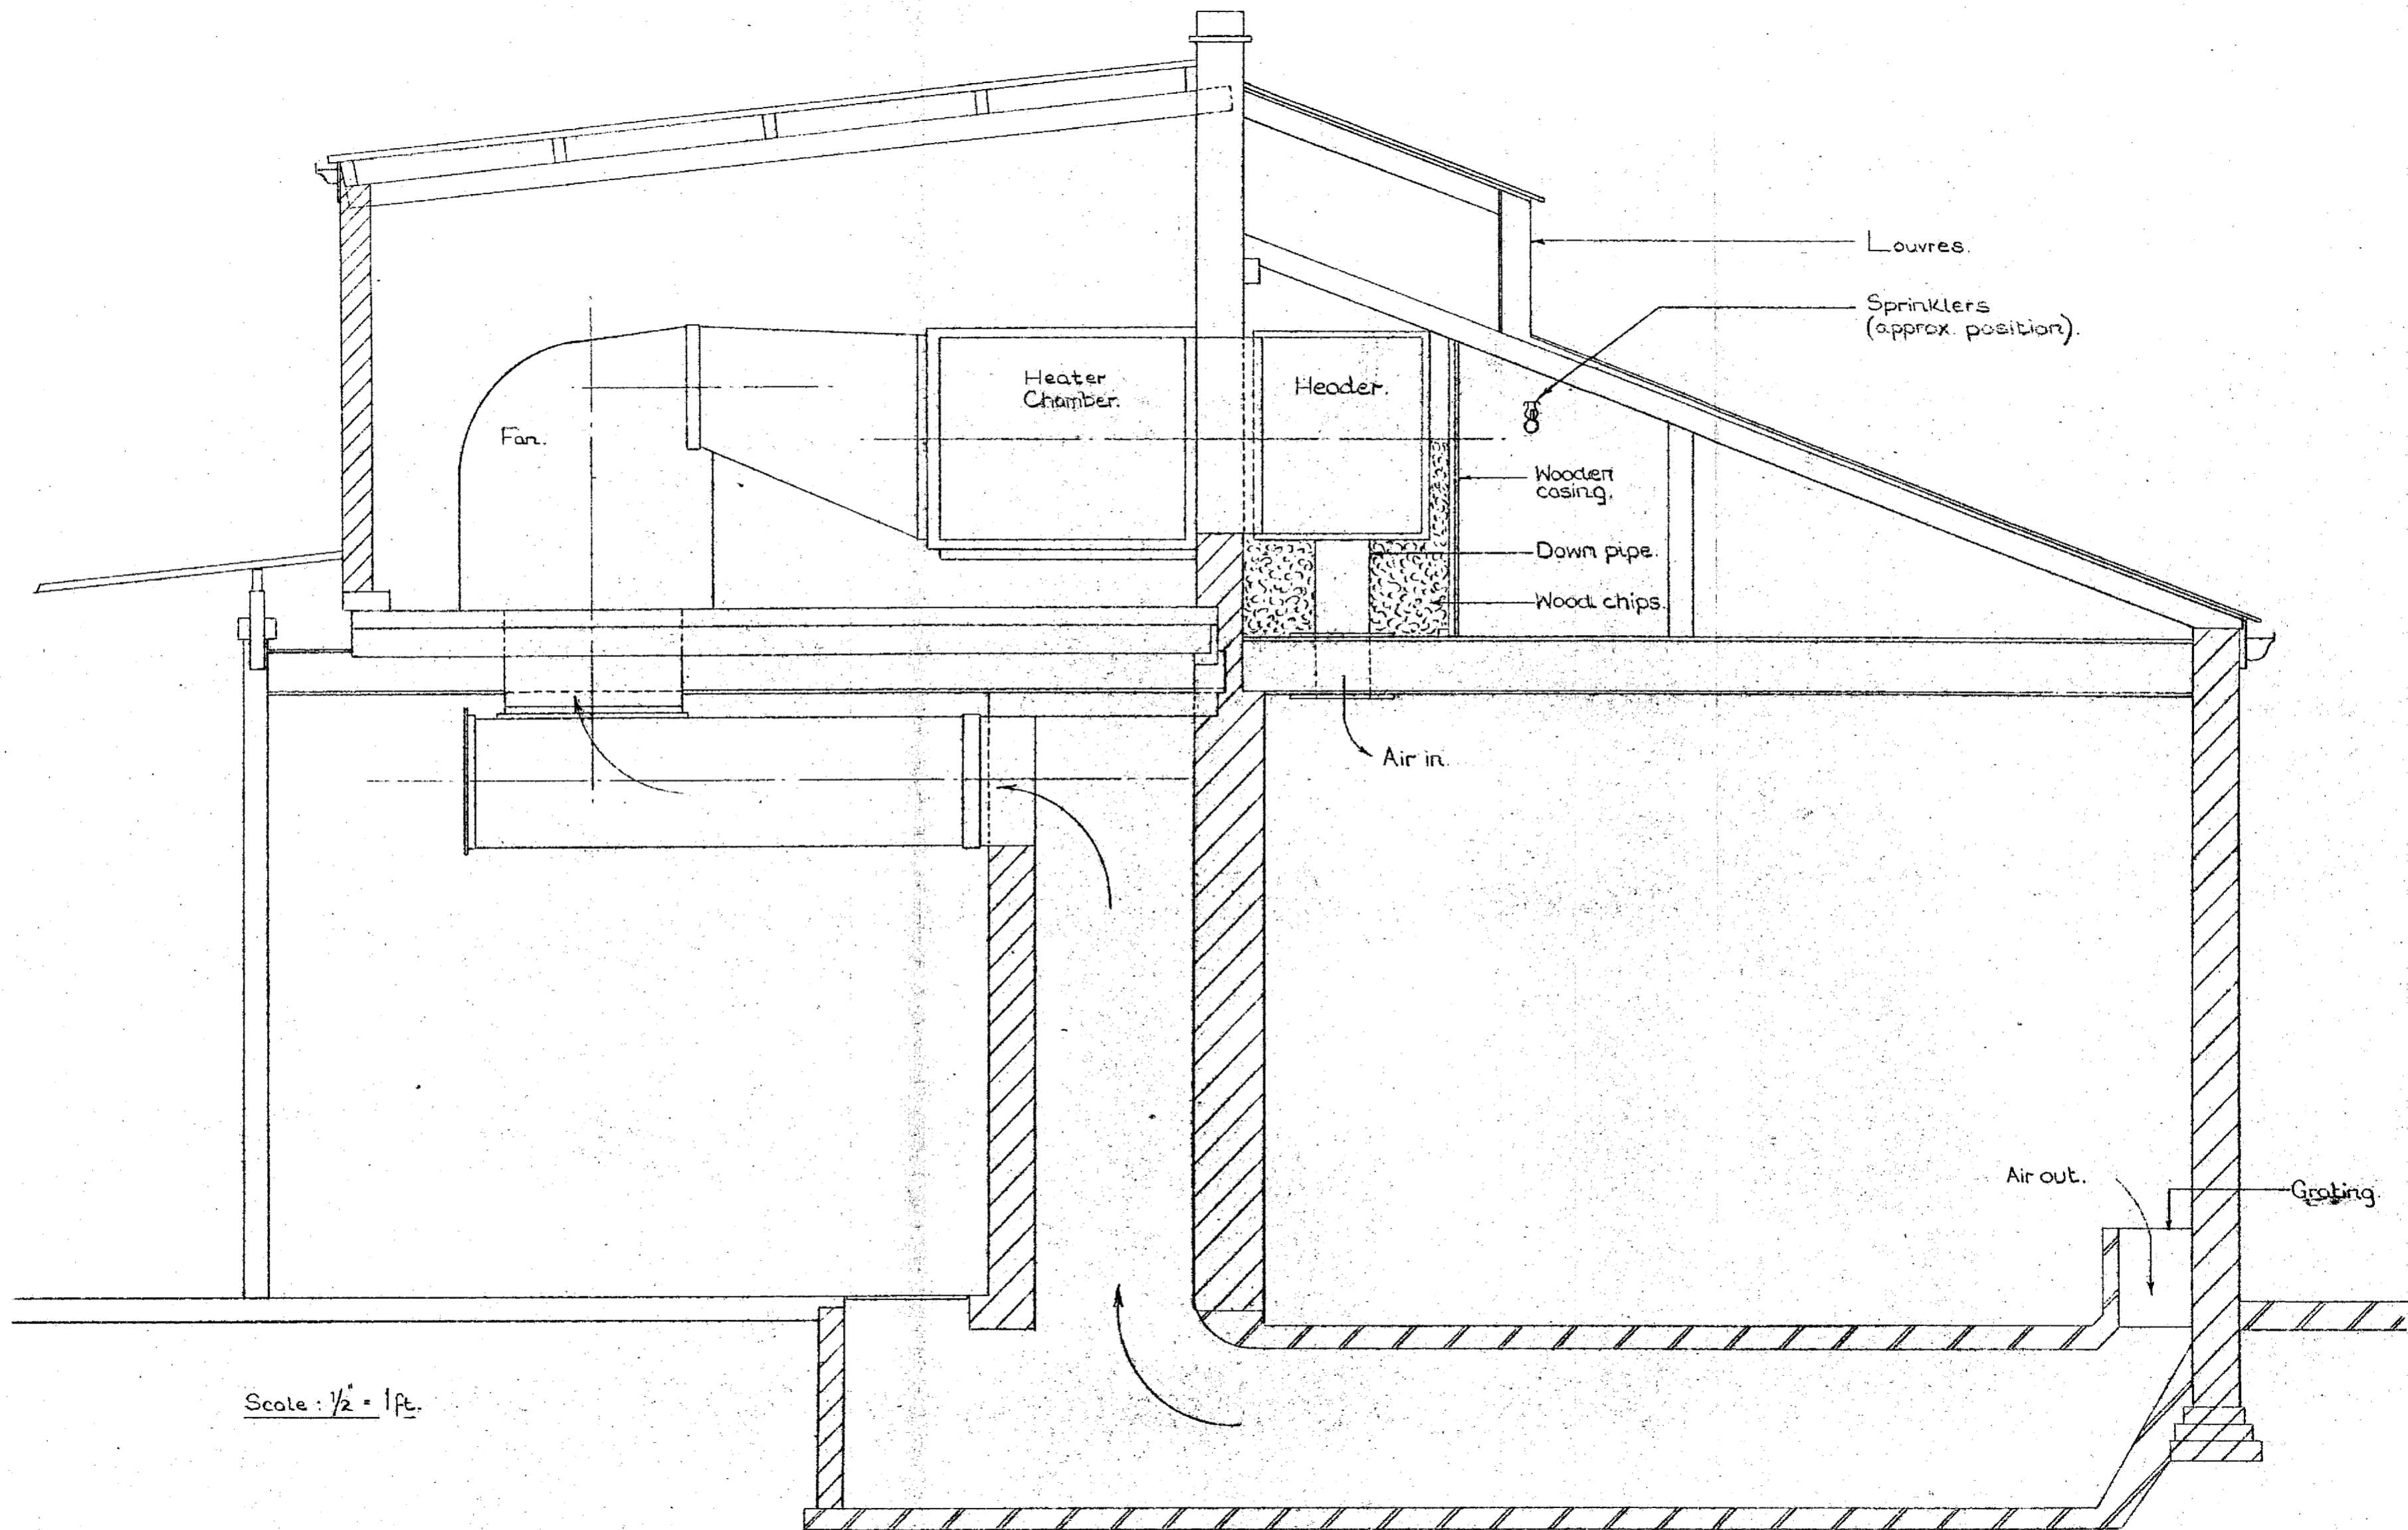
FIG. 2. VENEER DRYING KILN - SECTIONAL ELEVATION.

The kiln was last entered at about 5 p.m. on the day of the fire, when a load of corrugated cardboard was put in to it. At 5.58 p.m. the sprinkler alarm sounded. When Mr. Wilds arrived on the scene of the fire the matchboarding in the west end of the gable had been burnt through above the end of the header, and the roof space above the header was involved for about one third of its length from the west end. It was clear that the fire had reached an advanced stage before the sprinklers were actuated; in view of the position of the sprinklers (Fig. 2) this is understandable.

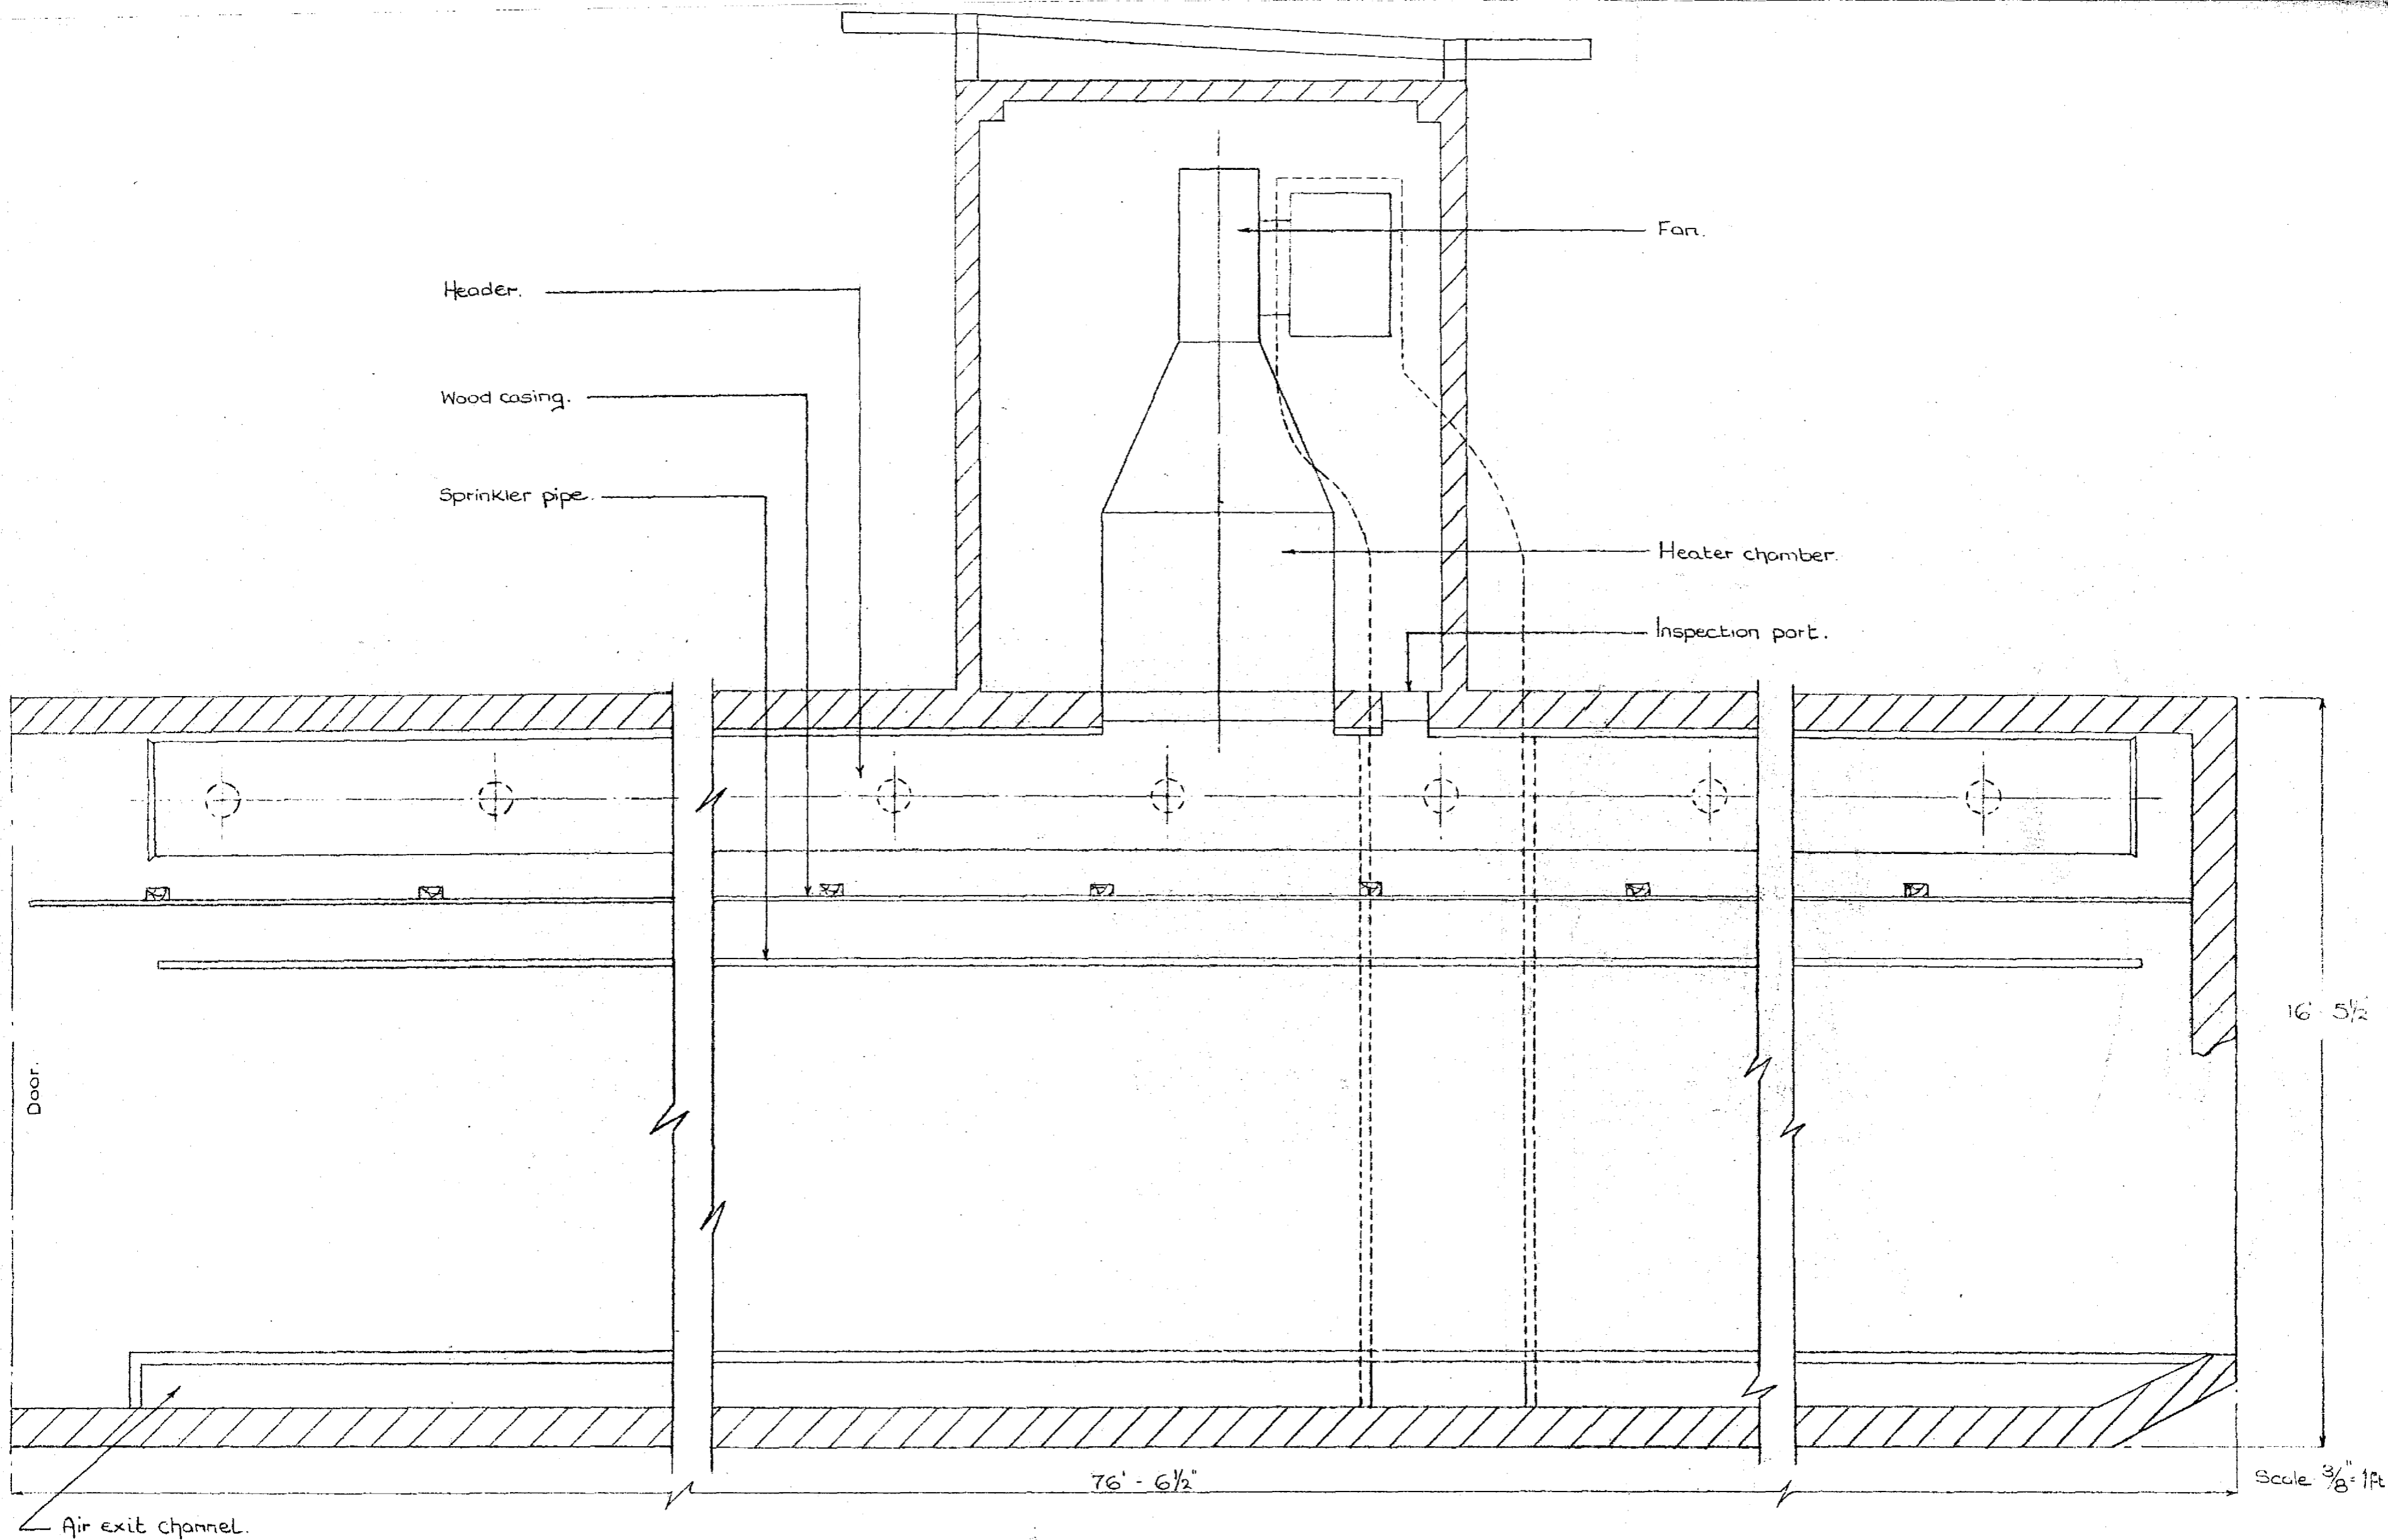
FIG. 3.

Fire in air circulation system. The possibility of a fire having occurred first in the air circulation system was considered. The exit channel under the grating along the south wall of the kiln and the inside of the header were both inspected; the latter through the inspection port shown in Fig. 3. Apart from a thin coating of dust, probably wood dust, the channel and header were free from combustible material.

However, the inside of the header was coated with a tar deposit, on the top and the side nearest the wall, in the central sections where the fire had been most intense. The steam radiator nearest the exit from the air heating chamber was just visible from the inspection port and did not appear to have any deposit on it.

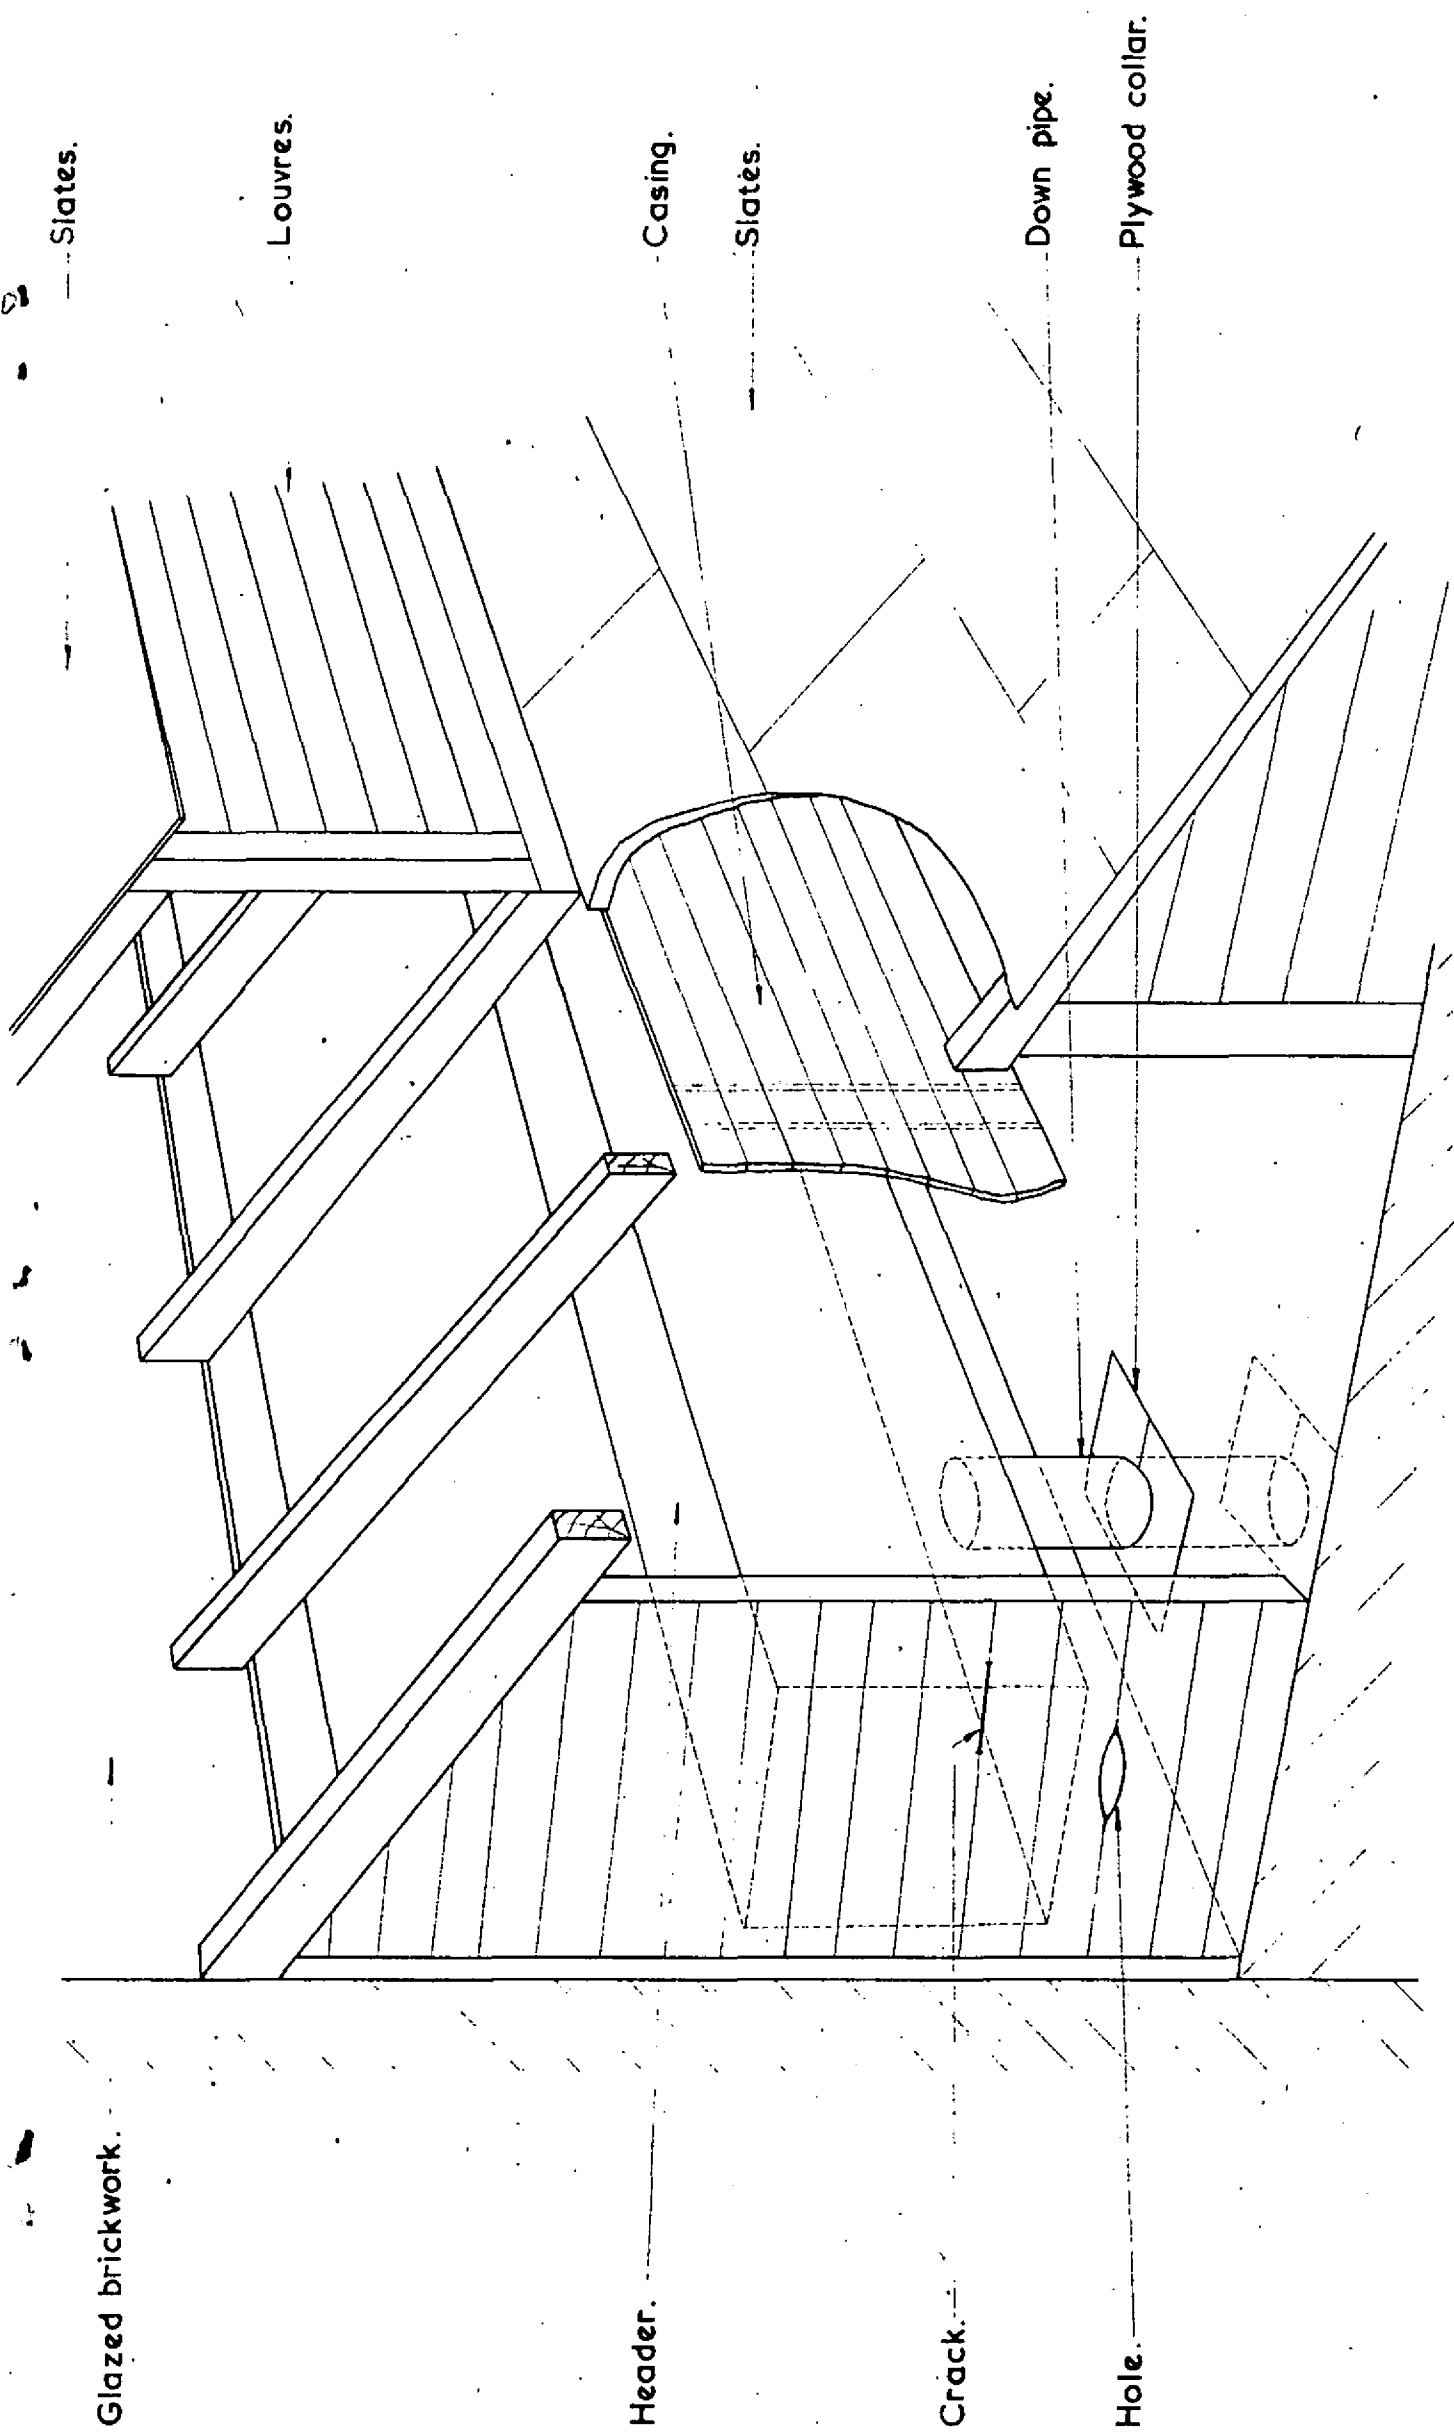
FIG. 4. CUT AWAY SKETCH OF WEST END OF ROOF SPACE.

Where the wooden casing had not been destroyed by fire it was pulled away in order to attack fire in the wood-chip insulation. Pockets of fire were found in the wood chips along the whole length. The largest pocket of fire was round the first down pipe at the west end of the header (Fig. 4). At this point the wood chips were heavily charred and were glowing on the surface where they had shrunk away from the underside of the header. The upper side of the plywood collar surrounding the down

pipe was charred and the inside of the casing was more heavily charred than the outside. A hole had been burnt, at the point indicated in Fig. 4, through the matchboarding that filled the gable end. The matchboarding was heavily charred round this hole on the inside. Above a height of about 3 ft. the matchboarding had been destroyed.

The hole in the matchboarding (Fig. 4), mentioned above, was examined. The heavy charring round the hole extended for 2-3 inches on the inside of the matchboarding. Immediately above this charred area there was about 6 in. of undamaged wood and then more charring. It was quite clear that there had been an intense and localised fire in the chips near this hole. This fire is likely to have been little more than slow smouldering until the hole was burnt through and an air draught was admitted. On the other hand, there was a crack between the boards (due to a broken tongue) approximately in the position indicated in Fig. 4 and there may have been a similar crack where the hole developed.

The outside of the matchboarding in the west gable end (Fig. 4) appeared to be undamaged for at least a foot in between the hole and the upper part that was destroyed. For the fire to spread from the hole to the upper part it would have been necessary for a jet of flame to have issued from the hole and to have been blown back by the west wind to ignite the boarding at a higher point. It is not easy to understand how the required jet of flame could have occurred.
