F.R. Note No. 2967 אינידו

A VISIT TO THE SCENE OF A FIRE AT THE AMALGAMATED DENTAL ENGINEERING CO., HAMM MOOR LANE, CHERTSEY, SURREY.

H. L. Malhotra

February, 1957.

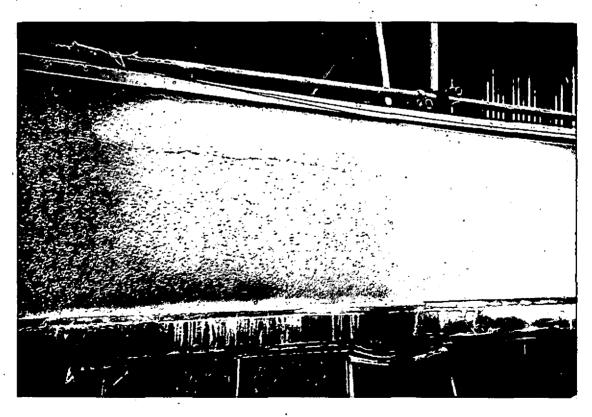
Slight damage was also noticed on the exterior at the end of the bay as shown in Figure 4.

FIG.4a. EXTERIOR VIEW SHOWING DAMAGE TO ALLOY GLAZING BARS
