REPORT OF A VISIT TO THE JAGUAR CAR FACTORY, COVENTRY

L. A. Ashton (J.F.R.O.) and G. Langdon Thomas (B.R.S.)

Summary

A brief description is given of the fire which occurred at the Jaguar Car Factory in February 1957 and the factors which contributed to the rapid growth of the fire are considered.

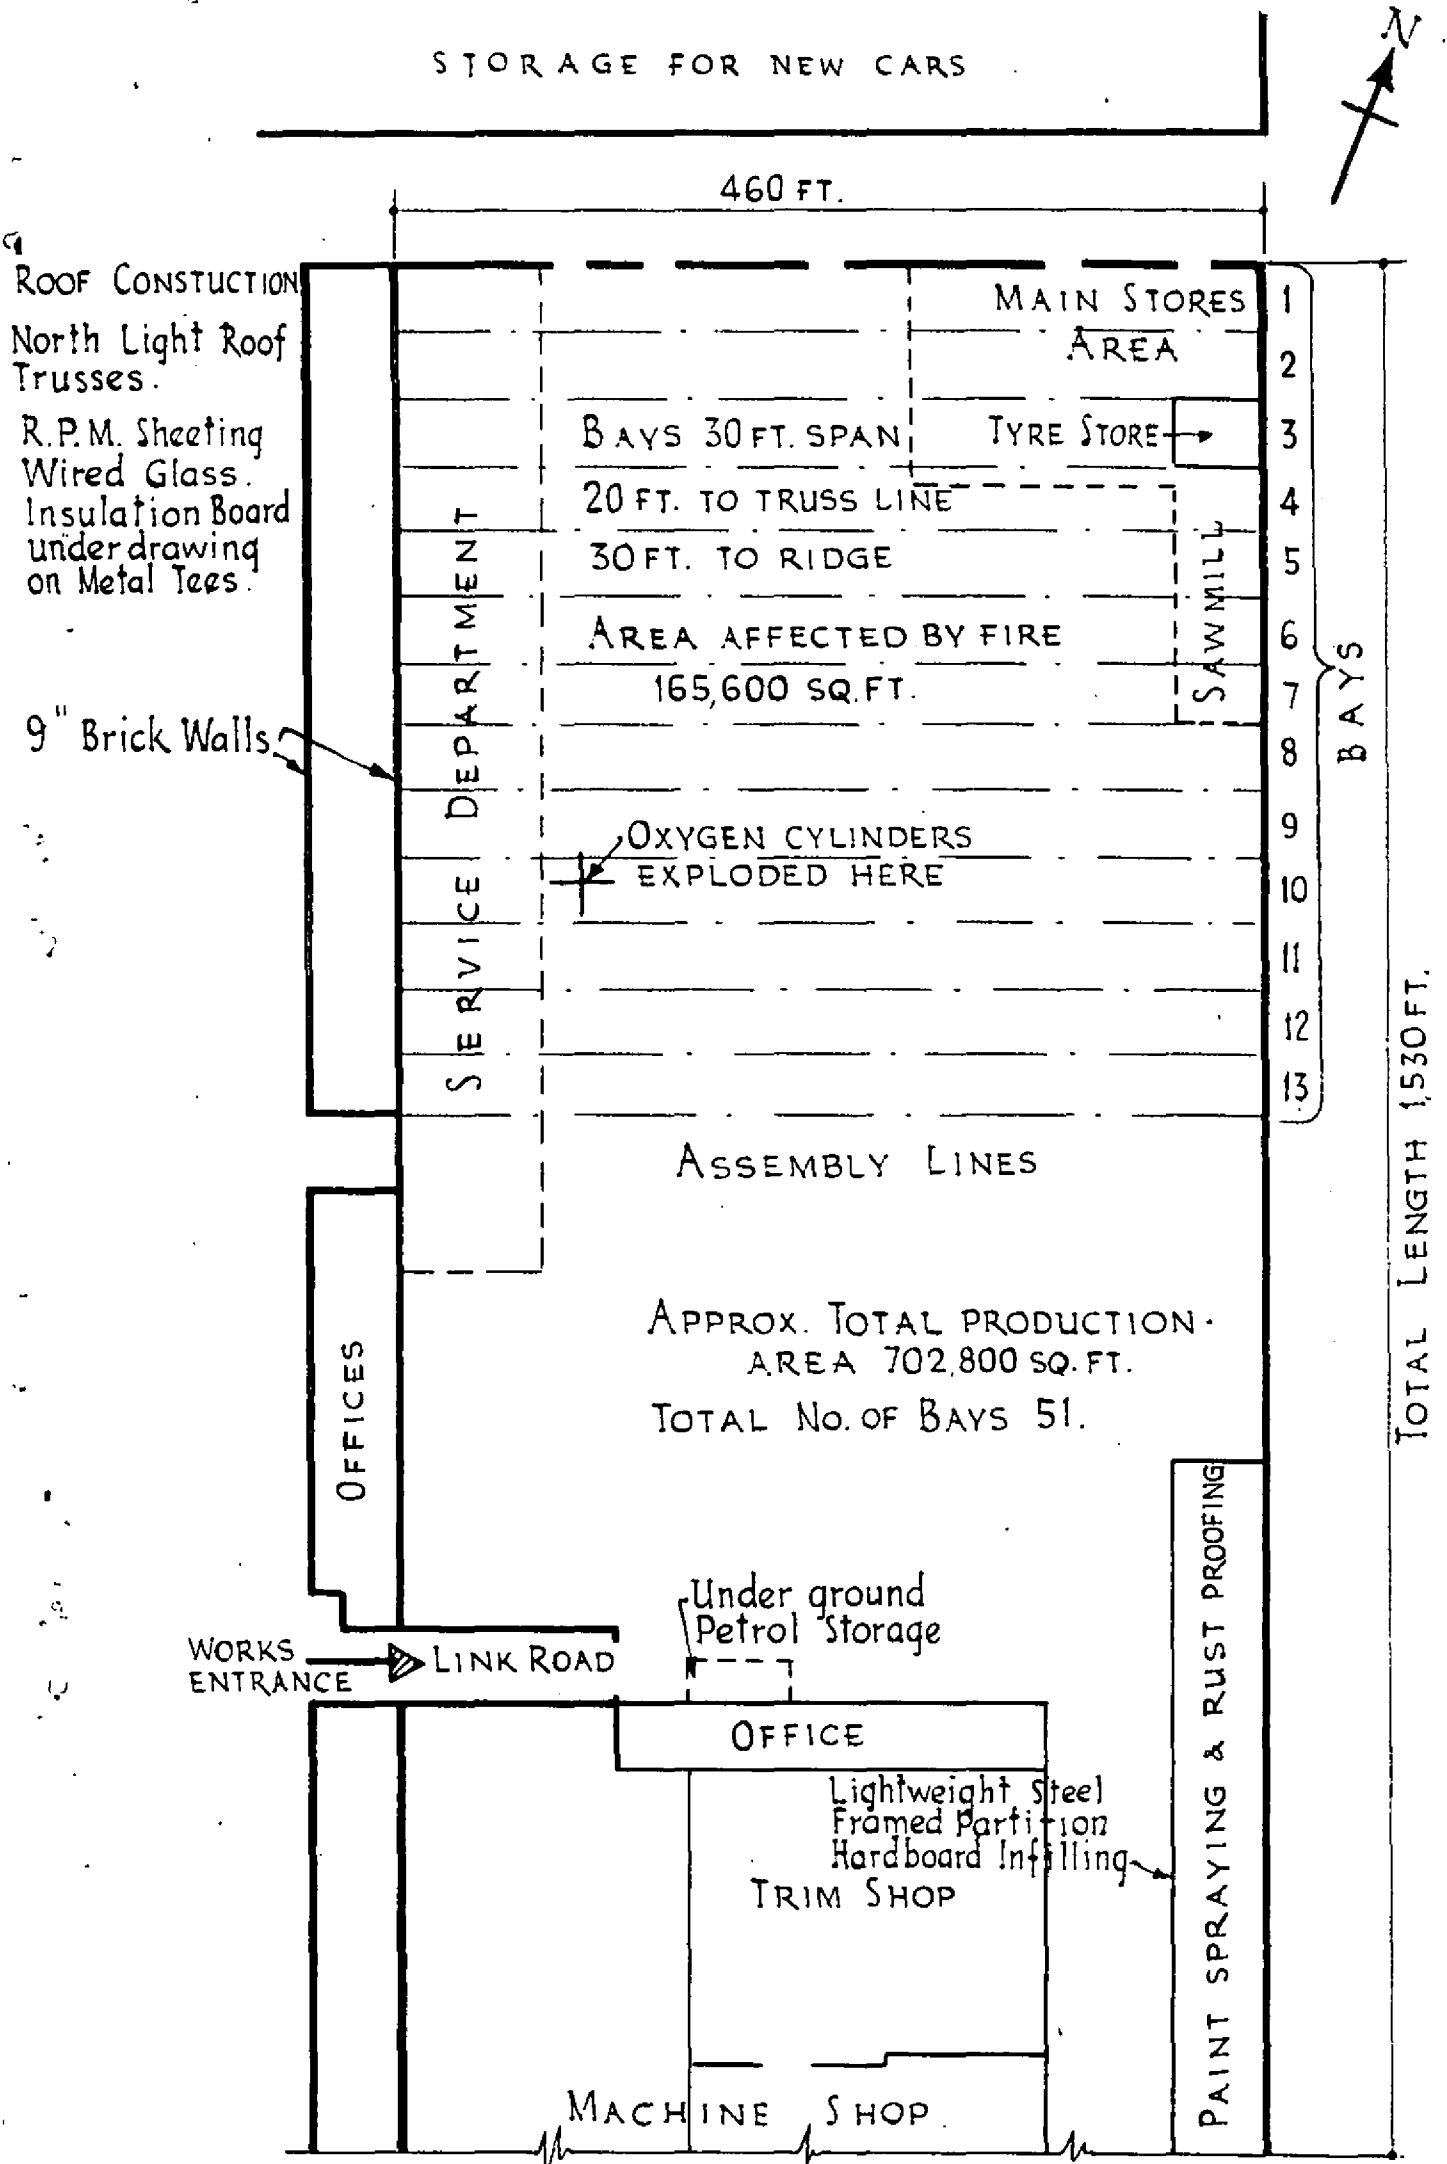
FIG. 1. LAYOUT OF PART FACTORY AREA
 JAGUAR CAR FACTORY: COVENTRY.

The building consisted of a large single-storey structure 460 ft. wide by 1530 ft. long which provided the production area of the Jaguar factory. Steel saw-tooth, or north light, roof trusses of 30 ft. span were supported on steel stanchions, none of the internal steelwork being protected against fire. The roof covering was a form of corrugated steel sheeting protected against corrosion by a factory-applied bituminous coating on both sides. Below the roof covering was a lining of fibre insulation board supported in metal tees, which in some bays were fixed below the purlins and in the remainder above the purlins. In portions of the roof there was thus an unstopped air gap between the roof covering and the lining. The north lights in the bays were wired glass in patent glazing. Roof ventilators had been installed about 70 ft. apart along the ridge of each bay. External walls were of 9 in. brickwork. Across the building at its mid-point was the main entrance, termed the link road, which was bounded by block walls built up to the underside of the roof lining, but these walls were not continuous across the building and therefore did not form a complete separation between the assembly lines and the machine shop, etc. (see Figure 1).

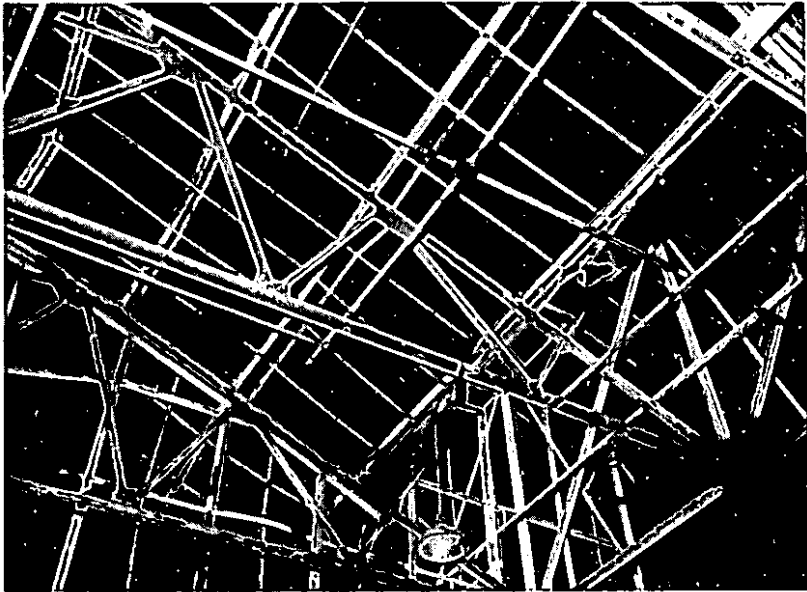
Plate 2. Underside of roof away from seat of fire.
(57/102)
