F.R. Note No. 46/1952

## EXPLOSIONS IN SALVUS BREATHING APPARATUS

This report describes the explosion of a Salvus breathing apparatus in the Derbyshire County Fire Brigade and an investigation into the possible causes of this and similar explosions.

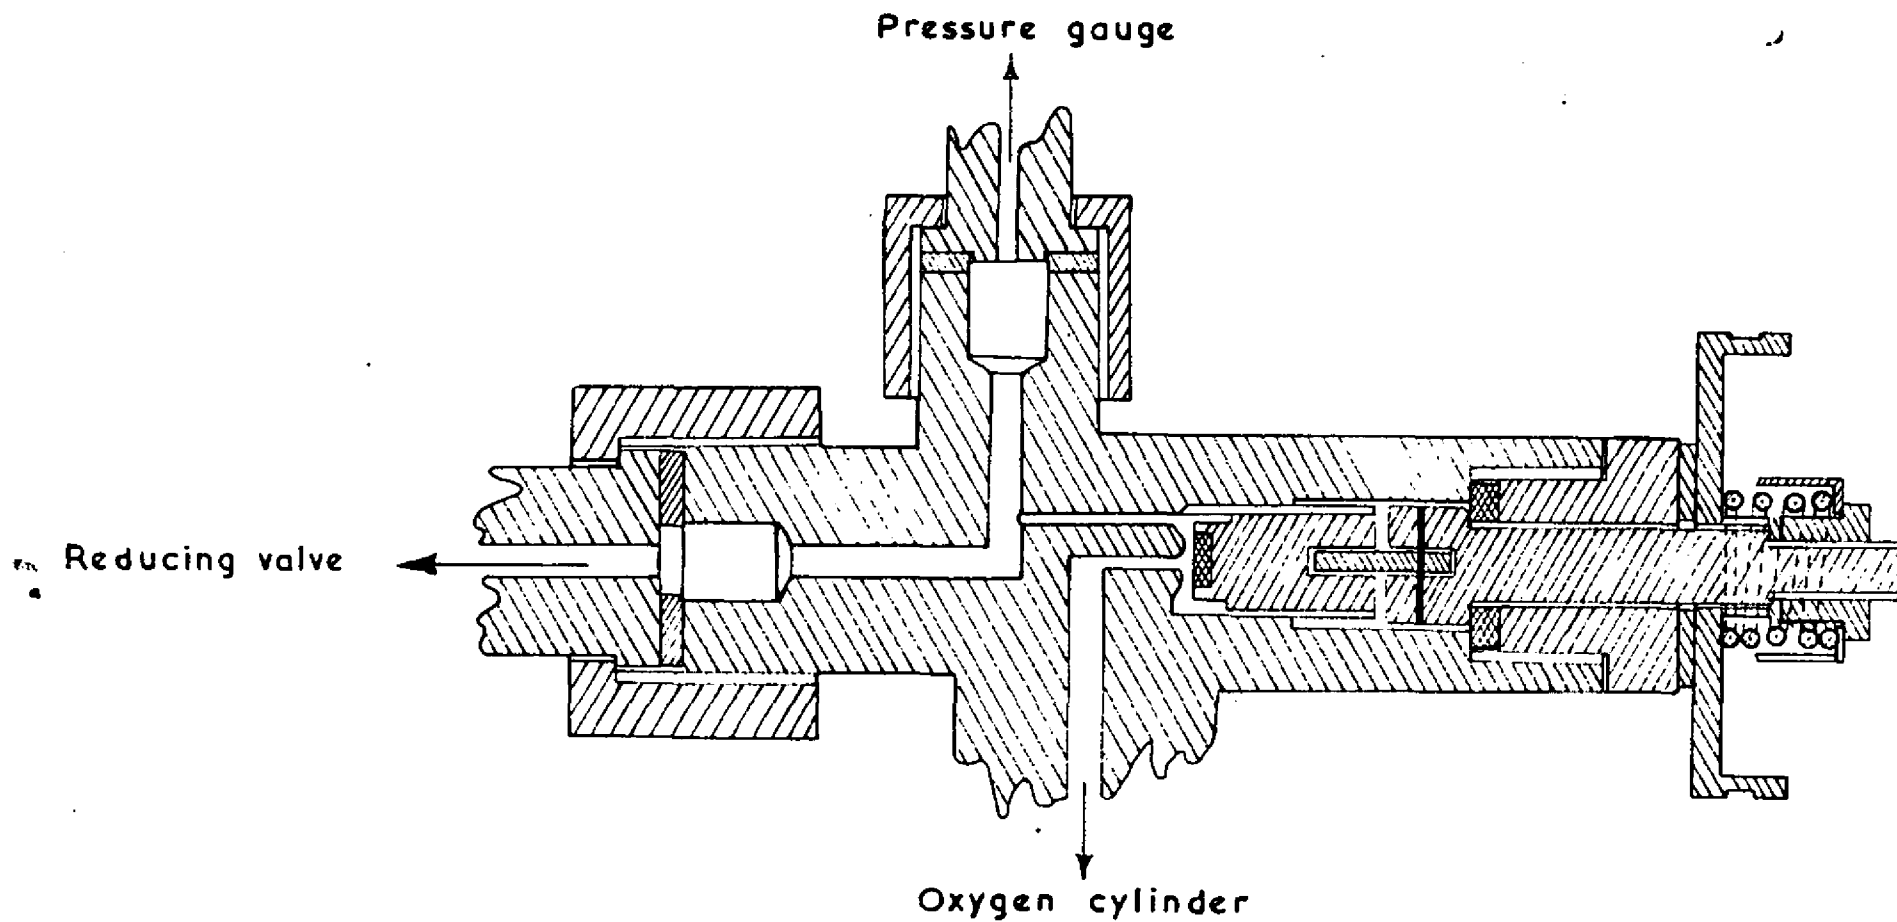
FIG. I. DIAGRAM OF CROSS PIECE FITTED TO OXYGEN CYLINDER.  
SHOWING MAIN VALVE ASSEMBLY  
( $1\frac{1}{2}$  TIMES FULL SIZE)

A compression from 1 to 120 atmospheres with an initial temperature of  $15^{\circ}\text{C}$  results in a theoretical final gas temperature of  $860^{\circ}\text{C}$ . In practice, owing to the large surface area and the small volume of gas, the heat produced will be rapidly dissipated so that the maximum temperature attained will depend on the speed of compression. The design of the main valve is such that this may be rapid.

A diagram of the cross piece fitted to the oxygen bottle of a Salvus breathing set, showing the main valve assembly, is given in Fig. 1. Turning the hand wheel through quarter of a revolution lifts the valve 0.01 in. off its seating and in so doing gives an orifice sufficient to allow a rapid rise in pressure in the small space into which the oxygen flows, unless this quarter turn is performed very slowly.

It is considered that an attempt should be made to produce a breathing apparatus having all-metal seats in the valves, connectors, and unions on the high pressure side, and a tapered needle and seating to the main valve which would restrain the initial surge of oxygen on opening the valve.

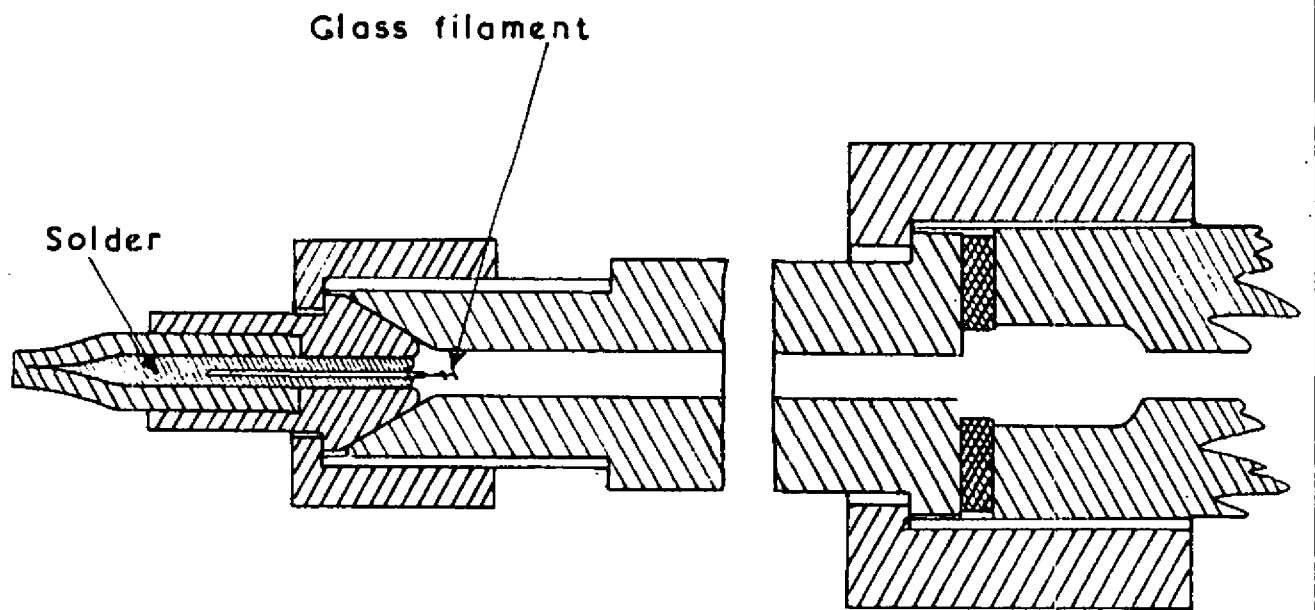
FIG.2. DIAGRAM SHOWING GLASS FILAMENT CARRYING GRAINS OF HEAT SENSITIVE PAINT INSERTED IN ADAPTOR FITTED TO CROSS PIECE OF OXYGEN BOTTLE

An attempt was made to measure the temperature attained in the high-pressure side of the apparatus on opening the main valve, using heat-sensitive paints which melt at known temperatures. It was found that these paints dry to a powder having a grain size of the order of 0.001 in. A glass rod was drawn out to a diameter of approximately 0.01 in. and this was set in solder in a brass nipple. The end was then drawn out to a filament having a diameter of approximately 0.001 in. and protruding 0.1 in. from the end of the nipple. A few grains of paint were picked up on the filament and the nipple was inserted in an adaptor fitted to the cross-piece of an oxygen bottle taken from a Salvus breathing apparatus as shown in Fig. 2. The paint was subjected to one or more rises of pressure by rapidly opening the valve after which it was examined under the microscope for signs of fusion. It was found that a paint having a melting point of 232°C fused completely after one compression but that one having a melting point of 288°C showed no signs of fusion after ten compressions.

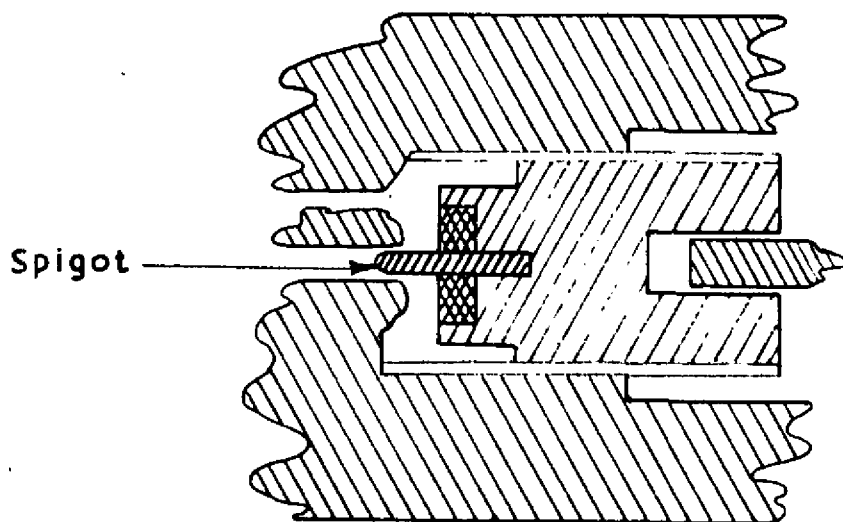
FIG.3. DIAGRAM OF MODIFIED VALVE SHOWING SPIGOT FITTED IN CENTRE OF SEATING

In order to reduce the rate of rise of pressure on opening the main valve Messrs. Siebe-Gorman suggested fitting a spigot in the centre of the valve seating as shown in Fig. 3. This would have the effect of throttling the initial flow of oxygen, but would not impede the flow when the valve was fully open.

The experiment using heat sensitive paints was repeated using both the smaller and the larger spigots. It was found that with the smaller spigot the paint melting at 232°C still fused completely on one compression but with the larger spigot this paint could not be fused and a paint melting at 176°C only showed evidence of fusion after several compressions.

It appears that the fitting of a spigot in the centre of the existing valve seating may reduce the risk of an explosion by throttling the initial flow of oxygen, but to be effective the spigot must not differ in diameter from the hole by more than 0.001 in. This may prove to be a very small clearance to maintain in practice.

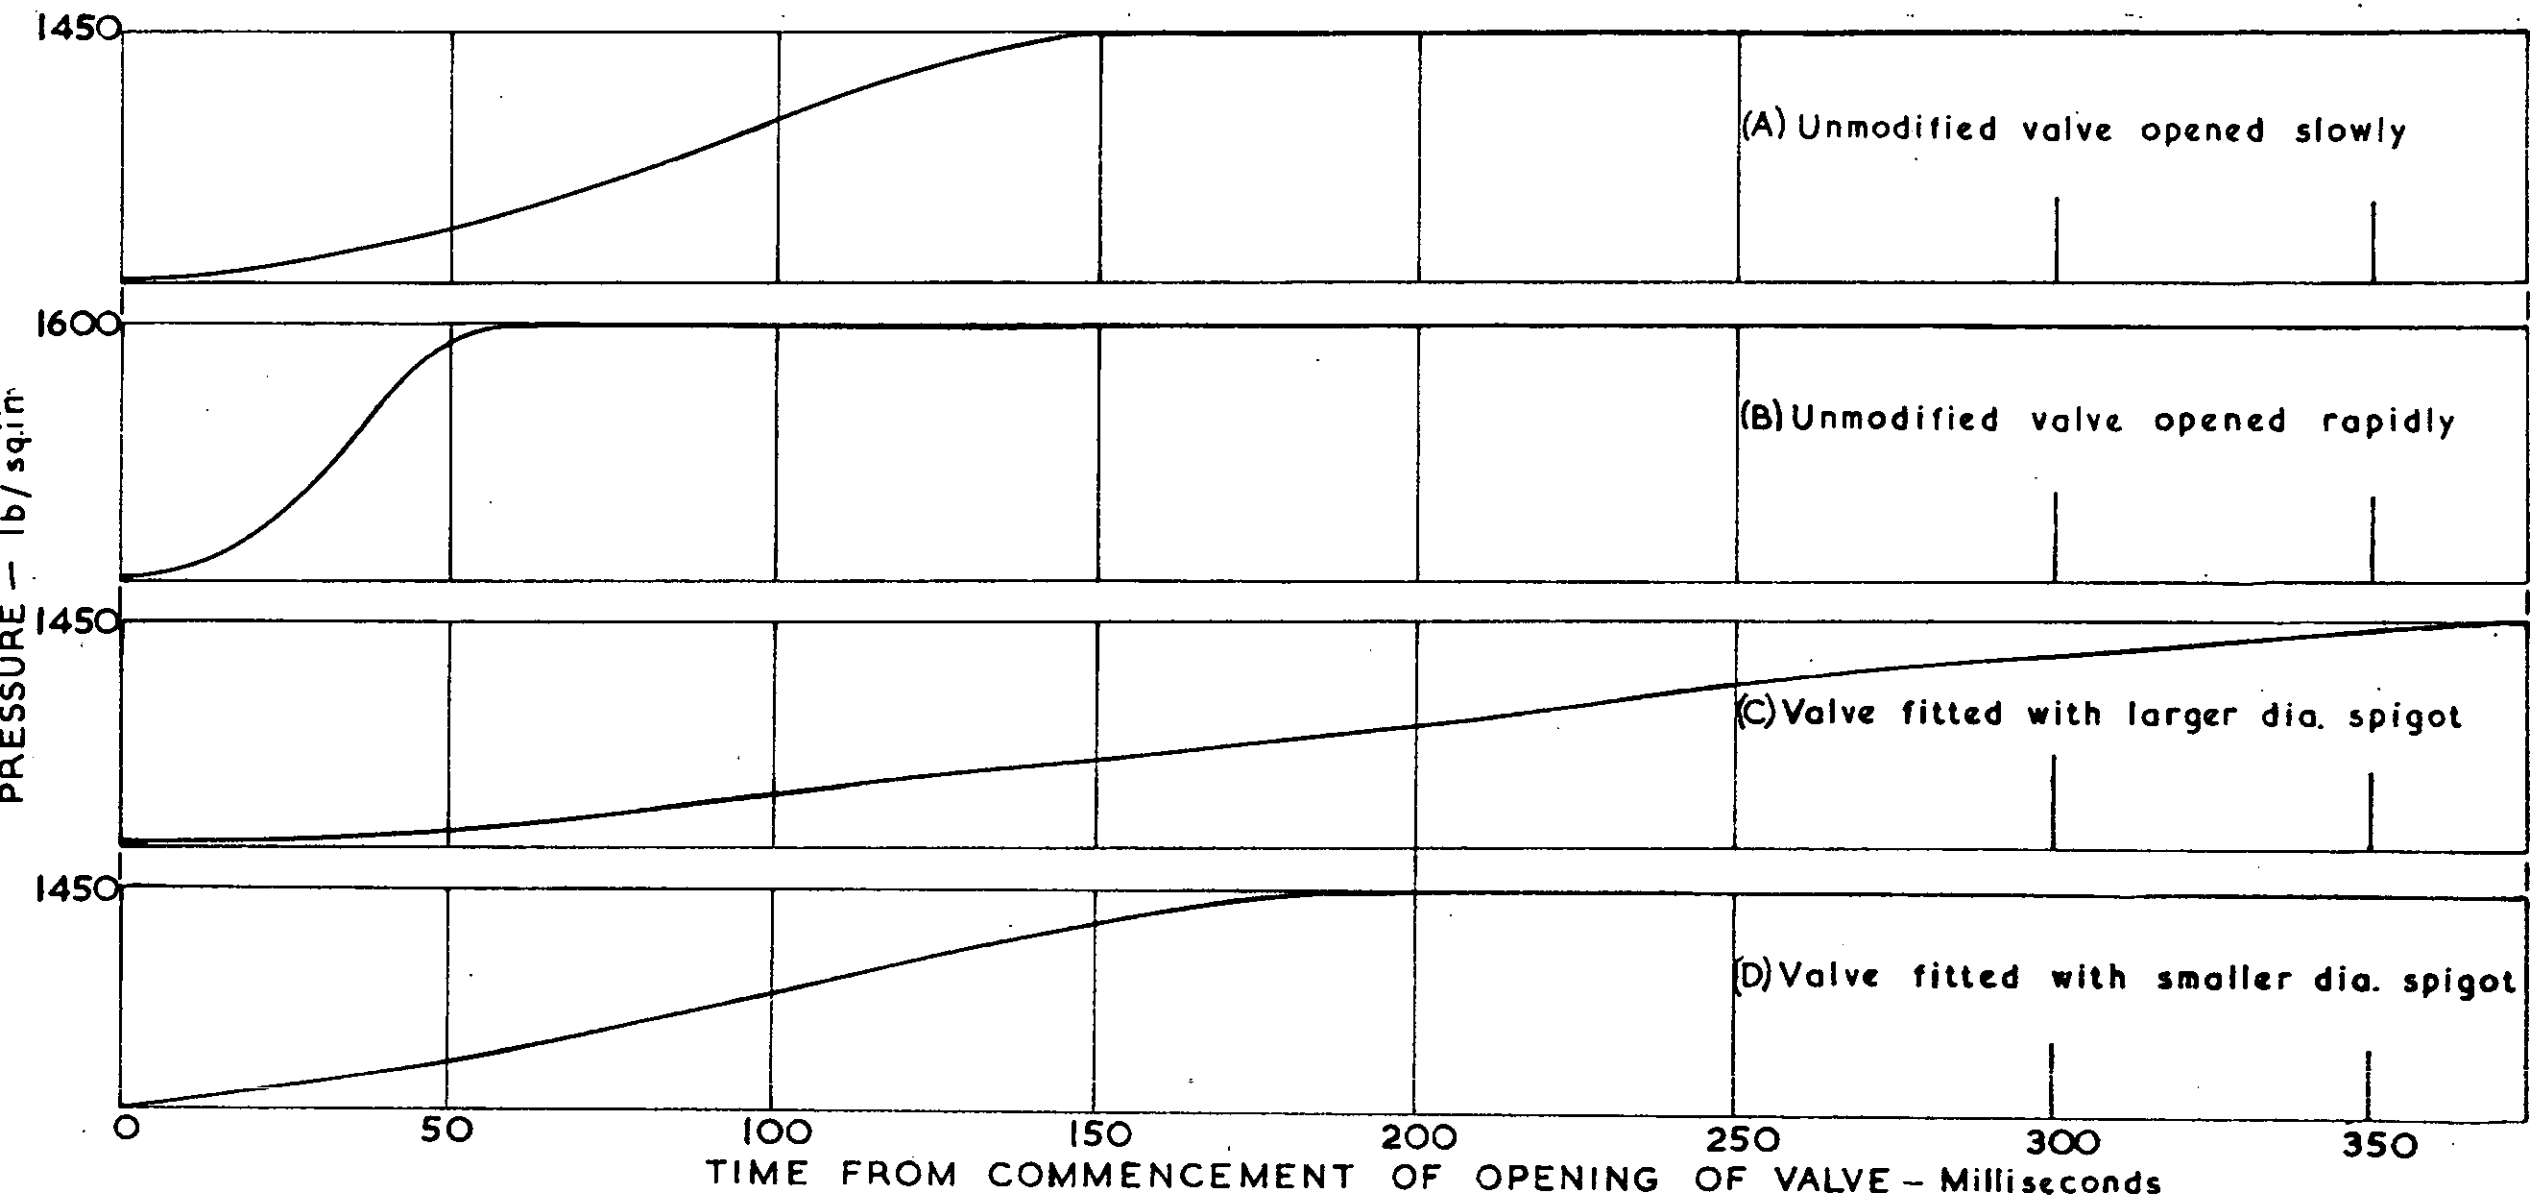
FIG. 4. OSCILLOGRAPH RECORDS OF PRESSURE RISE

Experiments were carried out, in conjunction with the Safety in Mines Research Establishment at Buxton, to determine the extent to which careful opening of the valve would reduce the rate of rise of pressure, and to examine the throttling effect of two sizes of spigot, one differing in diameter from that of the hole by 0.0005 in. and the other by 0.0025 in. The pressure rise was measured by a piezo-electric quartz crystal gauge which was fitted directly to the cross-piece of an oxygen bottle on the arm opposite the valve. The gauge was connected through an impedance-converter to a cathode-ray oscillograph fitted with a drum camera. The oscillograph record, which shows the minimum rate of rise of pressure obtained by opening the unmodified valve with extreme care, is reproduced in Fig. 4A. The record of the maximum rate of rise of pressure, obtained by opening the unmodified valve as rapidly as possible, is given in Fig. 4B. These figures show that if the valve is operated very carefully the time taken for the pressure to rise to its maximum value, normally about 120 atmospheres, may be as long as 150 milliseconds but that this time can be reduced to 50 milliseconds by a quicker opening of the valve.

It was found that, when the valve was modified by fitting a spigot in the centre of the seat, the rate of rise of pressure was less dependent on the manner of opening the valve. Oscillograph records of the rates of rise of pressure on opening valves fitted with the two sizes of spigot are shown in Figs. 4C and 4D. The time taken for the pressure to build up was 375 milliseconds using the valve fitted with the larger spigot, but with the smaller spigot the time was 175 milliseconds, little better than could be achieved by opening the unmodified valve carefully.
