F.R. Note No. 5

January, 1952.

DEPARTMENT OF SCIENTIFIC AND INDUSTRIAL RESEARCH AND FIRE OFFICES' COMMITTEE JOINT FIRE RESEARCH ORGANIZATION

A DUST EXPLOSION AT MESSRS. THORLEY LTD., MANDSWORTH, MANUFACTURERS OF ANIMAL FELDING STUFFS

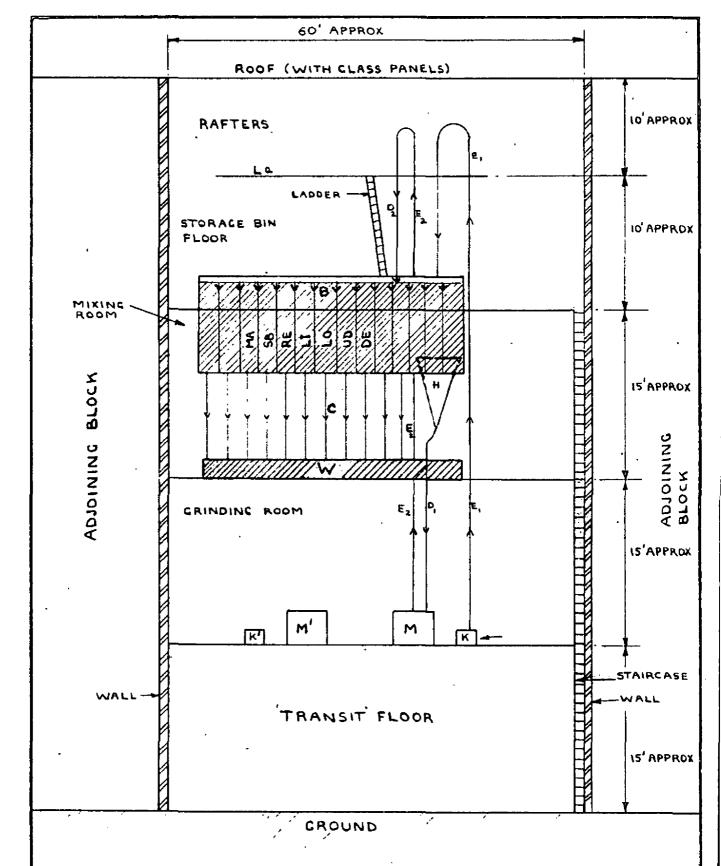
SECTIONAL ELEVATION OF BLOCK IN WHICH EXPLOSION OCCURRED

The plant was contained in a four-storey brick building, with wooden floors, with similar blocks adjoining both sides as shown in fig. 1. The building contained few windows so that permanent electric lighting was necessary and the upper floors were reached by a staircase adjacent to one wall, access could also be obtained from adjoining buildings.

Processing: the cattle cake was initially broken into fragments, by the kibblers K, which were then passed up the elevator E<sub>4</sub> and fed into the metal hopper H (at rear); the elevator consisted of iron cups (6 in. x 3 in. x 3 in.) which were iron studded to a cotton belt and was enclosed by a wooden casing. The broken cake fell by gravity from the hopper, through metal ducting  $D_4$ , into the mill M.

The powdered product then passed up elevator  $E_2$  (similar to  $E_4$ ) and was fed into the storage bins B; from B it then fell through the metal chutes C into the mixer W after which it passed to a cubing machine in another building. This process was duplicated by kibbler  $K^4$  and mill  $M^4$ , the corresponding elevators are omitted from the figure.

Production was back to normal at the time of the visit (2.30 p.m. 19.12.51); it seems probable that ignition took place in the mill M and flame subsequently travelled the whole length of the elevator ducting  $E_2$ .

The atmosphere was full of fine dust in the three upper rooms and layers of dust up to 1 in. in depth were spread evenly over all floors; the rafters were covered with layers of dust approximately 3 in. thick which were easily dislodged and showered into the room below, dust was also heaped into the corners of rooms. The Manager stated that these deposits, if collected, could be used again as "returns".

Apart from the magnetic separators in the kibblers no precautions were taken to prevent ignition in the mills and there were no vents in the elevator trunkings; no further precautions were taken after the explosion to prevent a re-occurrence.

Great improvement in the standard of housekeeping could be made without difficulty; the fire hazard would be considerably reduced if dust were collected at regular intervals, moreover the dust so collected is usable as "returns".
