FIRE AND THE MOTOR CAR

**RESULTS OF TESTS ON THE PROPAGATION OF FIRE
IN PARKED CARS**

October 1967.

**FIRE
RESEARCH
STATION**

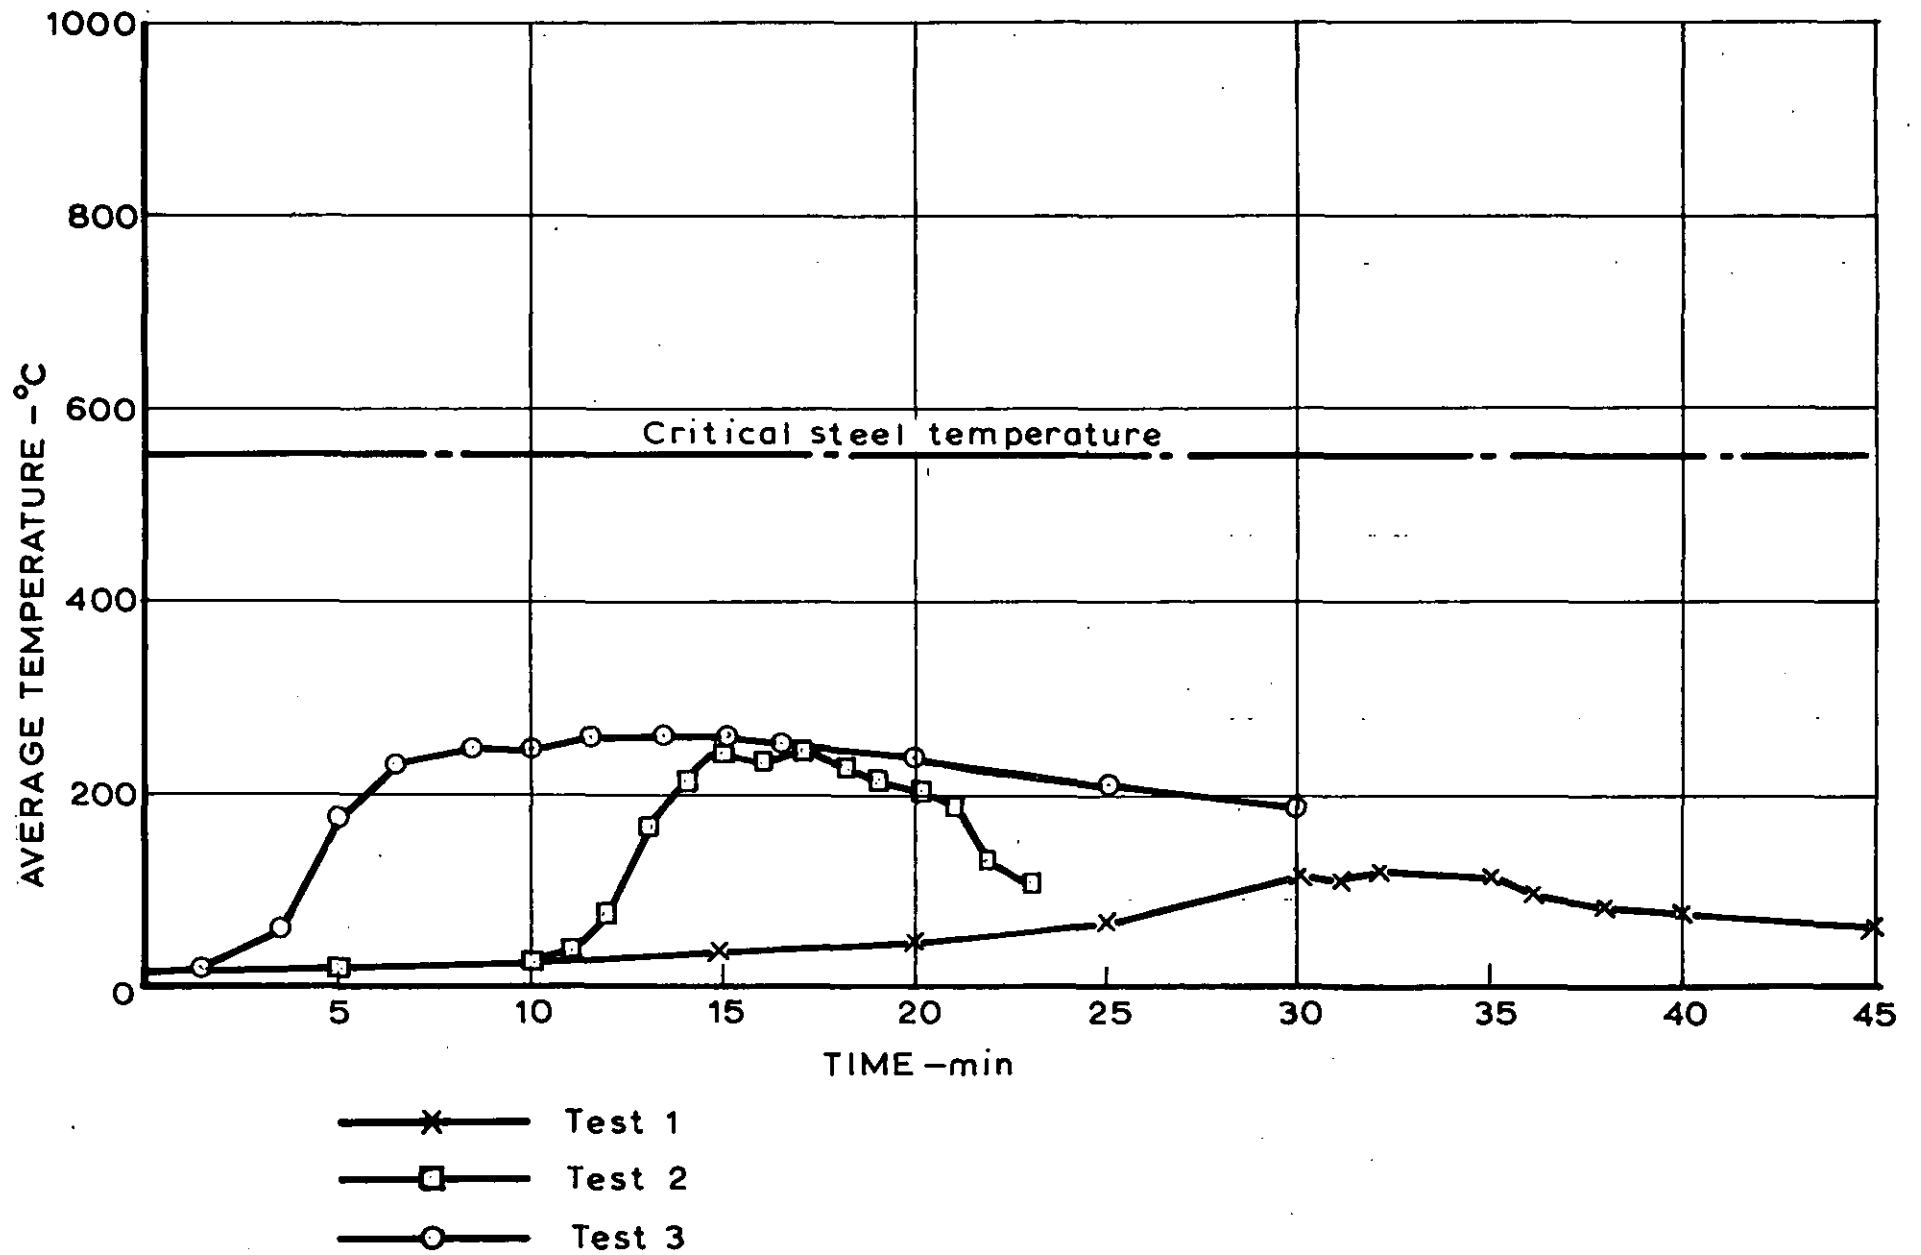
FIG.1. AVERAGE STEEL TEMPERATURES FOR COLUMNS IN TESTS 1 AND 2, AND BEAM IN TEST 3

Temperature measurements were made on the steel columns 24 in from the base and 6 in below the false ceiling level. Fig. Nos 1-3 of Appendix 2 shows the average steel temperatures attained by the structural steel elements.

Even when the fire was at full development the temperatures recorded were relatively low and a critical condition for any form of non-combustible structural element was never reached. The maximum temperatures recorded only persisted for a very short period of time.

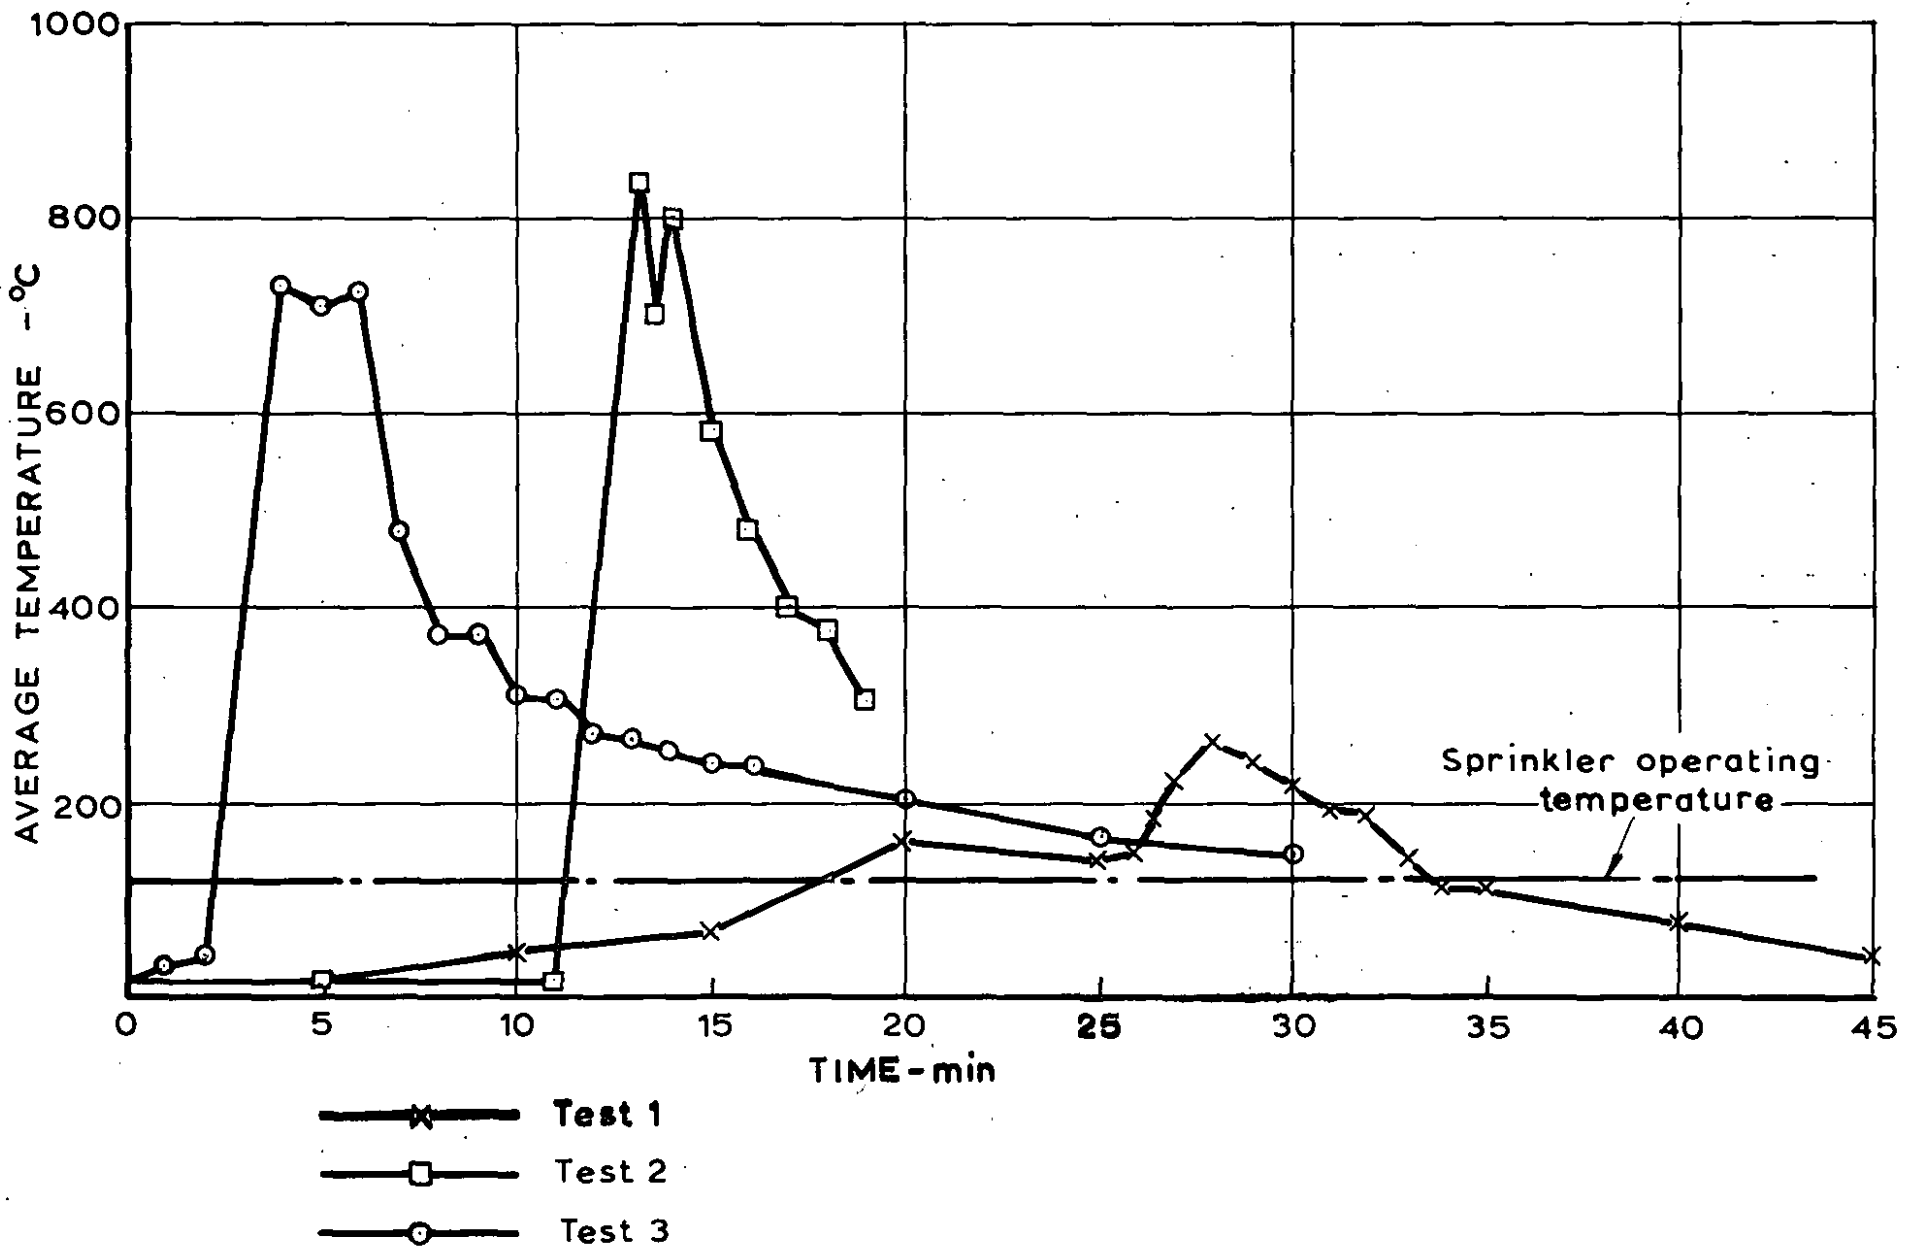
FIG.4. AVERAGE GAS TEMPERATURE ABOVE CENTRE CAR IN TESTS 1,2 AND 3.

Their temperatures were measured by means of thermocouples placed 12 in below the suspended ceiling and the average gas temperature above the ignited car are shown in Fig Nos 4-6 of Appendix 2.

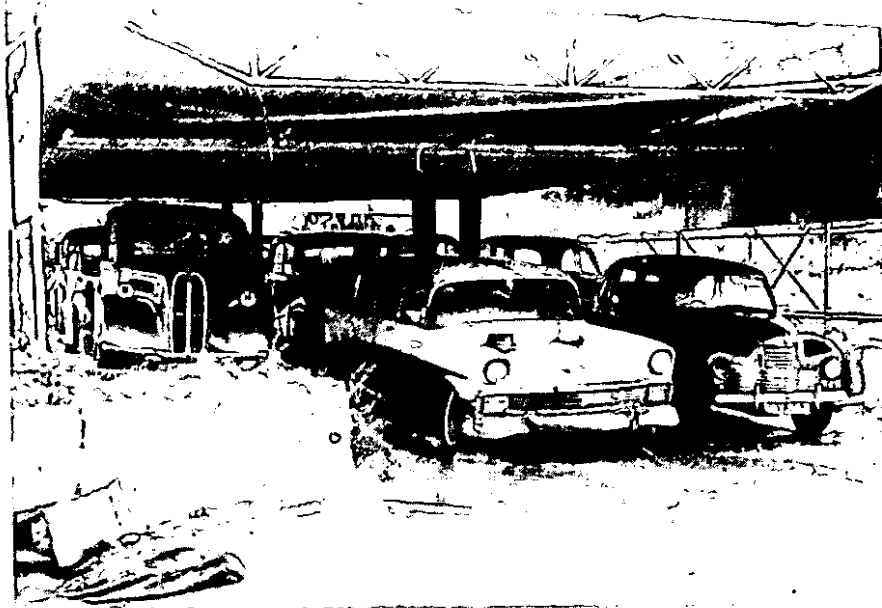
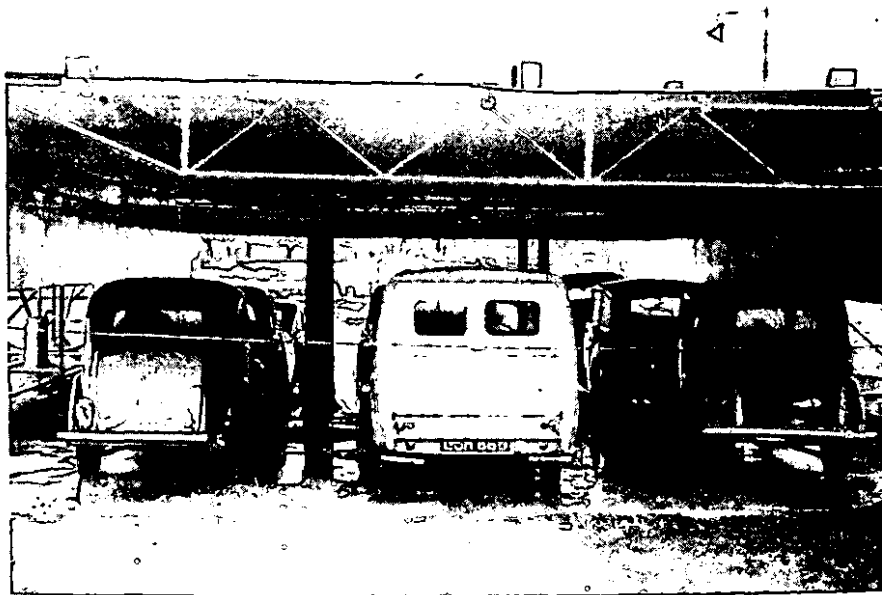
PLATE 1

GENERAL LAYOUT OF CARS IN POSITION
BEFORE FIRST TEST

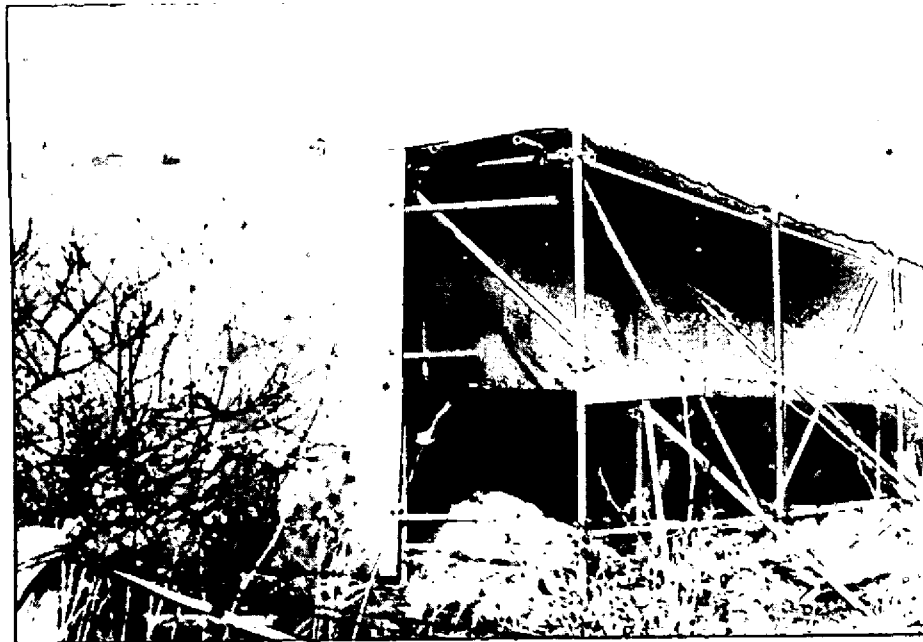
The procedure during the three tests was similar with the exception that in the third test the two ends of the structure were closed in by screens to reduce the ventilation to the minimum that would be tolerated in a building of this character; the purpose being to establish whether or not the pattern of fire development would be significantly changed by reducing the ventilation in this way. Plates 2 and 3 show the structural alterations used for Test 3.

STRUCTURAL MODIFICATIONS FOR TEST 3

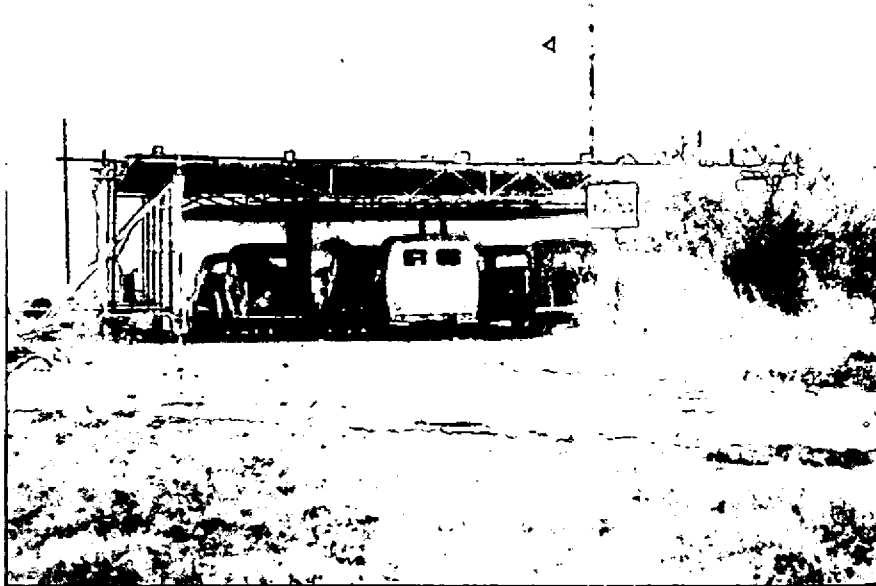
PLATE 4

Plate No.4 shows the progress of the fire in test No.1 at approximately 5 minutes from the commencement of the test and Plate No.5, the state of the car at the completion of the test.

TEST 1 5 min AFTER START

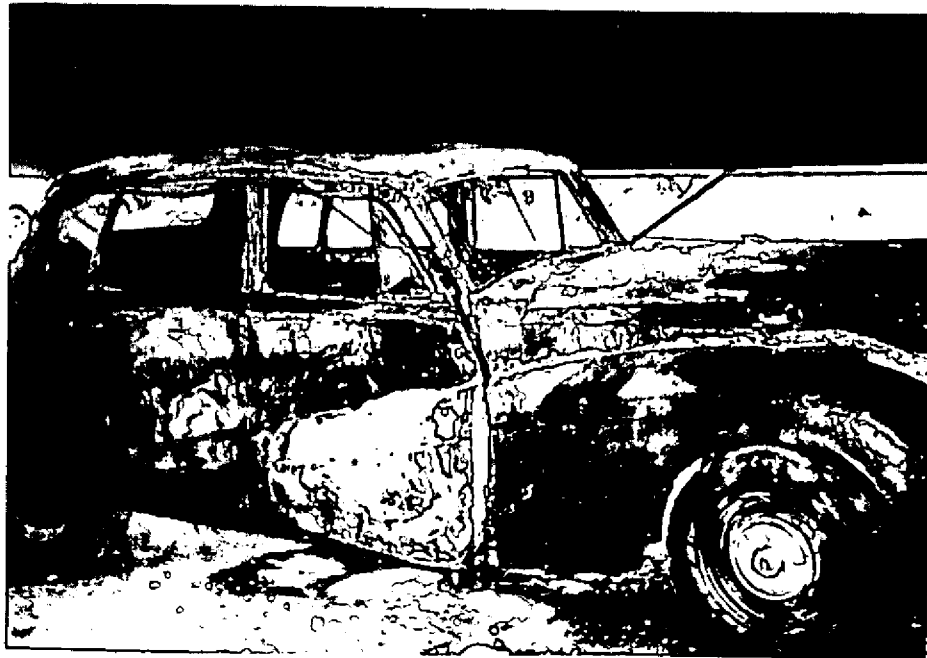
PLATE 5

STATE OF IGNITED CAR AT END OF TEST 1

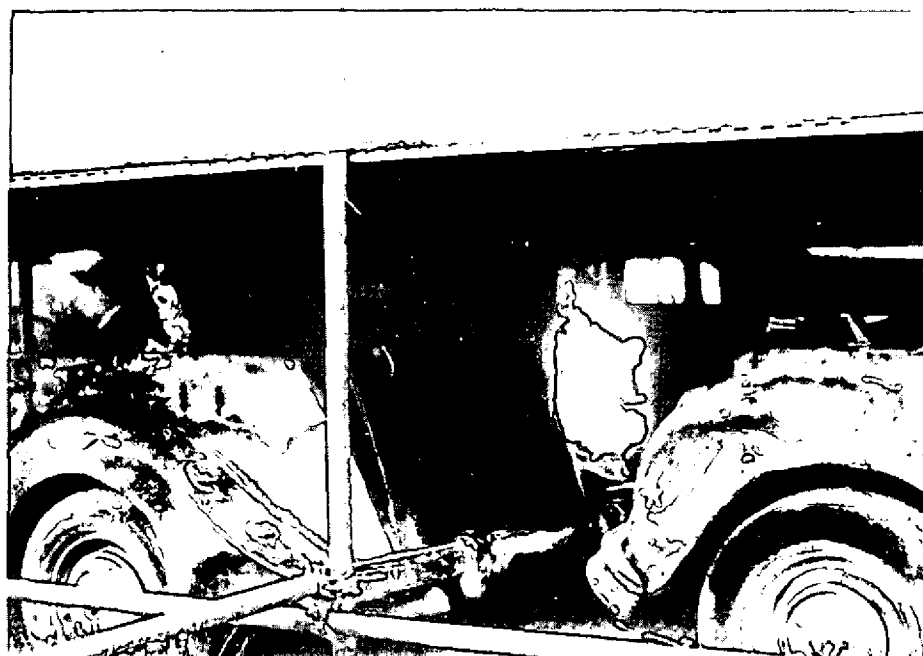
PLATE 6

One of the major hazards which was considered a possibility was disruption of the petrol tank and the flowing of petroleum under other cars in the vicinity via the sloping concrete ramp. In no case did this occur in spite of the fact that in Test No.2 the position of the spare wheel and other combustibles which were completely burnt away was situated directly above the tank containing five gallons of fuel. It was observed that the method of burning of the fuel when ignited, was via the filler cap and the connecting pipe which melted and the fuel burnt from this source only. From a knowledge of the disposition of combustible materials adjacent to fuel tanks, in the three tests, it is considered very unlikely that an explosion or disruption of a petrol tank would take place. A pressure build-up sufficient to cause disruption of the tank

could, we feel, not take place as all tanks are provided with a pressure release either in the filler cap or by other means. Plate No.6 shows the burning fuel at the filler pipe in Test No.3.

**BURNING FUEL AT FILLER CAP PIPE
DURING TEST 3**
