# Fire Research Note No. 835

FIRE TESTS IN TWO CARAVANS

E.G. BUTCHER and G.K. BEDFORD

September 1970

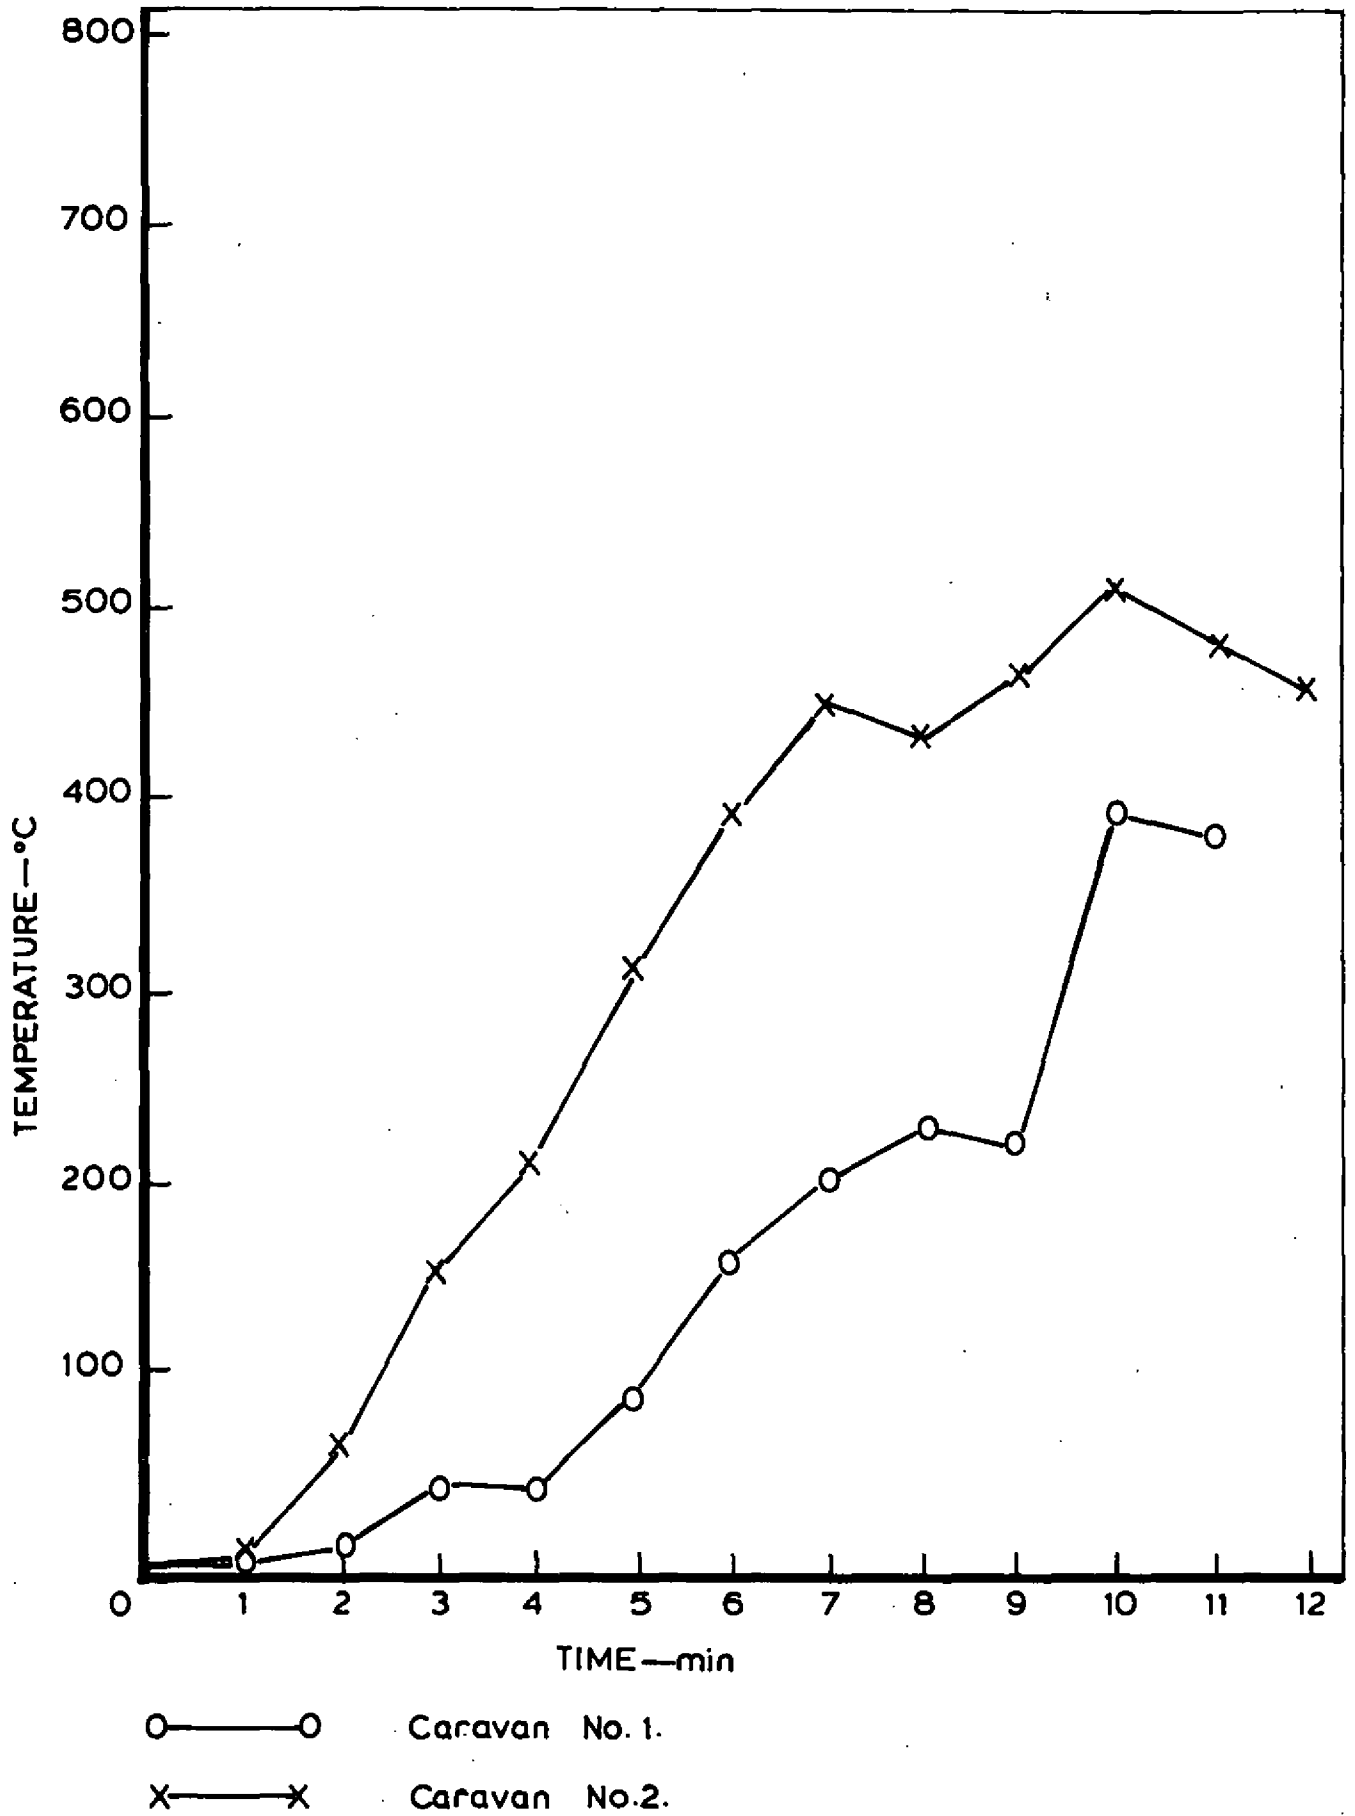
FIG. 2. MEAN TEMPERATURE IN CARAVANS

Fig.2 shows the overall mean temperature curve in both caravans .

The slope of this curve for the two tests is very similar and the low temperatures recorded in the early part of Test 1 are due to a slower initial build up of the fire as well as to the operation of the sprinklers in the period 3 to 4 minutes.

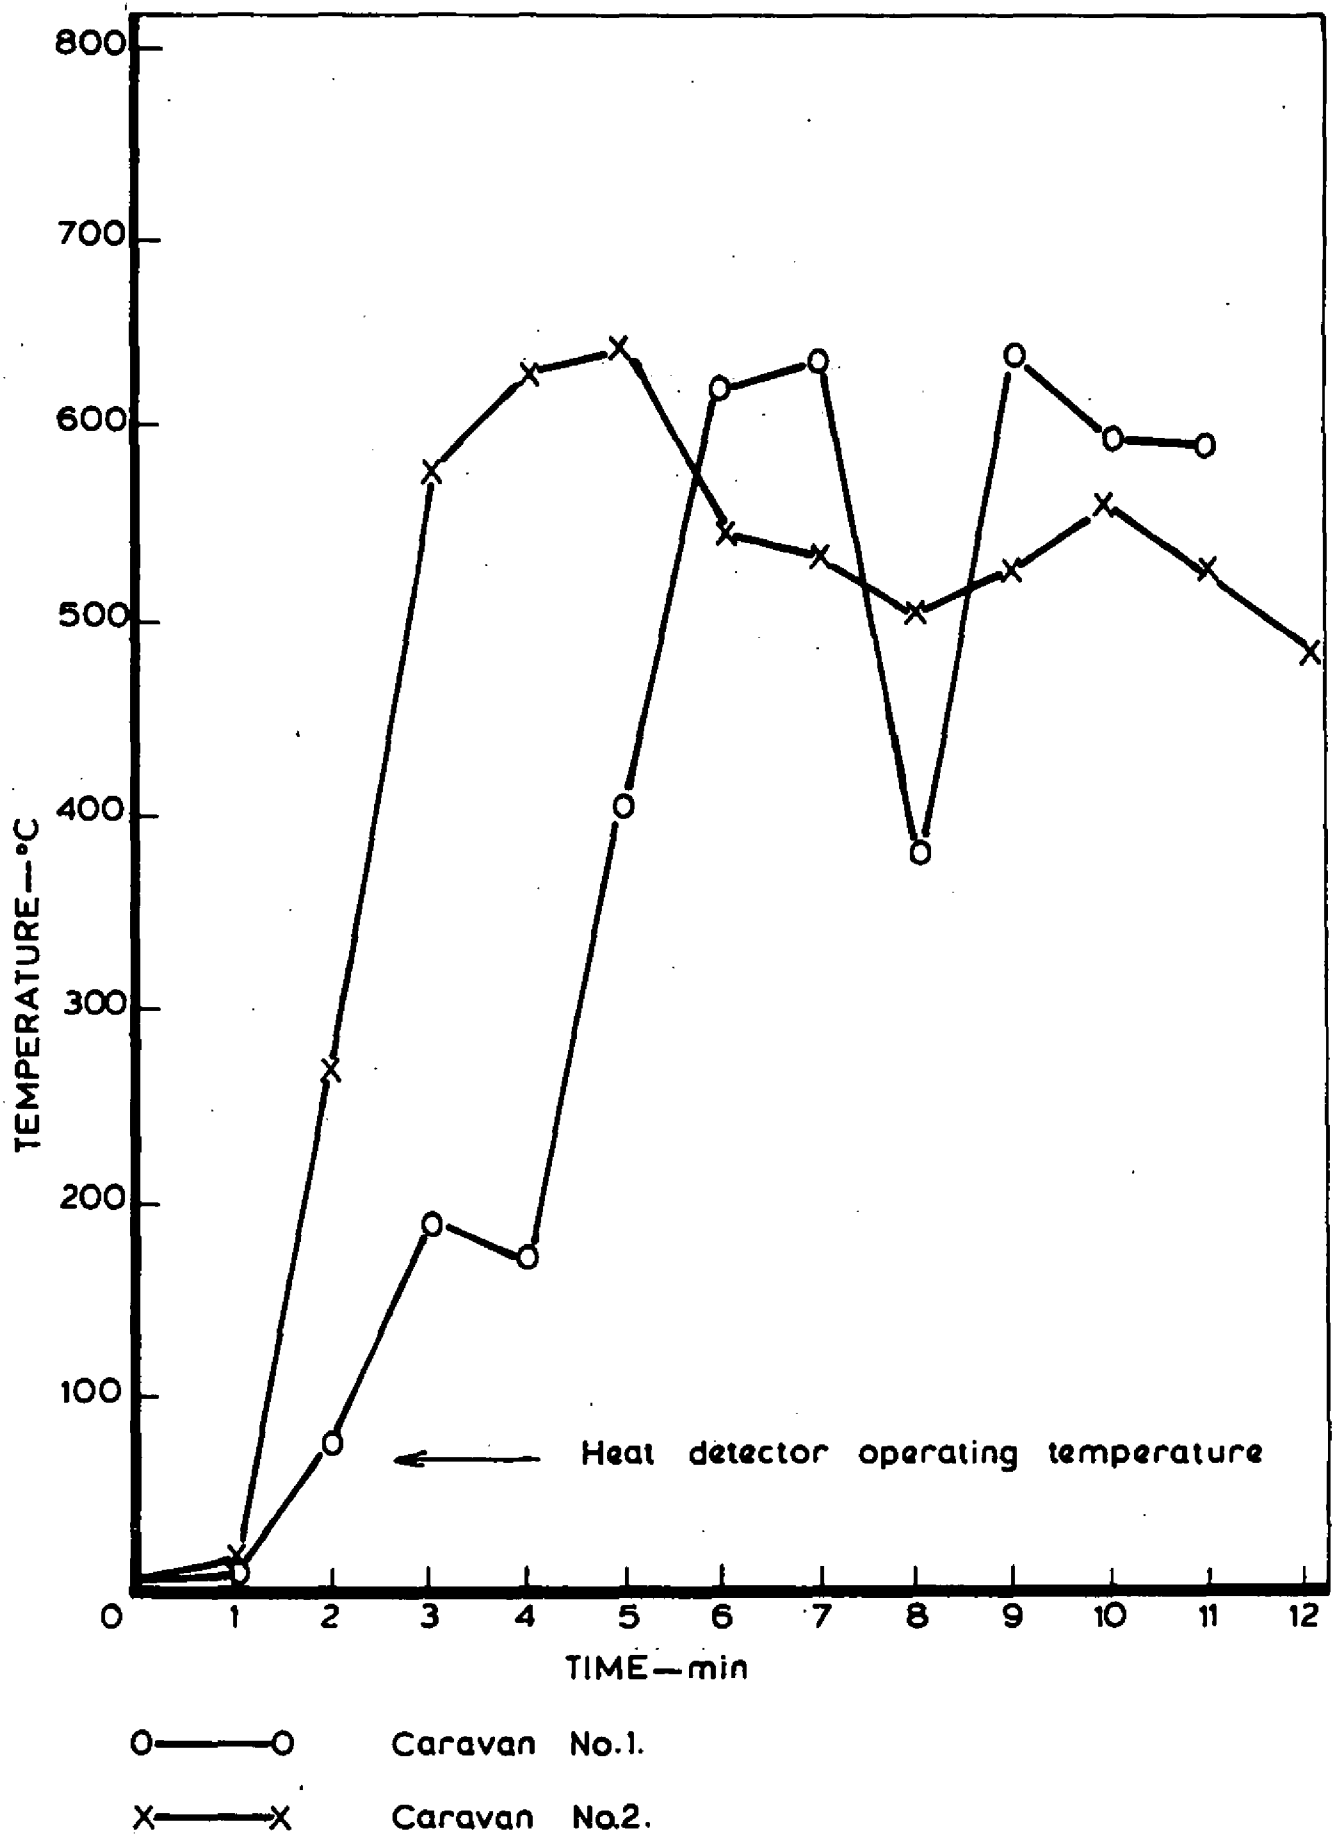
FIG. 3. MEAN TEMPERATURE RECORDED BY THERMOCOUPLES WHICH WERE USED TO REPRESENT HEAT DETECTORS

Fig.3 shows the mean temperature of the thermocouples which were 76.2 mm (3 in) from the ceiling at the points marked H in Fig.1. These were intended to represent heat detectors and if these had been set to operate at 65°C (149°F) then they would have given an alarm at 114 sec and 76 secs after the start of the first and second test respectively.

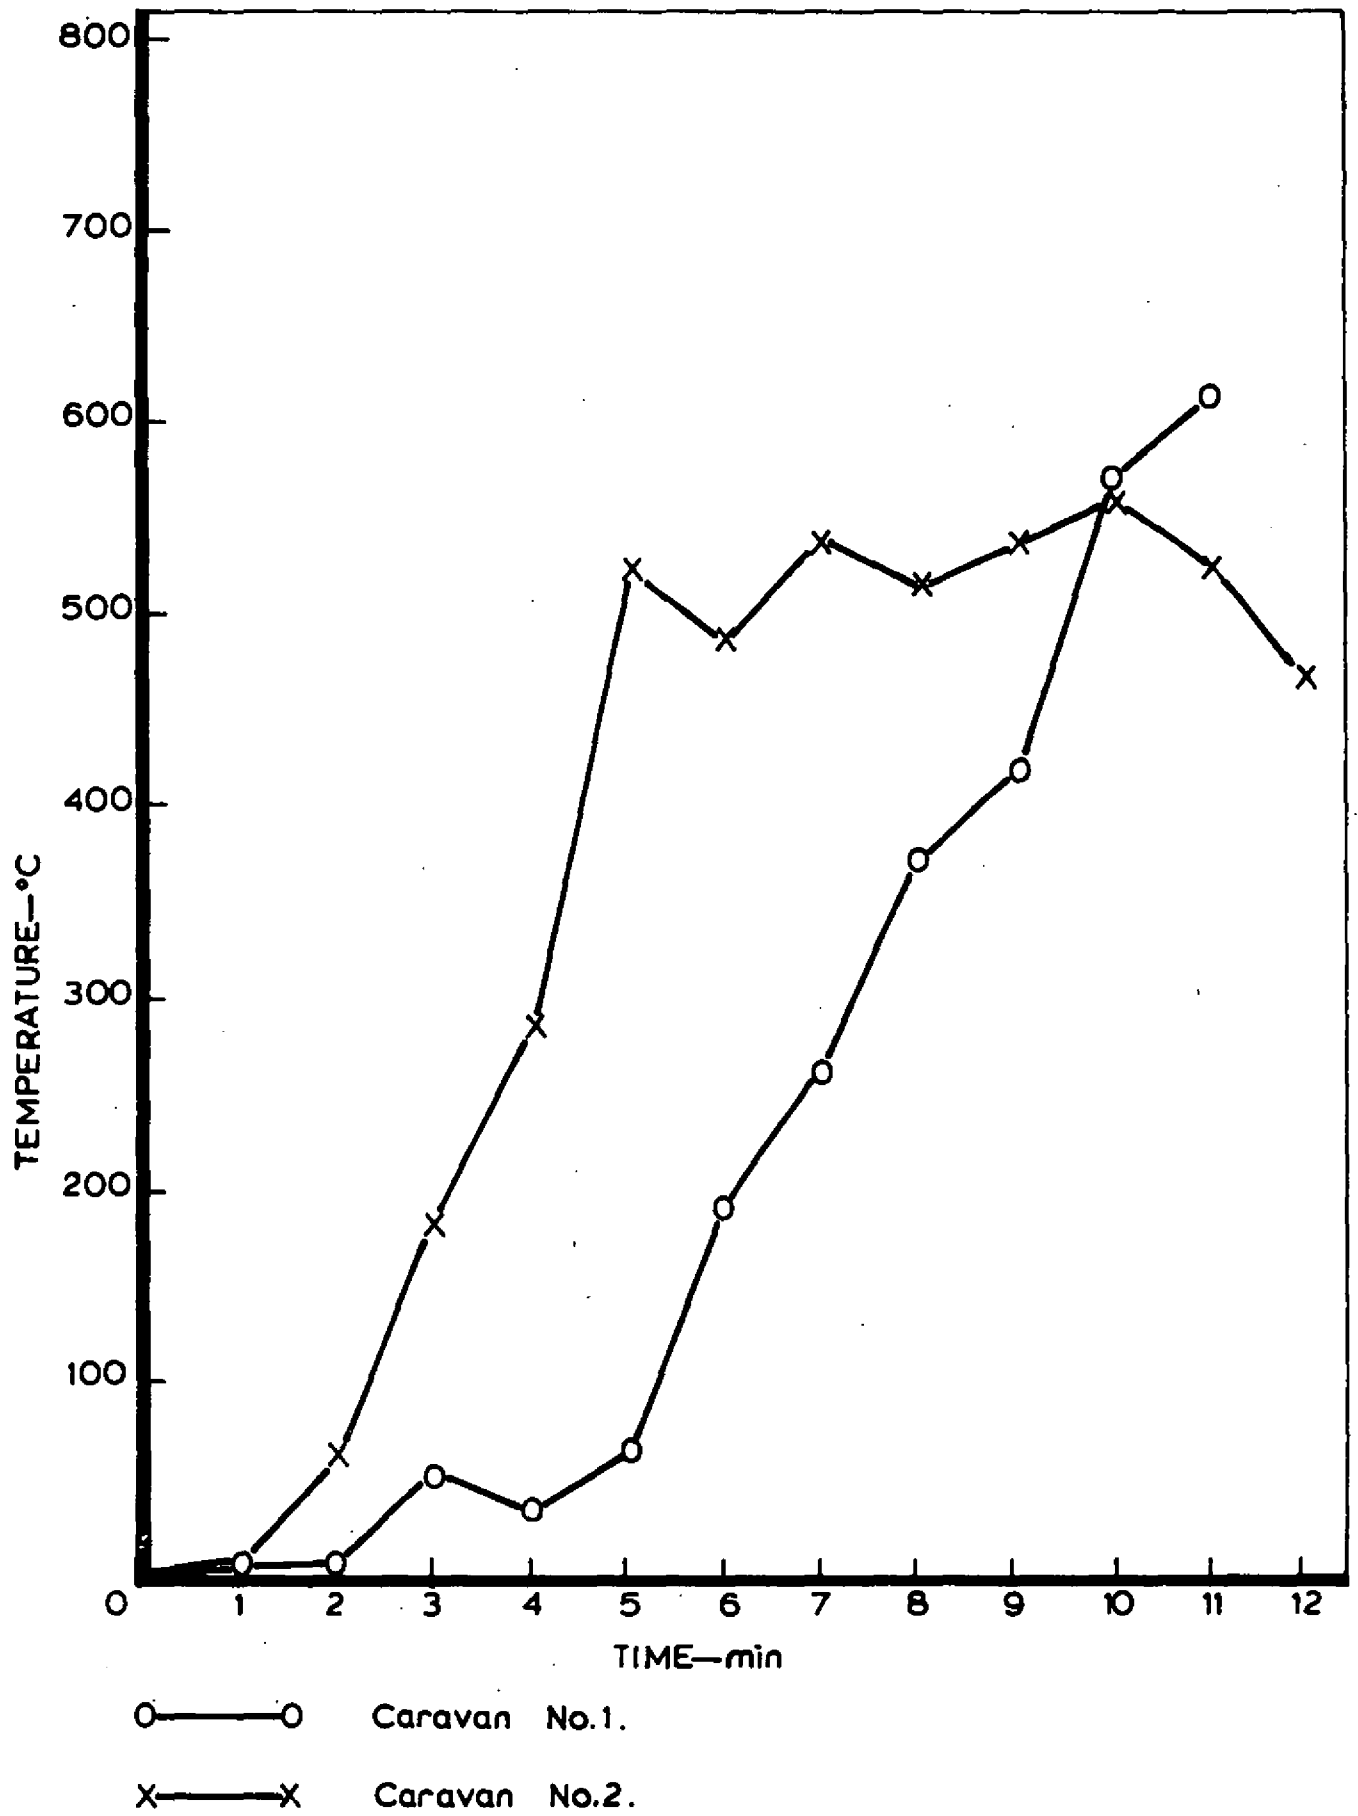
FIG. 4. MEAN TEMPERATURE 0.46m (18) BELOW CEILING IN CENTRAL LOUNGE AREA

Figs 4 and 5 also show the mean reading of the other two pairs of thermocouples placed at the points marked H. These were at head height, 0.46 m (18 in) below the ceiling and crouching height, 0.92 m (3 ft) from the floor respectively.

These two figures show the same general picture as that of Fig.2 but since they are in the sprinklered area the effect of the water cooling is more

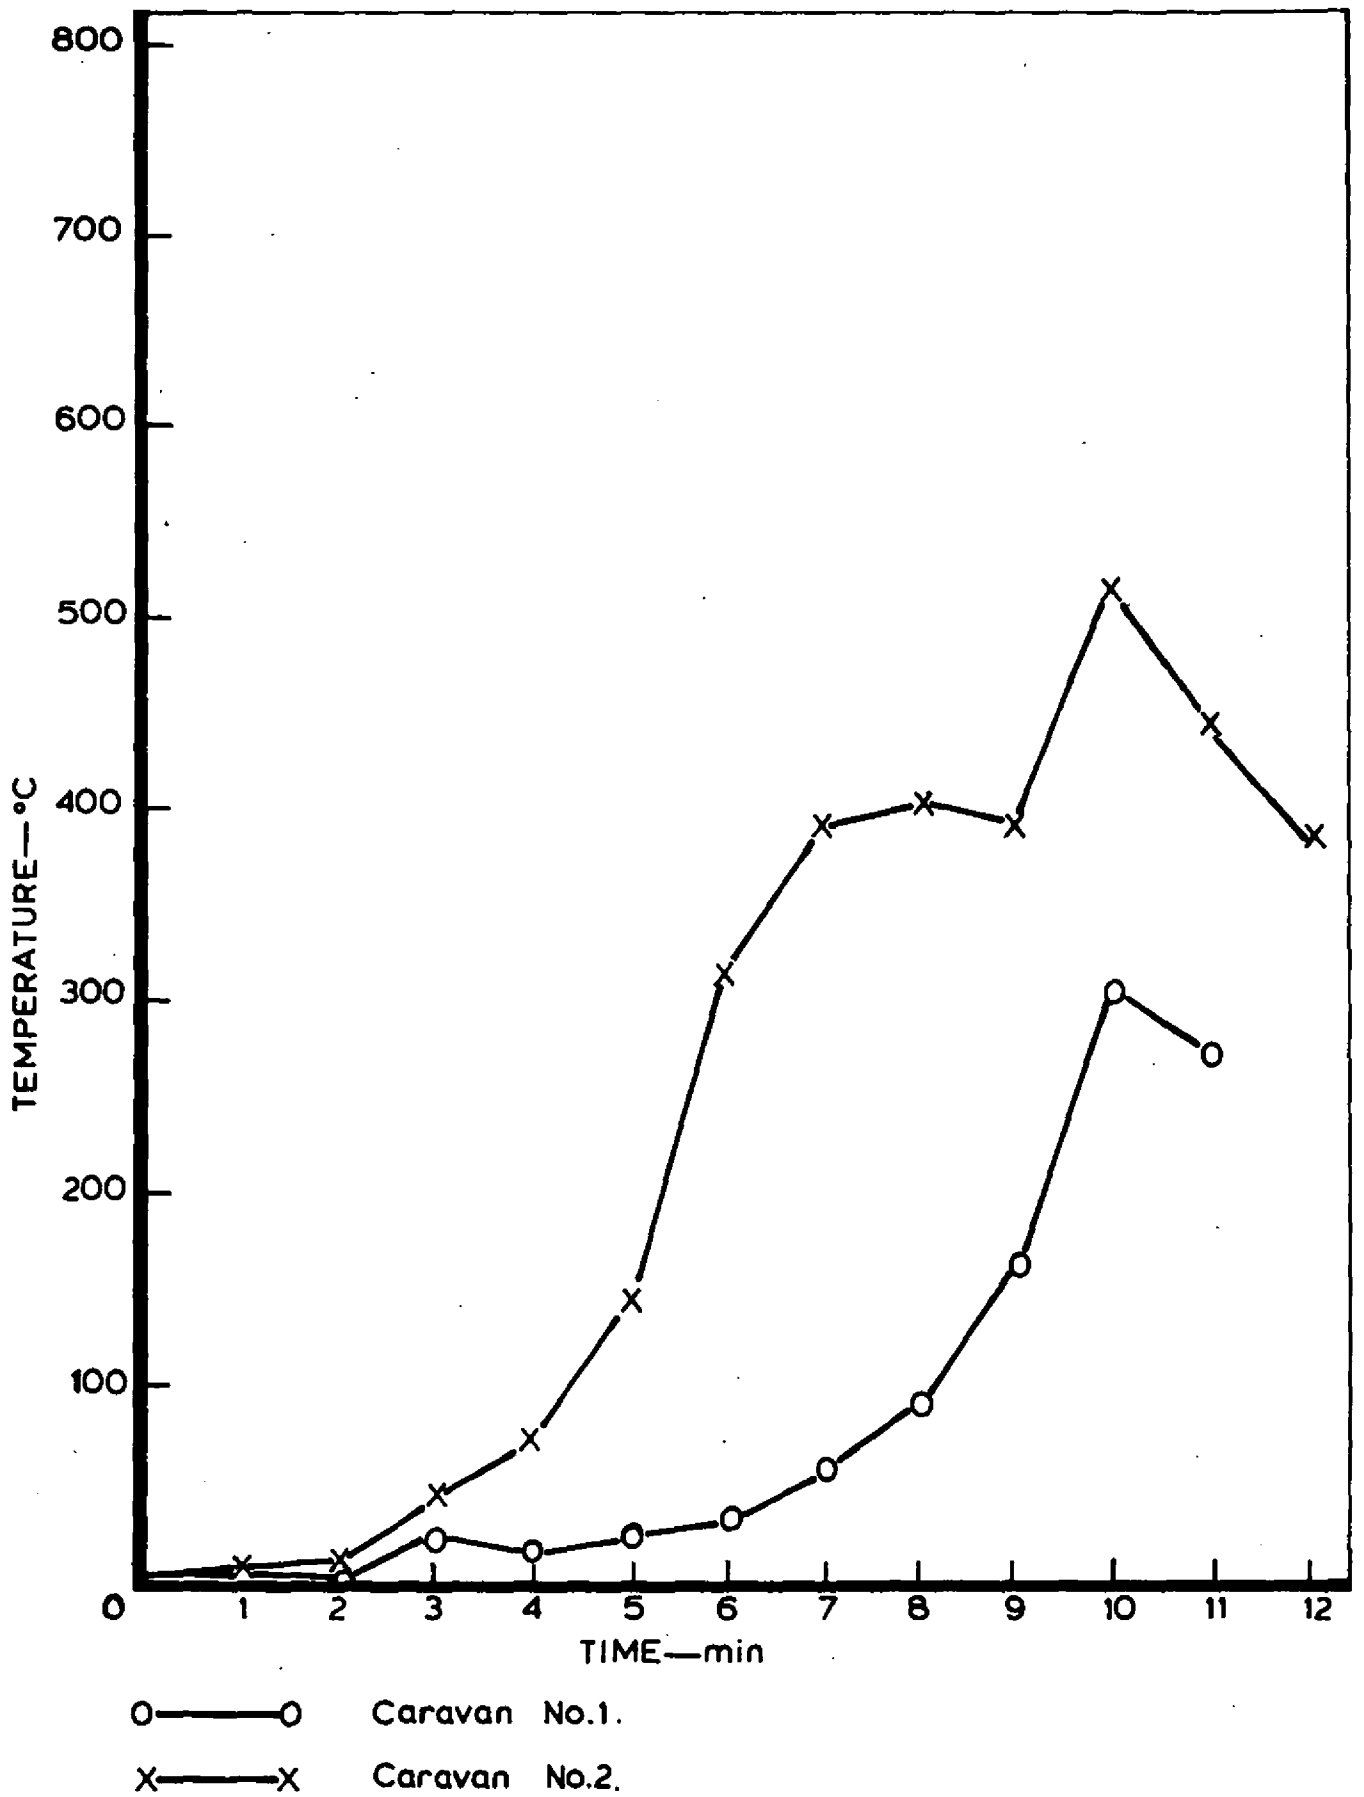
FIG. 5. MEAN TEMPERATURE 0.92m (3ft) FROM FLOOR IN CENTRAL LOUNGE AREA

marked particularly in Fig.5 which is for the low level thermocouples.

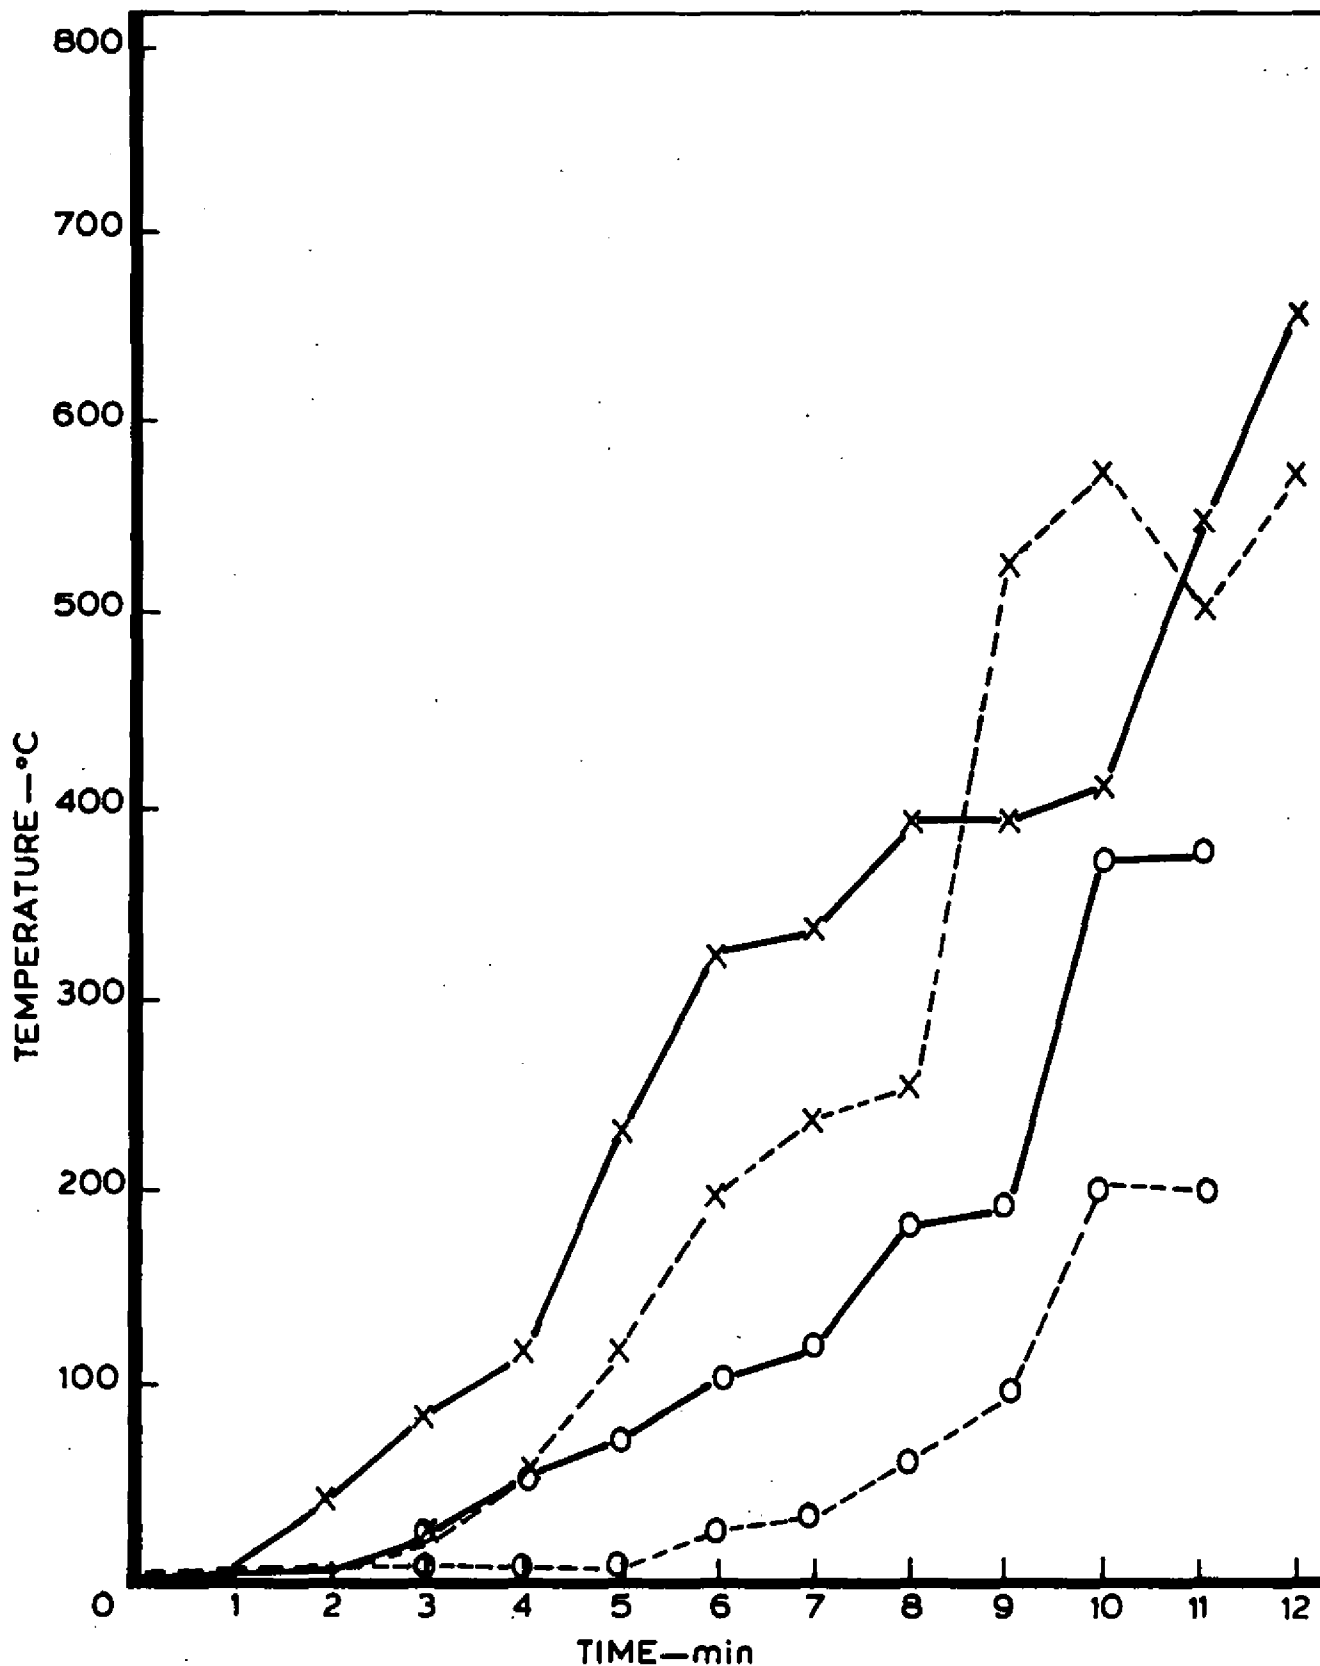
FIG 6 TEMPERATURE IN BEDROOM AREA

Fig.6 shows the temperature curves of the individual thermocouples which were 0.46 m (18 in) from the ceiling and 0.92 m (3 ft) from the floor in the bedroom area. It can be seen from the curves that in so far as the danger is from temperature then a definite advantage can be obtained in respect of survival in the bedroom if the person concerned takes up a crouching position on the floor.

In Test 1 a temperature of 150° was reached in the bedroom in just over 7 minutes (Fig 6) but in the centre part of the lounge area this temperature was reached in 5½ minutes. On the other hand in Test 2 the bedroom reached 150°C in 4½ minutes and the central lounge area in 2½ minutes. In Test 1 the sprinklers operated 3½ minutes after the start of the test and the cooling effect which the water spray had can be clearly seen in Figures 3, 4 and 5. It can be estimated from the graphs that if the sprinklers had not operated the temperature of 150° would have been reached in the central lounge area in 4 minutes and in the bedroom in 5½ minutes. The figures given in the foregoing were measured at head height in the caravans. Those for the crouching positions (1 metre from floor) occur after longer periods

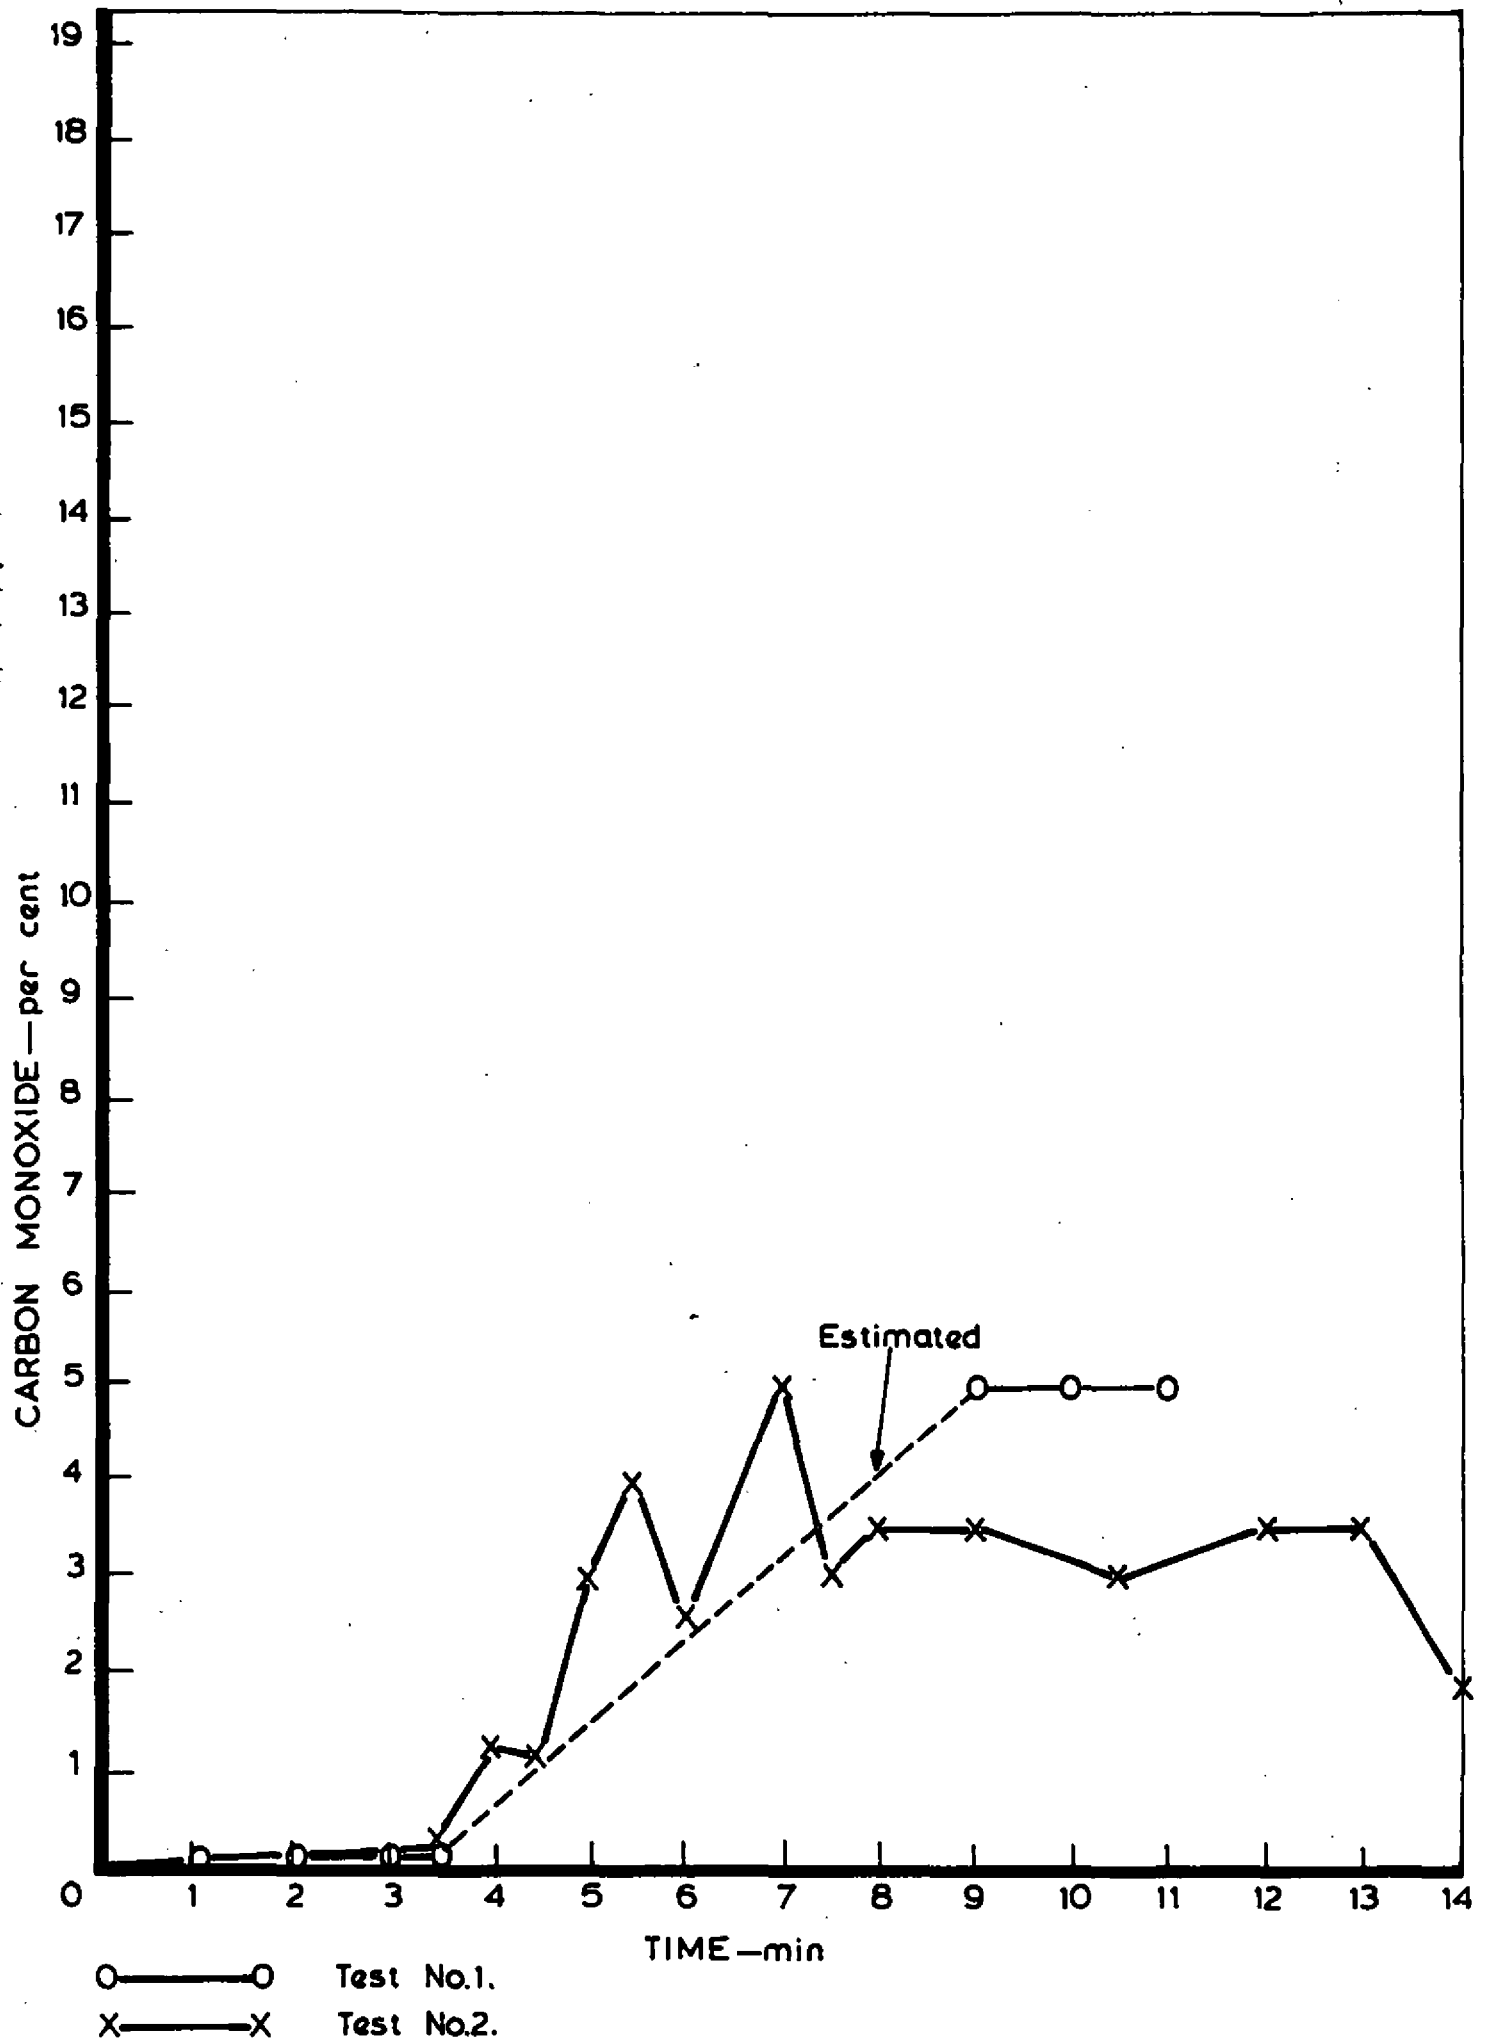
FIG. 7. PERCENTAGE CARBON MONOXIDE IN LOUNGE AREA

Figs 7 and 8 show the build up of CO in both the lounge and bedroom areas. From the graphs it can be seen that after a period of 5 minutes the gas levels rise extremely quickly. Fig 9 shows the CO<sub>2</sub> concentration in the lounge area during the two tests and Fig.10 gives the mean values of CO concentration for the caravans.

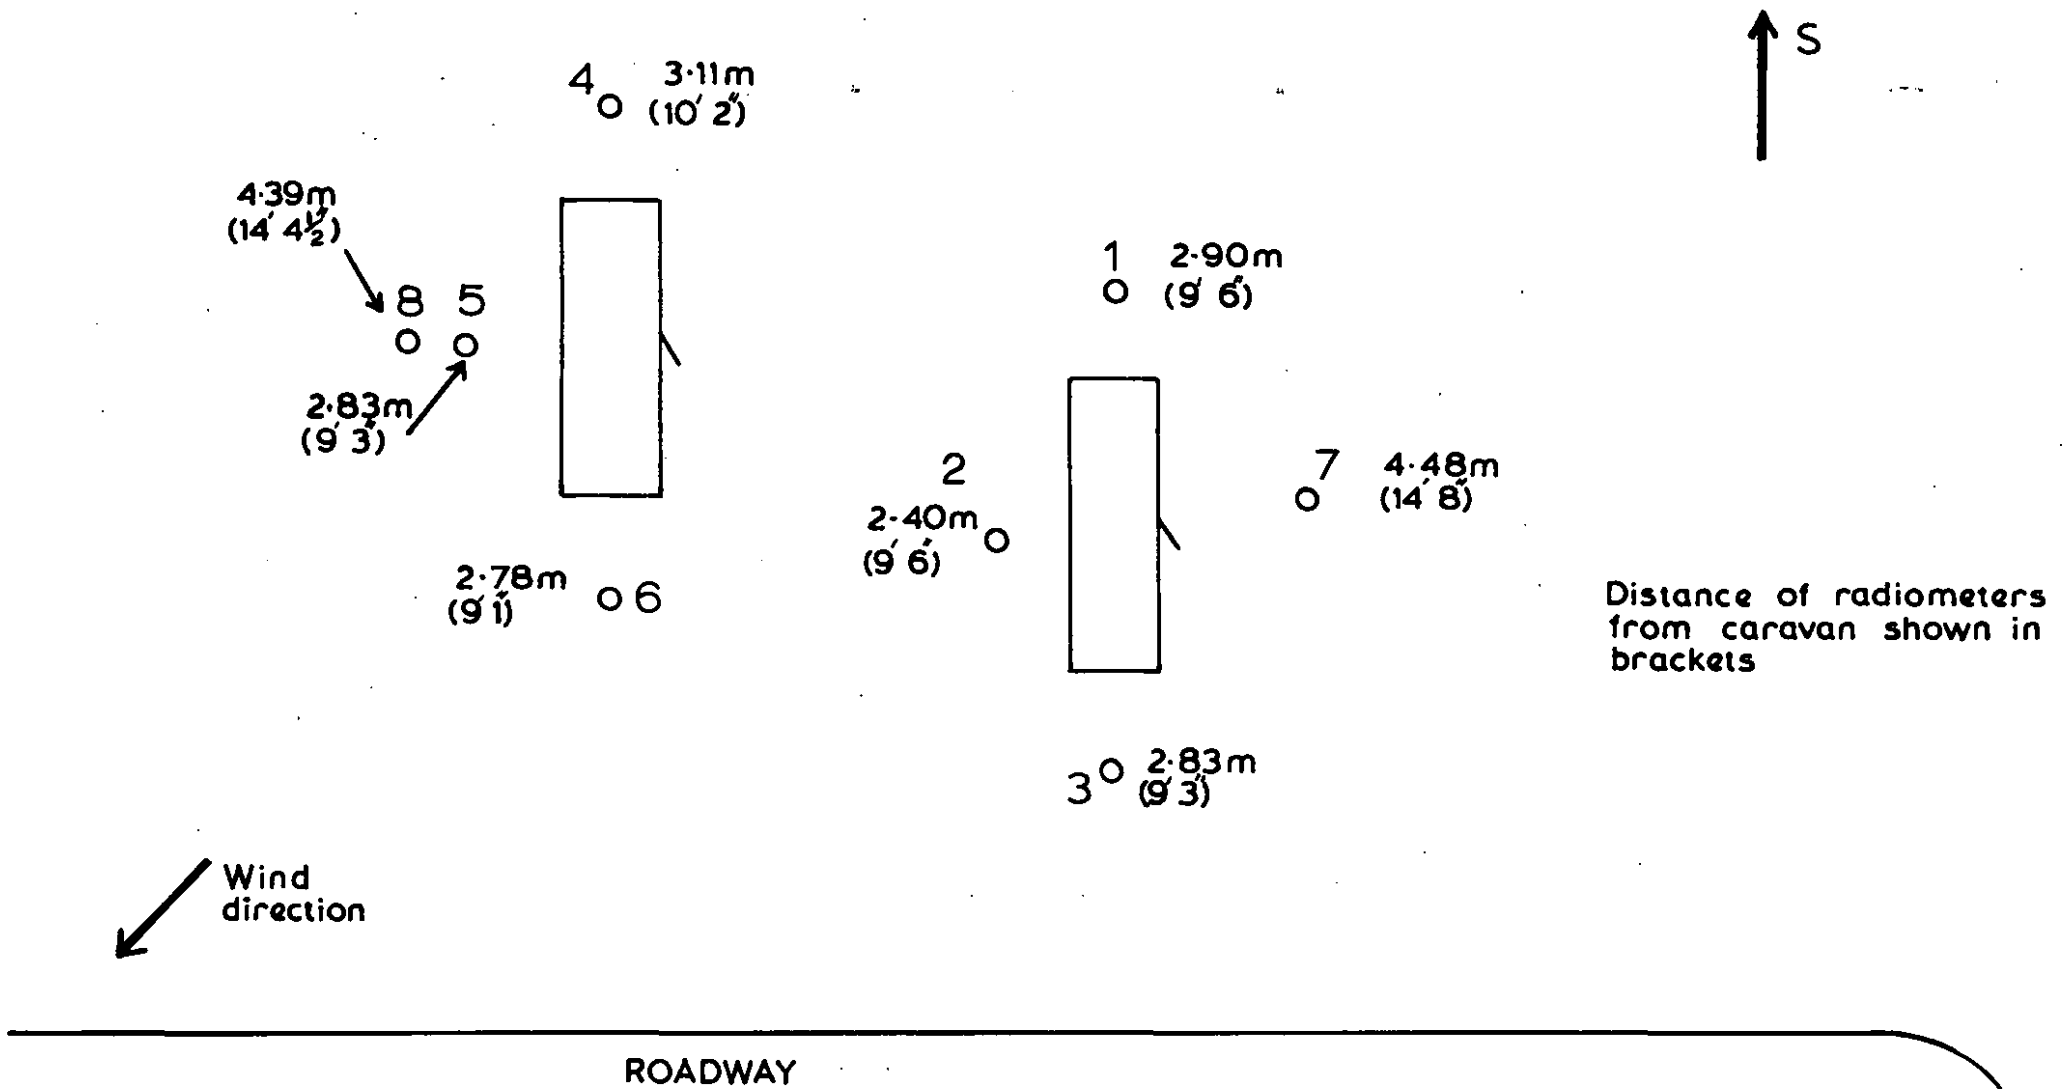
FIG 11 DIAGRAM SHOWING POSITION NUMBERS AND DISTANCES OF WOOD BLOCK RADIOMETERS FROM CARAVANS

Fig 11 is a site plan of the two caravans and shows the position of the wood block radiometers used in the two tests. Table 1 sets out the radiation data obtained, and calculations have been made on two assumptions about the time of exposure namely one of 10 minutes and the other of 20 mins.

The level of radiation falling on a given block divided by the approximate configuration factor gives an effective intensity for the radiation emitted by the fire of between 3 and 4 W/cm<sup>2</sup> assuming the whole caravan was emitting rather than just the windows alone.

This value of radiation intensity would suggest that the minimum separation distance between caravans should be 10 ft for the still air conditions which prevailed during the tests. However, the calm conditions in which the tests were carried out are relatively rare and therefore a longer separation distance should be used in practice to allow for the effect of wind on the flames emerging from a burning caravan, particularly those from the windows.

4. The information obtained during the tests from the radiation data suggests that the practice which allows for a separation distance of not less than 6.00 m (20 ft) is probably of the right order when allowance is made for the effect of wind on flames emerging from the windows.

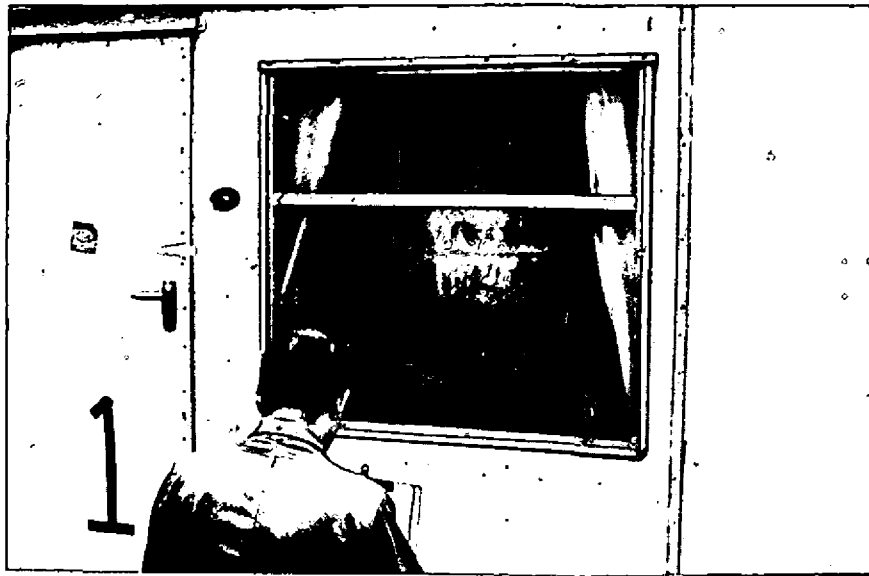
TEST NO. 1. 1 min AFTER START OF TEST  
PLATE 3

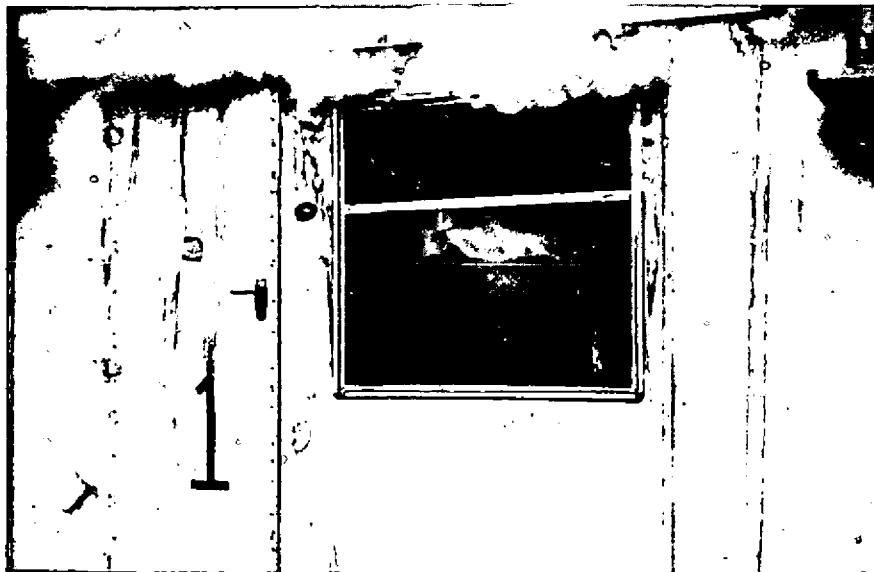
TEST NO. 1.  $3\frac{1}{2}$  min AFTER START OF TEST  
PLATE 4

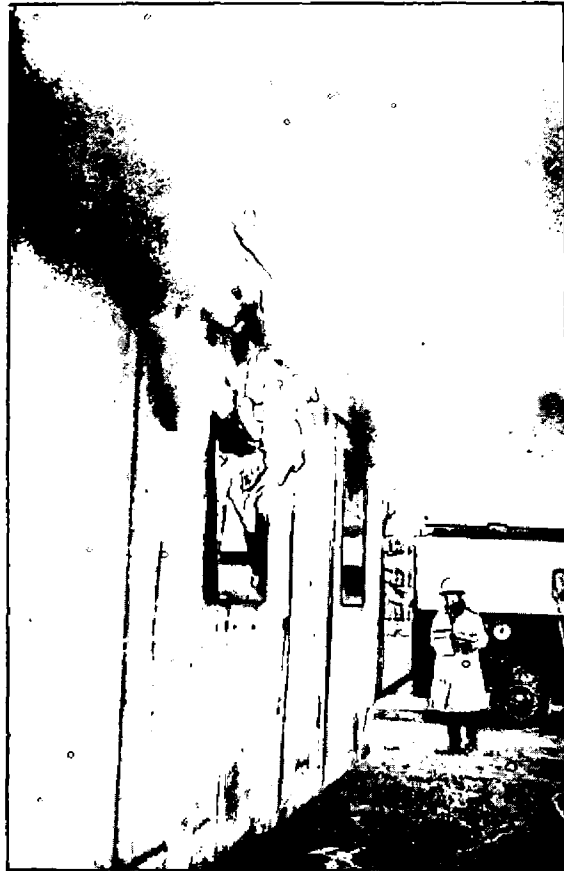
TEST No. 1. 5 min AFTER START OF TEST  
PLATE 5

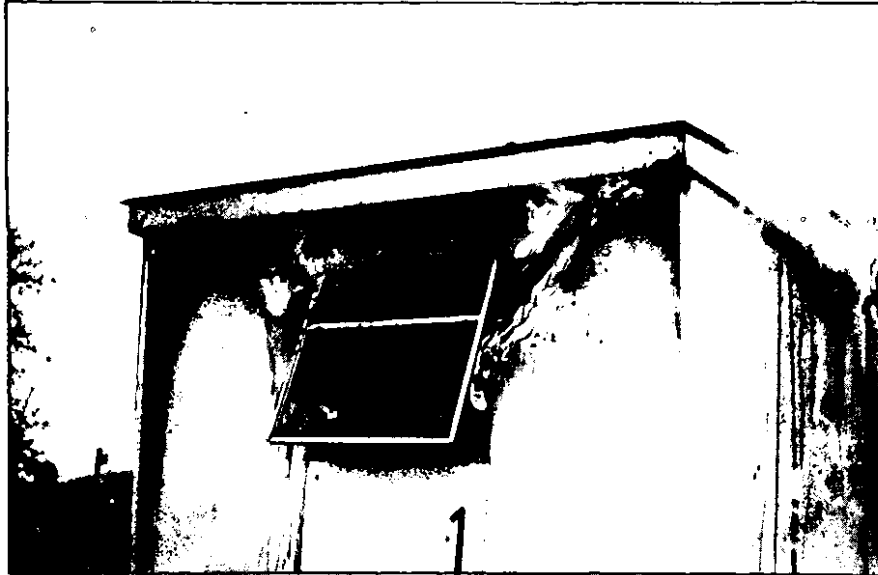
11	30	All windows appeared to be cracked but most of the glass still in place.
19	20	Flames issuing from window near the door on West side.
22	05	All glass fallen out from windows.
22	25	Flames now penetrating walls on North and West sides of caravan.

TEST NO. 1. 11 min AFTER START OF TEST  
PLATE 7

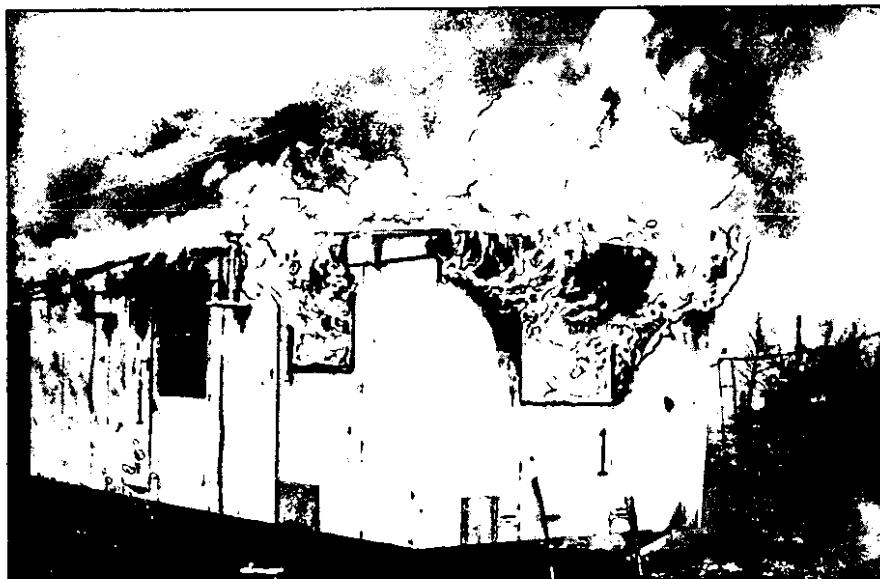
TEST NO. 1. 19 min AFTER START OF TEST  
PLATE 8

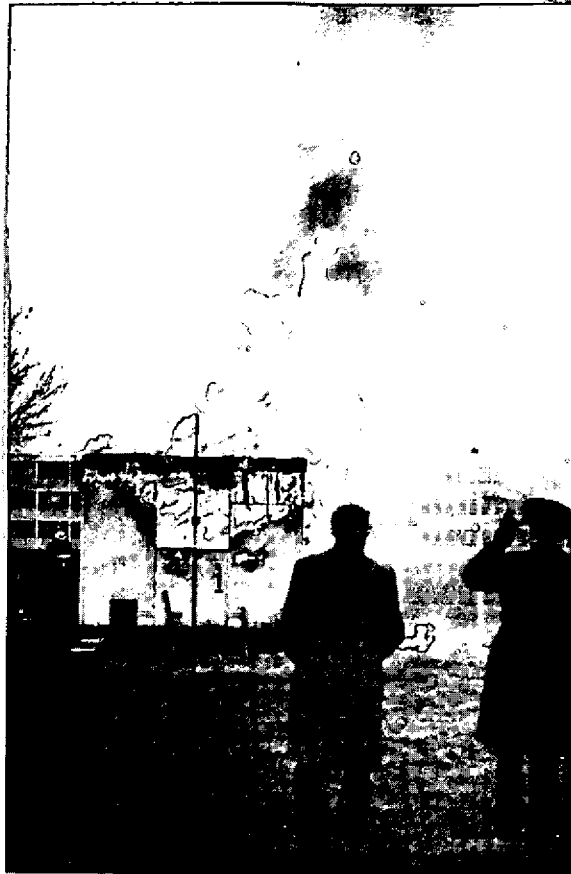
TEST NO. 1. 23 min AFTER START OF TEST  
PLATE 9
