Fire Research Note No. 855

AN INVESTIGATION INTO THE FIRE RESISTANCE
OF TIMBER DOORS

W. A. MORRIS

January 1971

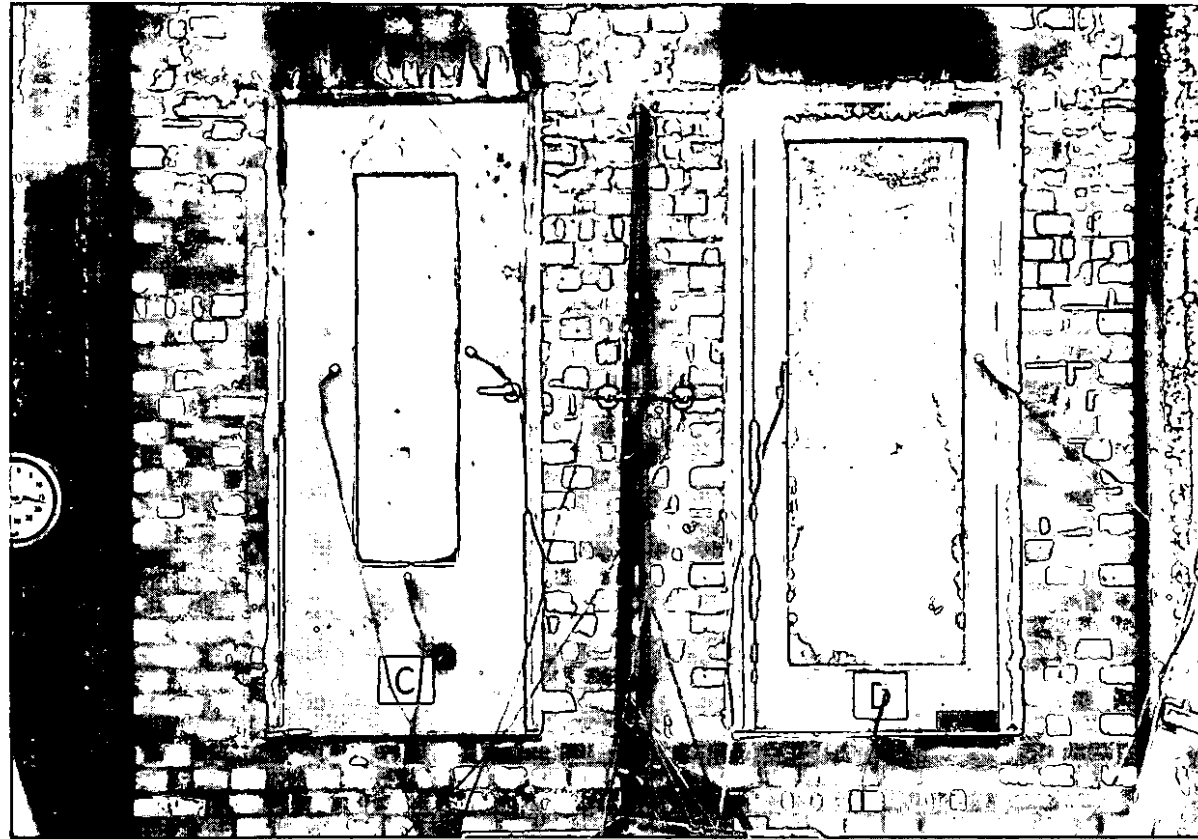
FLAMES PENETRATING AROUND THE DOOR EDGES 17 MINUTES
AFTER THE START OF A TEST
PLATE 1

It is apparent that a fire check door possesses lower integrity than a corresponding fire resisting door. In the majority of cases the integrity failure occurs by the formation of orifices or openings along the edges of the door, (Plate 1) an inherent weakness due to the nature of the door construction. The present tests have highlighted the importance of detailing at the edges of doors and have shown some ways of improving the resistance to fire penetration.

The first penetration of fire through a timber door generally occurs at the edge of the door, usually in the upper part. Failure is caused by the fire exploiting the gaps between the door edge and the frame. Wider gaps quicken the fire penetration as shown in 5.3. A door may have a very good fit and give a good performance in a standard test, but unless control is exercised to ensure that a similar fit is maintained in practice the behaviour of the door in an actual fire may not be equally reliable. One of the ways in which the influence of the gaps can be minimised and a good performance assured is by the use of a special material along the edges of the door which have the property of intumescent at high temperatures. One type of intumescent material is available in the shape of a 3 mm x 12 mm ($\frac{1}{8}$ x $\frac{1}{2}$ in) strip and this was employed in eight of the specimens tested, two of which were the one hour door types 'I' and 'J'. There was a significant improvement in the performance of all the doors where the strip was used (Table 4) with the exception of door E₂. This door had a wood particle board core and was only fitted with a single pair of hinges. The door was tested with the hingeside exposed to the furnace and bowing of the door caused the top hinge to pull away from the frame. (Plate 2).

5. The use of an intumescent strip to seal the edges of a door under fire conditions greatly enhances the performance of timber doors, including swing doors without rebated frames.

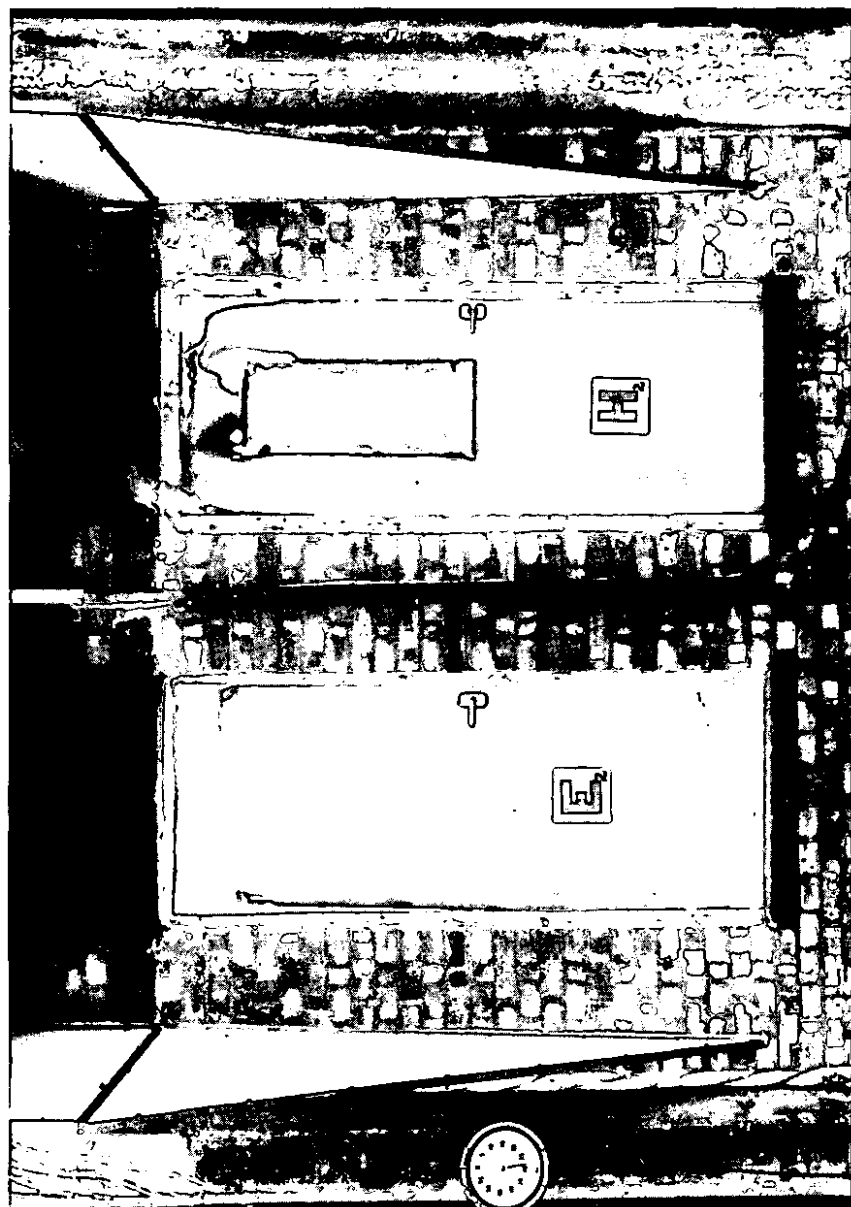
PLATE 2

Severe bowing occurred with this door (solid particle board) a significant gap developing by 21 minutes. The top hinge had broken away from the frame at 24 minutes. This was followed by ignition of the face of the door. The door collapsed completely at 30 minutes.

SEVERE BOWING OF A DOOR HUNG ON ONLY TWO HINGES (DOOR E)

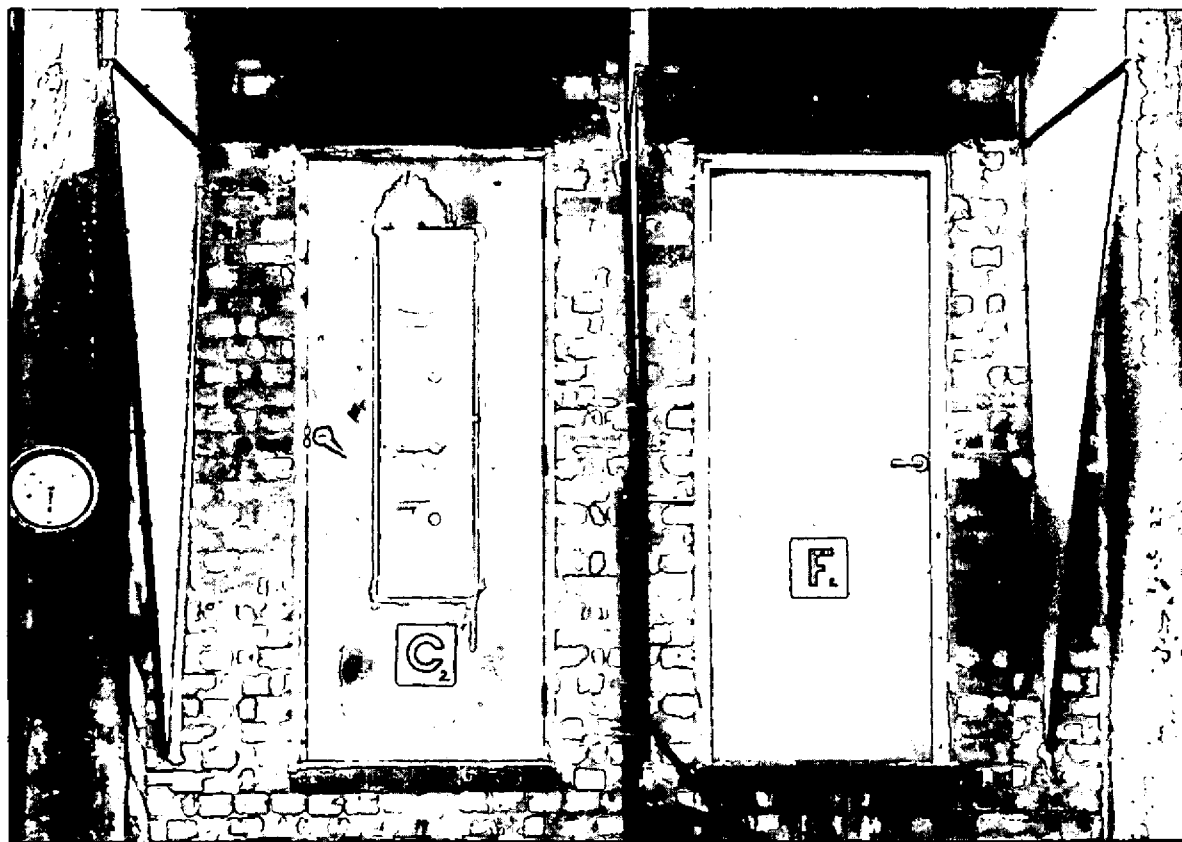
PLATE 3

The most significant improvements were in the cases of loosely fitted doors and the swing doors having no rebated stop. Door C₁ was similar to, and was exposed in the same manner as, door C₂. The fire penetration time for the latter door, which incorporated an intumescent strip, more than doubled. (Plate 3). The swing door D₁ was a very good fit in the frame (average gap less than 0.5 mm ($\frac{1}{64}$ in)); fire penetration occurred at 11½ minutes without the strip, but when the strip was fitted no penetration had occurred with a similar door after a test duration of 31 minutes. The strips used in the 55 mm door 'J', which had 25 mm (1 in) rebated stops, enabled the door to retain its integrity at the perimeter for a 65 minute test period, even though the frame had not been impregnated. The other 55 mm door, door 'I', failed when the fire penetrated the edge of the door at 35 minutes. Failure in this case however was due to excessive warping of the door.

DOORS HAVING THE EDGES SEALED WITH AN INTUMESCENT
STRIP AFTER 30 MINUTES OF TEST. DOOR 'C' IS A POOR FIT

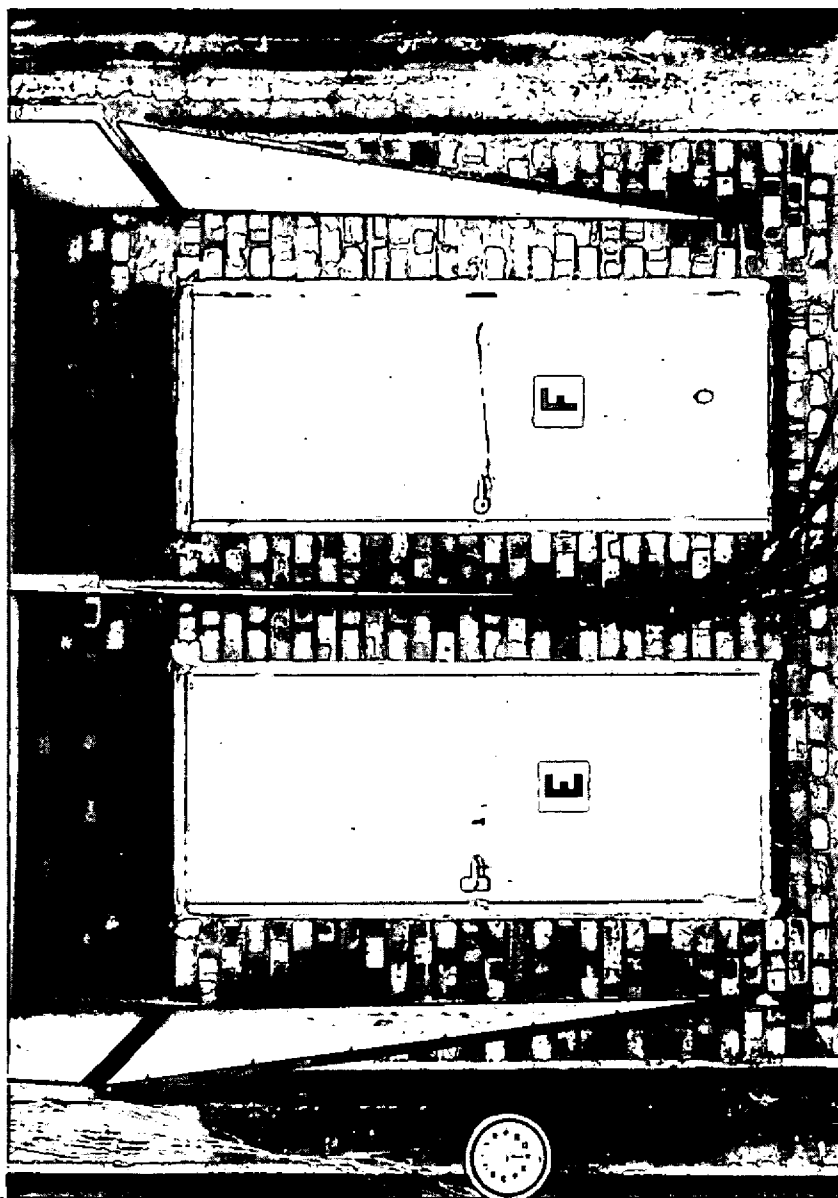
PLATE 4

No significant gaps developed between the door and its frame during the first 30 minutes of the test. Fire penetrated through the face of the door however at 26 minutes and ignition of the facing occurred at 38 minutes. The test was terminated at 39 minutes.

PENETRATION THROUGH THE FACE OF DOOR 'F', A 40 mm DOOR

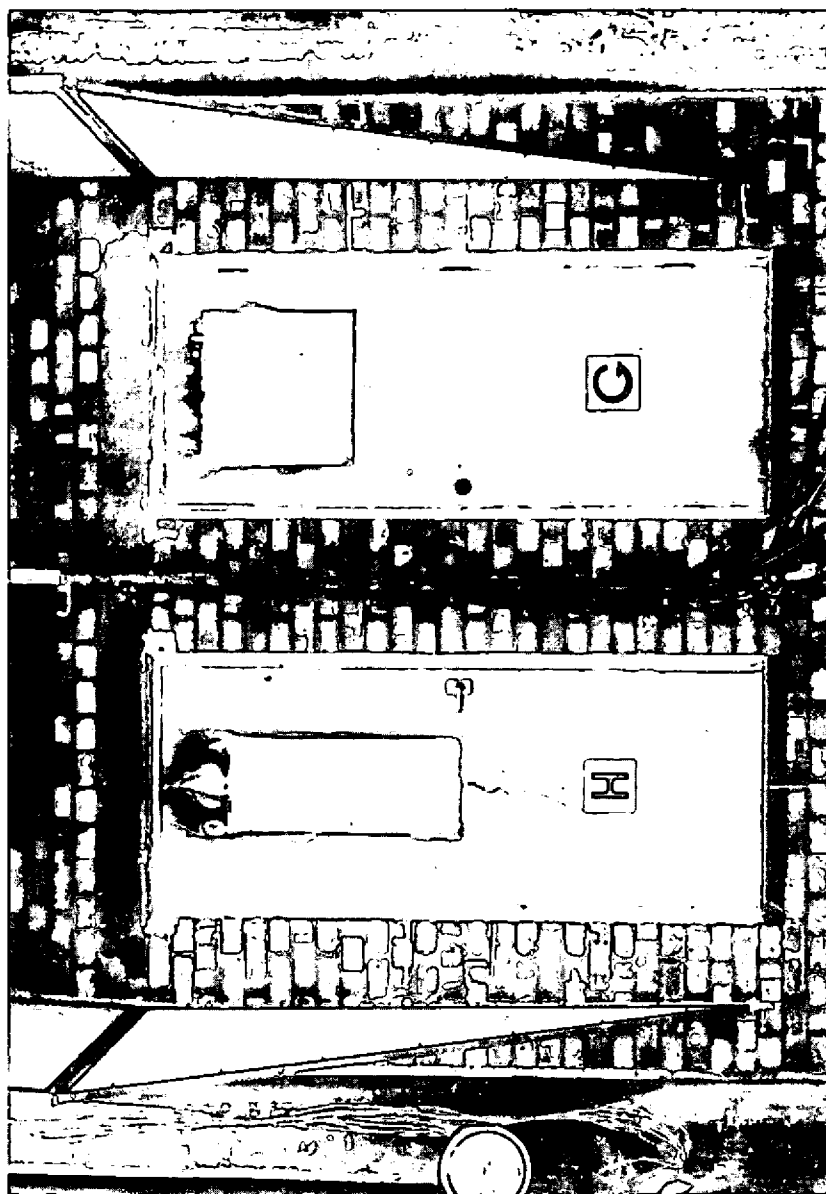
PLATE 5

If a door incorporates glazed panels, integrity failure may occur by the ignition of the beading or the frame on the unexposed face due to heat being transmitted through the glass. (Plate 5). This is usually due to the combined effects of conduction, radiation, and convective heating. In the tests, ignition of untreated timber beading occurred in every case except for doors 'C₁' and 'D₁' where the tests were terminated at 20 minutes. The ignition time for the beading varied between 17 and 31 minutes, and in only one case, i.e. door 'B₂' was the ignition time just in excess of 30 minutes. It can be concluded that a door having glazing retained by untreated timber beads is unlikely to attain a $\frac{1}{2}$ hour fire resistance. For the majority of the doors ignition occurred between 20 and 30 minutes. One glazed section in door 'B₂' had the bead on both sides of the door painted with an intumescent paint. The failure time of 30 $\frac{1}{2}$ minutes showed that this type of paint can be used successfully to protect the beading of a $\frac{1}{2}$ hour fire resisting door. (Plates 6 and 7). Such a treatment however would often be outside the direct control of the manufacturer. As yet no information is available on the continued effectiveness of this method of protection if overpainted with normal decorative treatments at a later date. A similar performance could be achieved by providing a decorative metal capping over the bead. It therefore seems that to achieve the $\frac{1}{2}$ hour fire check standard in a glazed wooden door the timber beading and the frame members do not require any flame retardant treatment, but to attain a $\frac{1}{2}$ hour fire resisting standard some preventative treatment is necessary. To eliminate doubts about the durability of flame retardant treatments the beading should be either non-combustible or covered with a non-combustible material.

TYPICAL FAILURE DUE TO HEAT TRANSFER THROUGH GLAZING

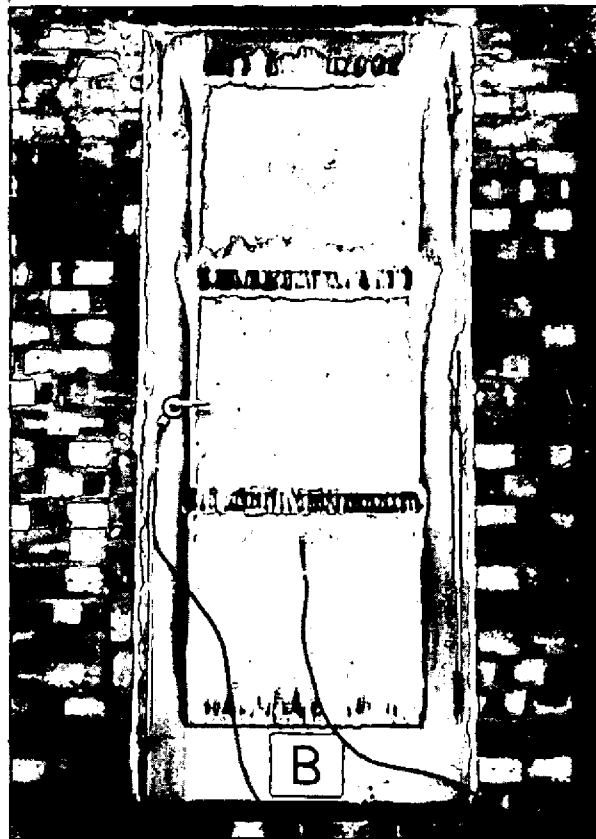
PLATE 6

FLAMING OF GLAZING BARS 23 MINUTES AFTER
START OF TEST

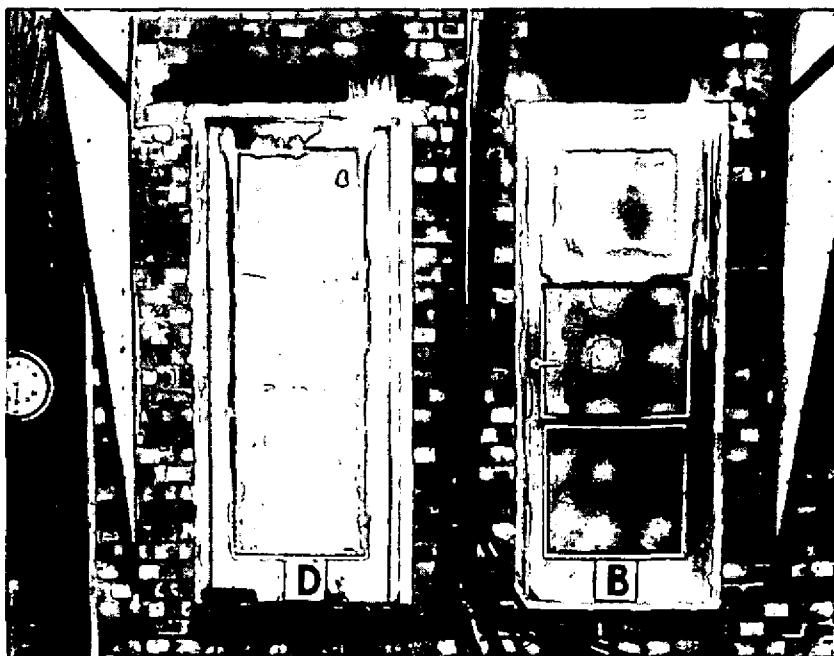
PLATE 7

Glowing of the frame near the latch occurred at 23 minutes and a gap 12 mm in width had developed by 26 minutes. Ignition of the top glazing bead occurred at $30\frac{1}{2}$ minutes and 15 seconds later the treated beading around the centre pane ignited (flames appeared to have been transmitted from the upper bead). The test was terminated at 31 minutes with the door retaining its stability.

FLAMING OF THE UNPROTECTED BEADING AT $30\frac{1}{2}$ MINUTES
AFTER THE START OF TEST - PROTECTED BEADS STILL NOT IGNITED

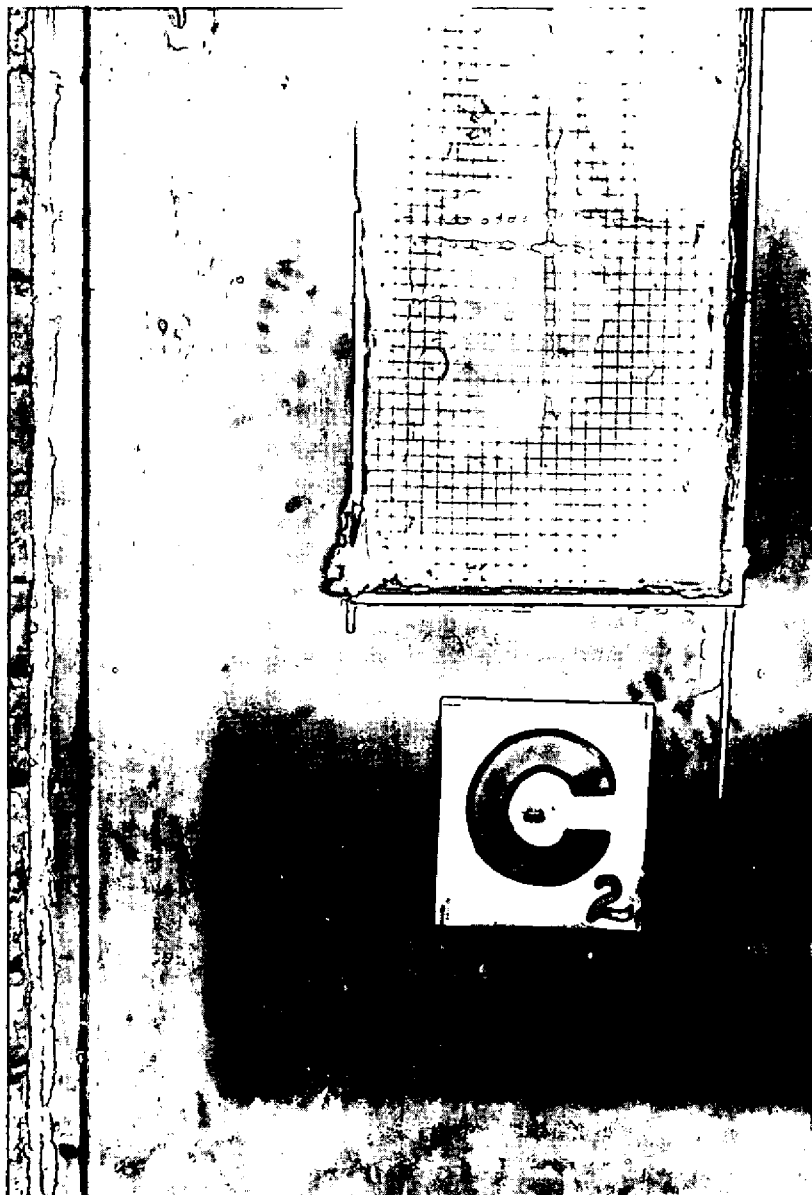
The timber glazing bead of door C_2 was treated with an intumescent paint but premature failure occurred when the fire penetrated between the planted beads and the door frame. (Plate 8). It is preferable to locate the glass in a rebated frame rather than by planted beading on both sides of the glass.

FLAME PENETRATION BENEATH THE BEAD WHEN THE
GLAZING IS NOT LOCATED IN A REBATE

15. Beading 13 mm in depth is adequate to retain glass up to 0.9 m^2 in area in $\frac{1}{2}$ hour doors.
16. If the glass is retained by planted beads on both sides flames can penetrate beneath the beads. It is therefore recommended that the glazing should always be located in a rebated frame.

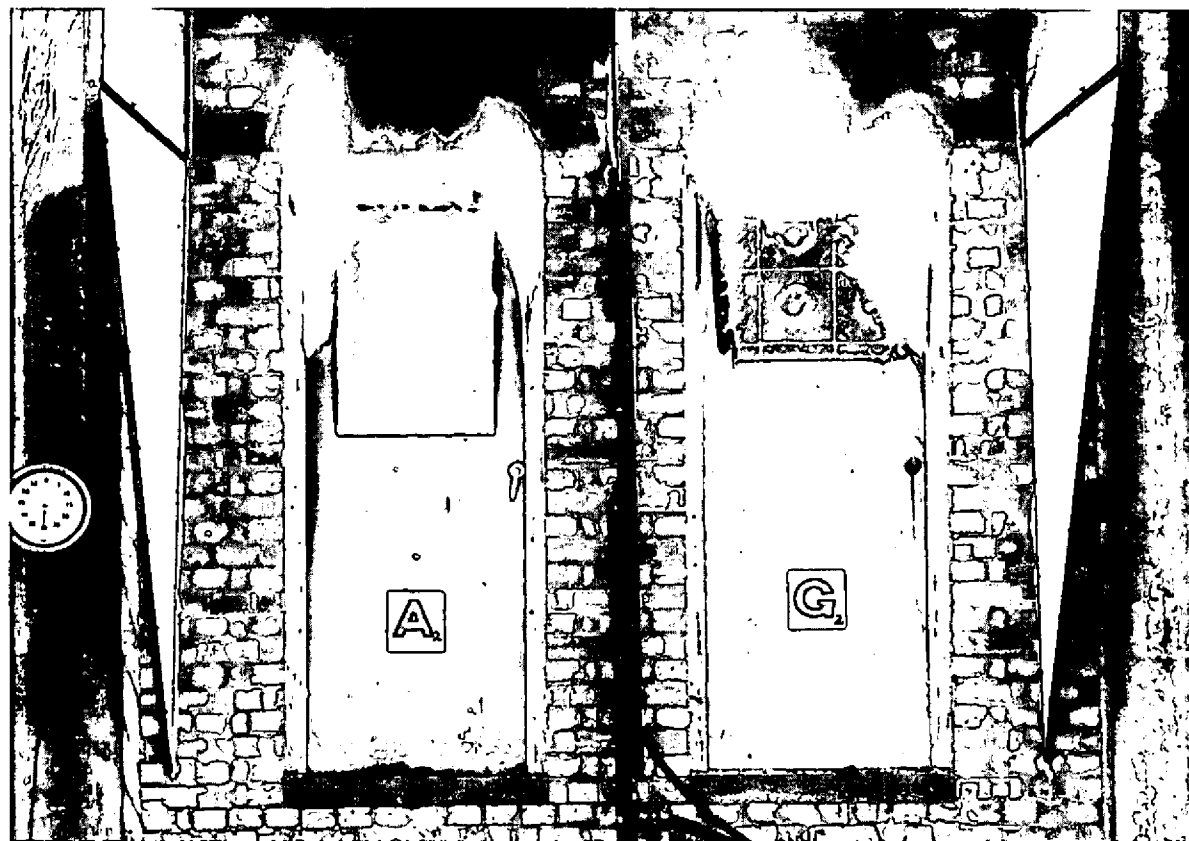
PLATE 9

Integrity failure of the door occurred at 17 minutes when the unexposed face of the door adjacent to the aluminium glazing bead ignited. At 24 minutes the glazed vision panel collapsed into the furnace. Significant gaps had formed at the top edge of the door by 25 minutes.

In two tests (doors ' G_2 ' and ' H_2 ') the glazing was retained by aluminium and PVC beading. Door ' G_2 ' with the aluminium beading failed at 17 minutes the glass collapsing before the end of the test. (Plate 9).

COLLAPSE OF THE GLAZING RETAINED BY ALUMINIUM BEADS (DOOR G_2)

12. Materials of low melting point should not be used for doors furniture as their collapse may result in a premature failure of the door.
13. Glazing retained in a door by untreated timber beads would not generally impair the ability of the door to attain $\frac{1}{2}$ hour 'fire check' standard.

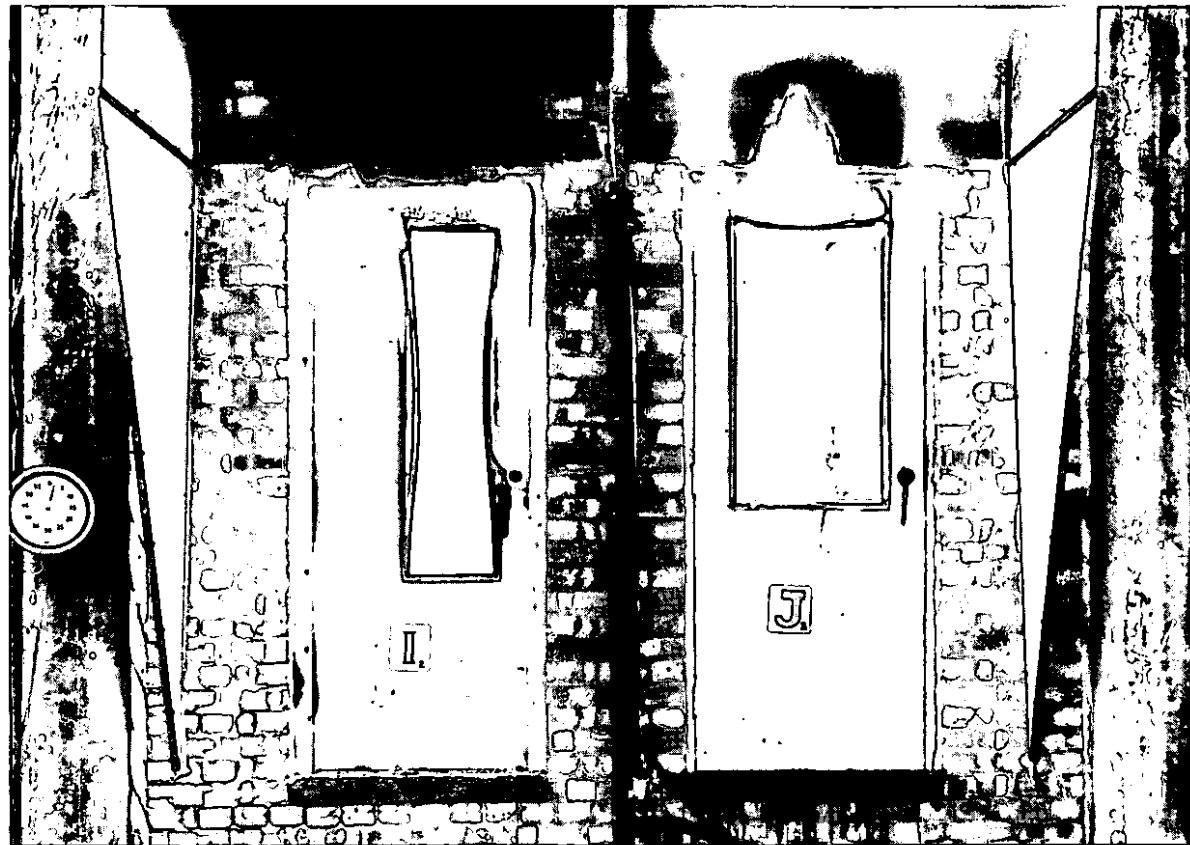
PLATE 10

Integrity failure occurred at $34\frac{3}{4}$ minutes when distortion of the door enabled flames to penetrate at the top edge. Severe distortion of the welded steel glazing surround was evident and ignition occurred beneath the beading at $55\frac{3}{4}$ minutes. The door retained its stability for the 1 hour test period.

EXCESSIVE DISTORTION OF THE GLAZING SUBFRAMES
BECAUSE NO ALLOWANCE HAS BEEN MADE FOR EXPANSION
