Fire Research Note No. 878

FIRE AT WULFRUN SHOPPING CENTRE,
WOLVERHAMPTON, 24. 12. 70

A. SILCOCK and P. L. HINKLEY

July 1971

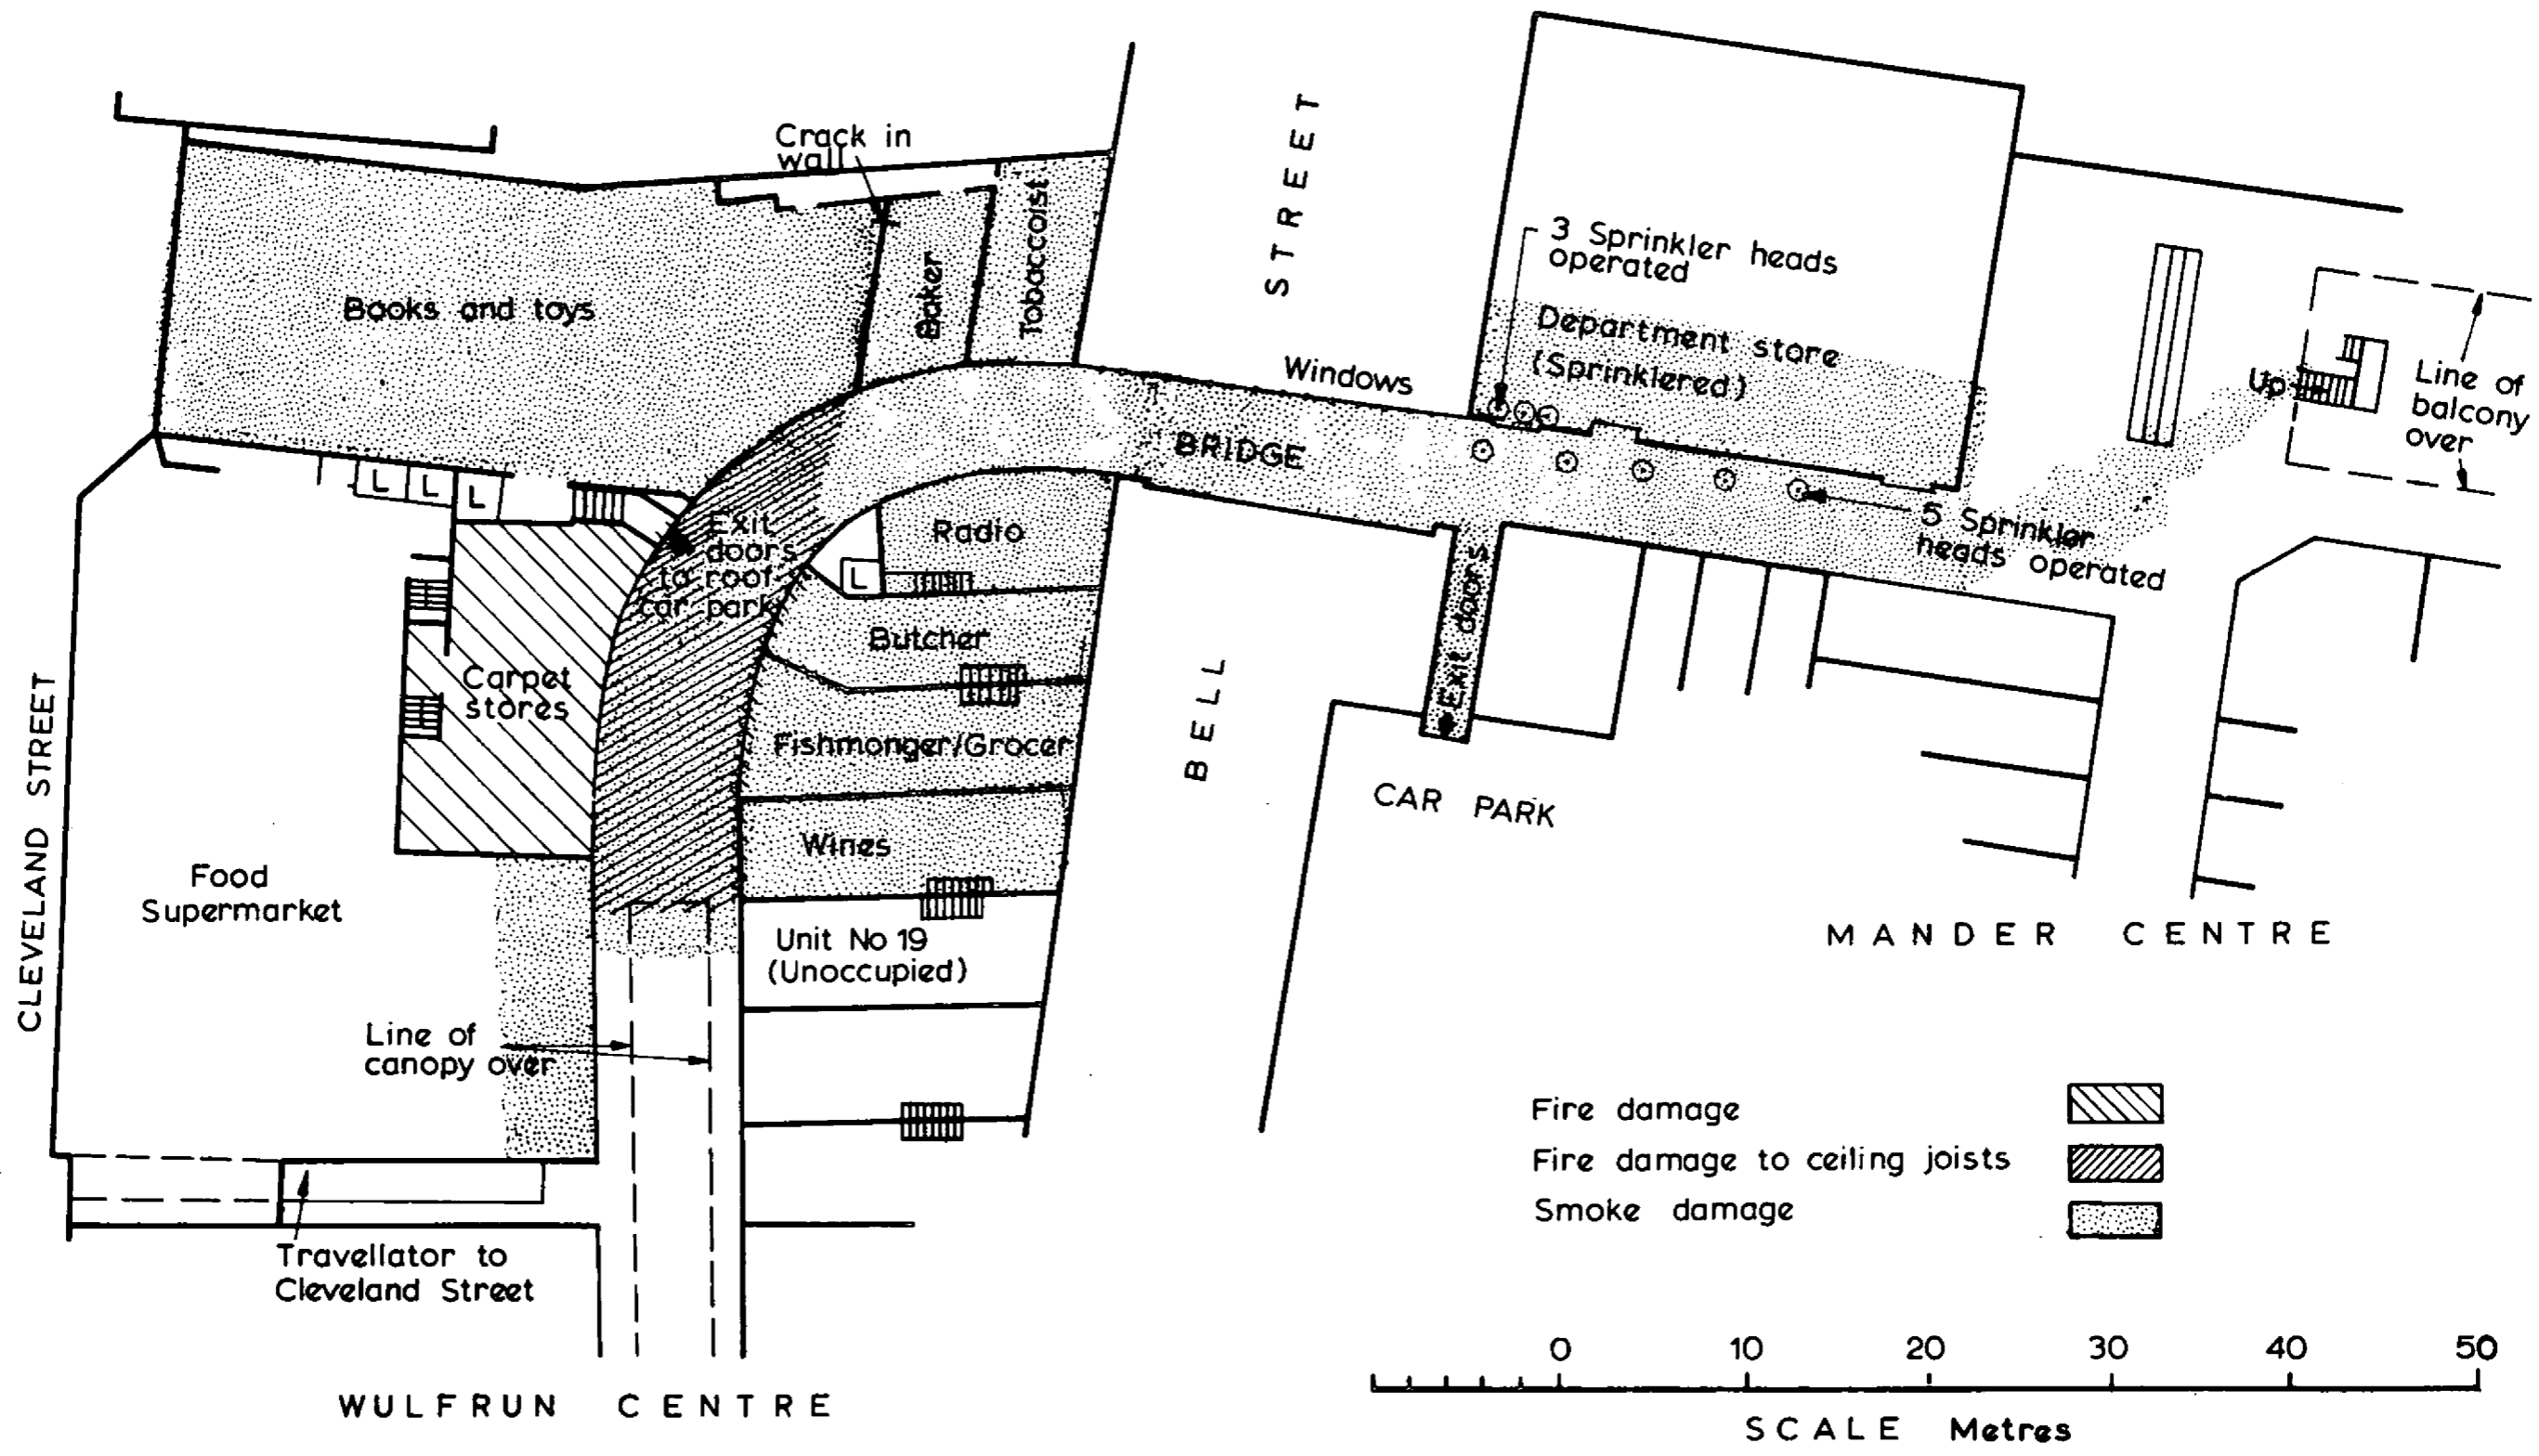
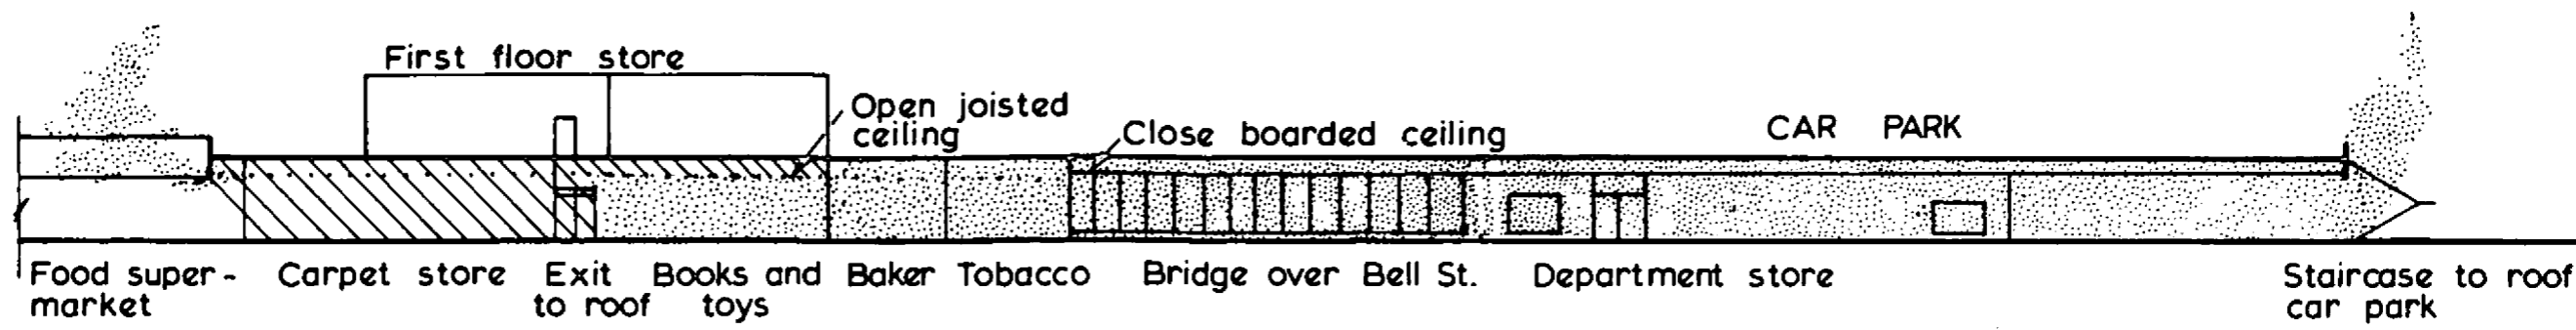
FIG. 1. PLAN OF WULFRUN CENTRE WOLVERHAMPTON

The complete complex consists of two elements - the Wulfrun Centre and the Mander Centre - separated from each other by Bell Street. A covered arcade which bridges over the street forms the connecting link between the two centres: shops line either side of the arcade except for the bridge section which has large openable windows on one side. (Fig.1).

- (iv) The timber open 'false ceiling' in the arcade was burnt in the area in front of the carpet store and for 16 m beyond (Figs 1, 2, and 3).
- (v) The reinforced concrete roof slab over the carpet stores and the adjacent part of the arcade was badly damaged by spalling of concrete and the consequent exposure of reinforcing bars.

- (vi) A crack due to thermal expansion appeared in the separating wall between the bakers' shop and the book shop. (See Fig.1).
- (vii) Three sprinkler heads inside the department store shop window display operated causing some damage to stock although there was no sign of damage to the outside of the showcase.

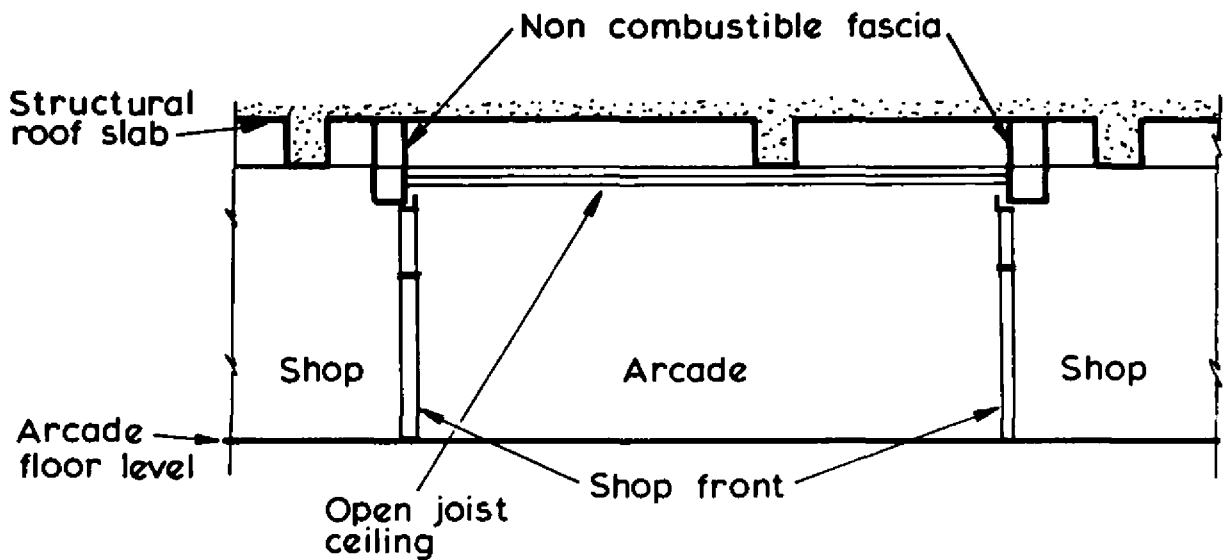
FIG. 2. CROSS SECTION THROUGH ARCADE

3.4. The deep non-combustible fascia above the shop fronts (Fig.2) remained in position preventing the flames beneath the ceiling from entering the shop; the glass windows remained in position for sufficiently long to delay the ignition of materials in the shop by radiation. These two factors undoubtedly restricted fire spread before the arrival of the brigade.

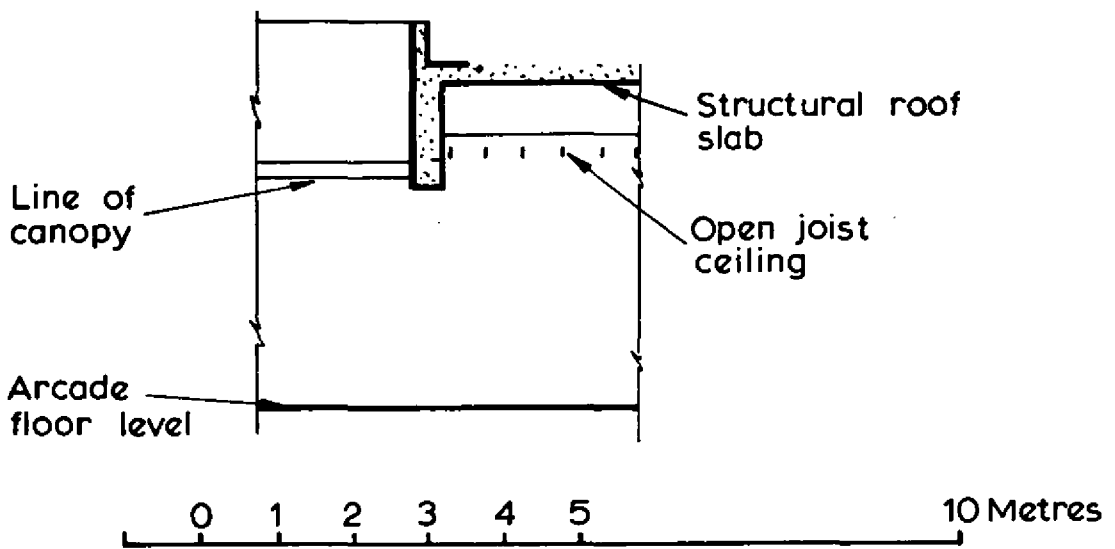
FIG. 3. SECTION THROUGH END OF COVERED ARCADE (WULFRUN CENTRE)

The Wulfrun Centre end of the arcade was partly closed by a screen extending downwards from the bottom of the roof slabs to 3 m from the ground (Fig.3); this very largely acted as a barrier to the passage of flames in that direction since there was only evidence of flames having impinged on the soffit of the canopies for a short distance beyond the covered section of the arcade. The screen would also act as a partial barrier to the travel of hot gases so that, if wind effects were small, more hot gases would travel towards the Mander Centre than in the opposite direction.

On the evidence of the charring of the decorative wood joists (Fig.3) simulating a false ceiling of the arcade, flames had extended beneath the roof slabs of the arcade for a distance of 16 m beyond the carpet store in the direction of the Mander Centre. At this point the hot gas layer would have had a mean temperature of roughly 400°C (Appendix II) which would probably have fallen to roughly 200°C at the Manders Centre end of the arcade. Other temperatures are indicated in Fig.1. The lack of damage to the surface finish of the close boarded ceiling of the bridge indicates that the boards were probably exposed to the 300°C hot gases for only a short time - with this exposure the surface of the ceiling was calculated to have attained a temperature of 100°C in about $\frac{1}{2}$ min and after 5 min it would have reached 180°C.

The carpet shop was completely involved in flames and horizontal flames extended for 16 m beyond the shop in the direction of the Manders Centre. In the other direction there was only slight damage from flames beneath the roof screen (Fig.3) although the layer of hot gases extended to about 1 m below the level of the screen. This suggests that flaming occurred within the layer of hot gases (rather than at its base) and that the flames beneath the ceiling were not starved of air.

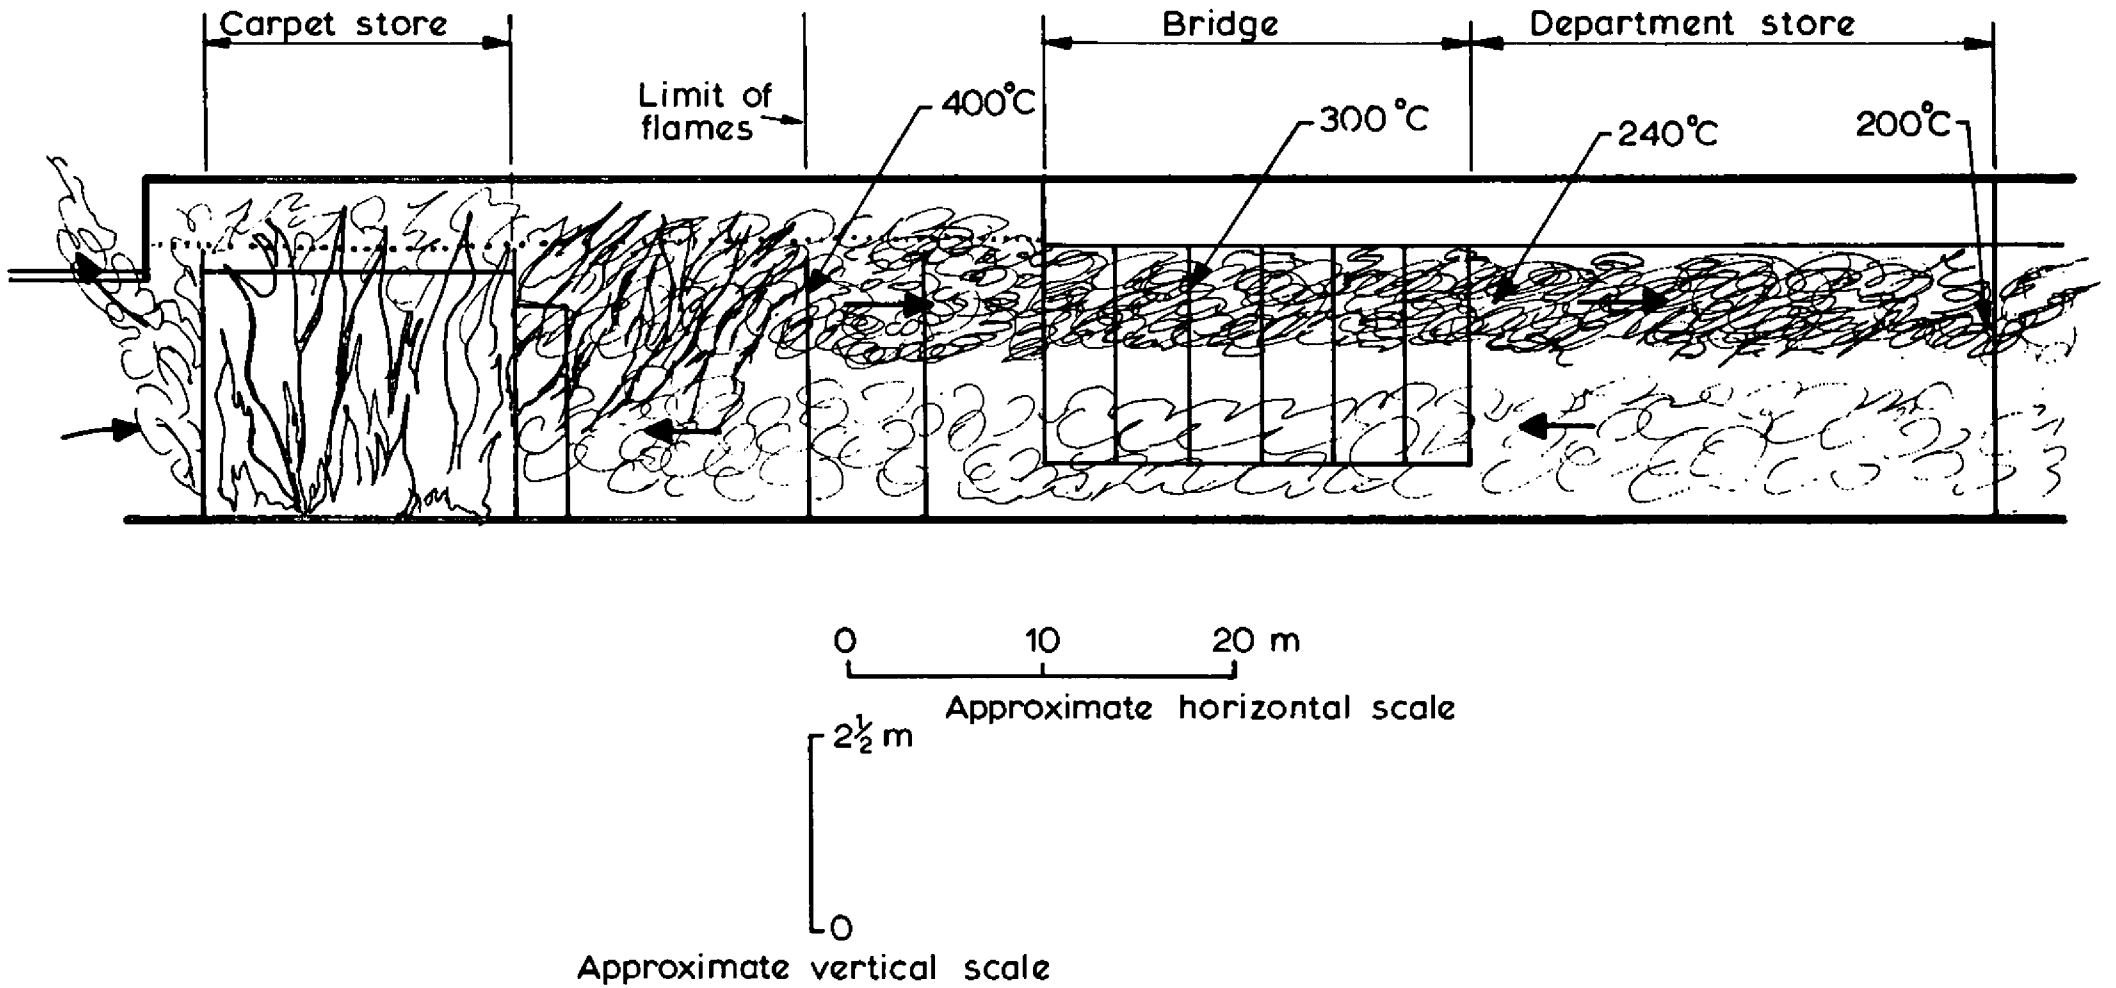
FIG. 4. TEMPERATURES AND FLOW PATTERNS IN ARCADE

Hot gases would have travelled away from the fire in both directions as a layer beneath the ceiling² which has been calculated to have extended down to roughly 2 m from the floor (Appendix II). Beneath this layer air would have been flowing in towards the fire (Fig.3); smoke would have mixed into this return flow of air particularly at the ends of the arcade and it would have been heavily smoke logged.

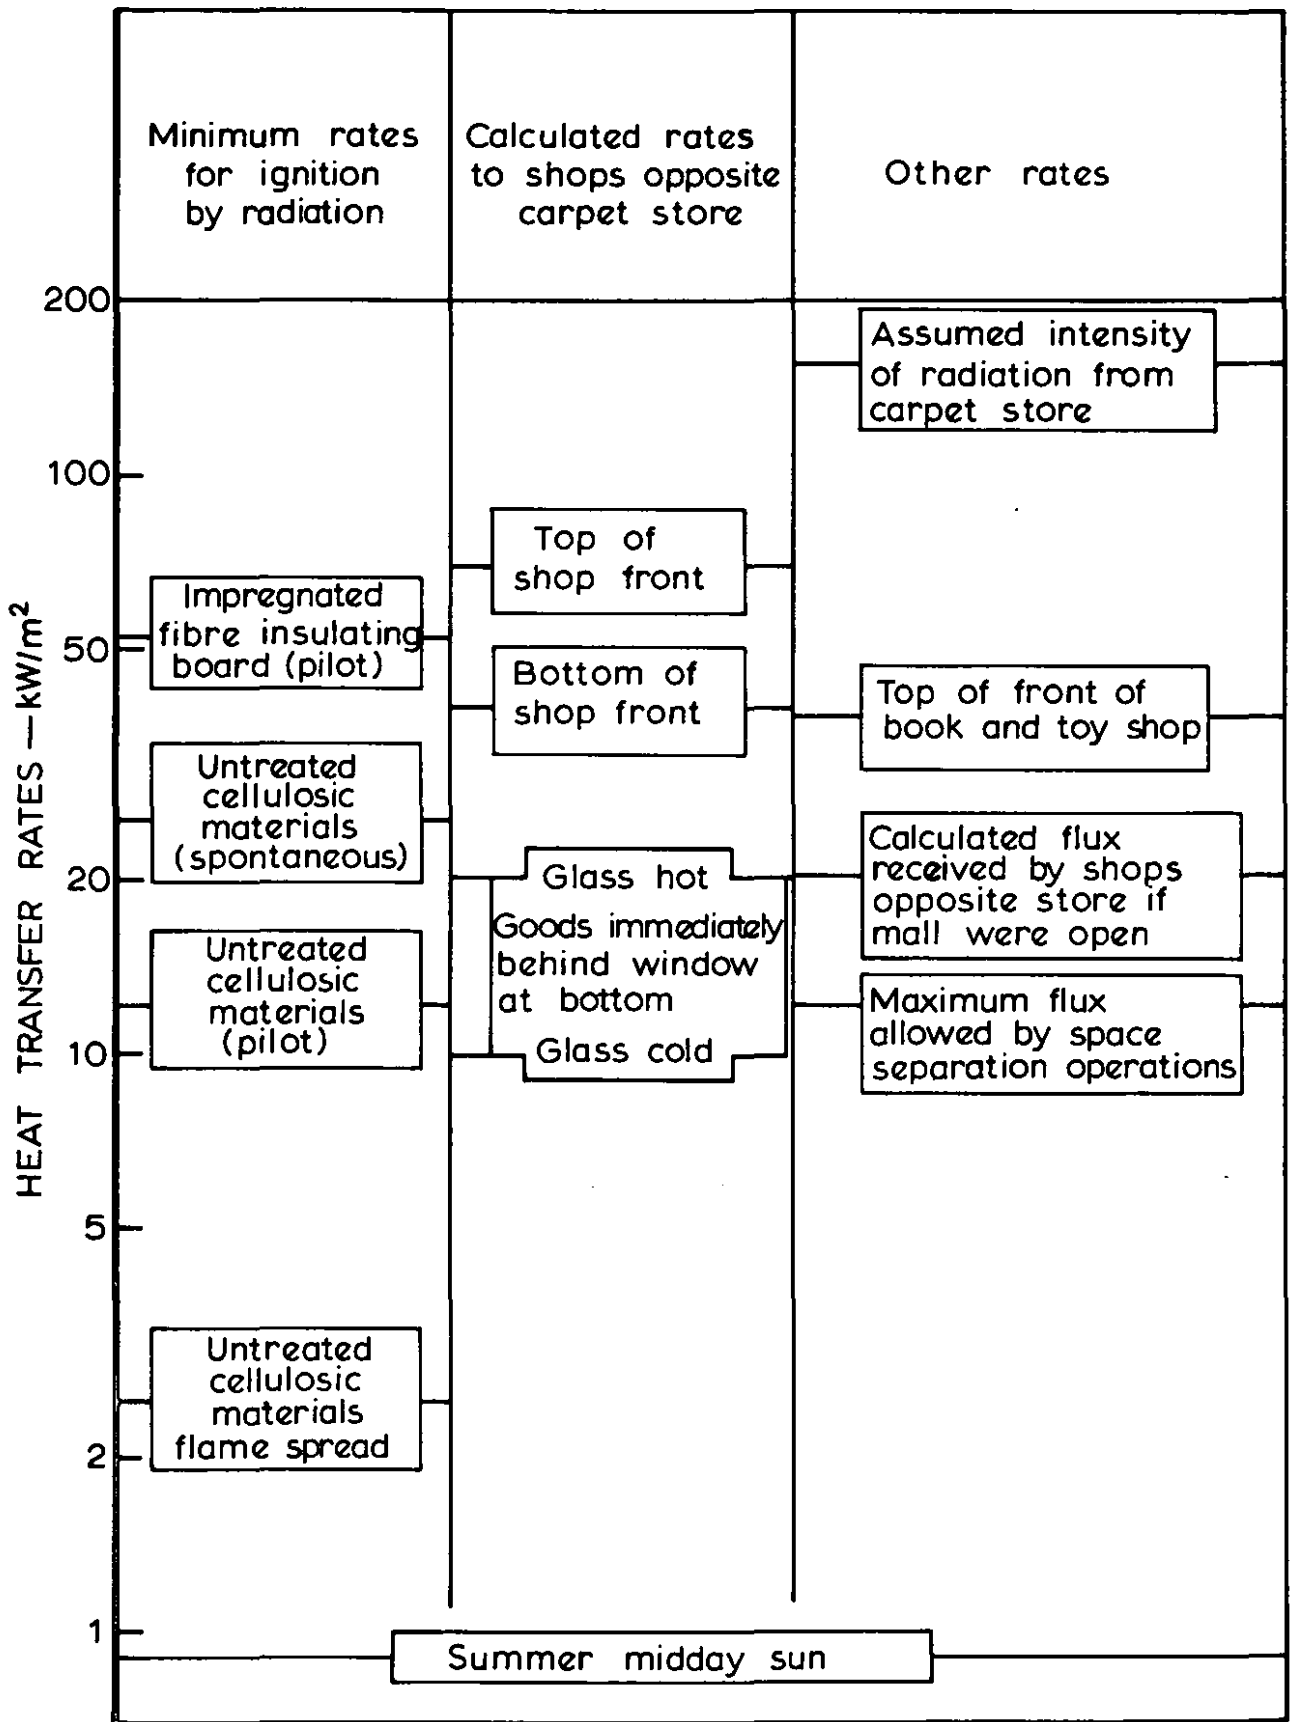
FIG. 5. COMPARISON OF HEAT TRANSFER RATES

Some calculations have been made (based on rather approximate data) of the rates of heat transfer to the shops opposite the burning carpet store and also to those adjoining it (Appendix II). These are compared with rates of heat transfer necessary to cause ignition of cellulosic materials^{4,5}, (Fig.5).

Because the arcade and its shops are in effect one building the space separation requirements of the Building Regulations do not apply and the separations of the shops across the arcade are less than those which would have been required had the shops been on opposite sides of an open street. Even so had the mall been open (with no projecting canopies) the heat radiated to the shops opposite the carpet store would probably not have been sufficient to cause spontaneous ignition of cellulosic materials, although pilot ignition would have been possible. However, because the arcade was roofed over, flames impinged on the top of the shop front and most combustible materials could be ignited. The heat transfer to the top of the front of the book and toy shop was probably less than that to the shops opposite but was still sufficient to ignite cellulosic materials.
