Fire Research Note

No 977

FIRE PROBLEMS IN PEDESTRIAN PRECINCTS PART 4
EXPERIMENTS WITH A GLAZED SHOP FRONT

June 1973

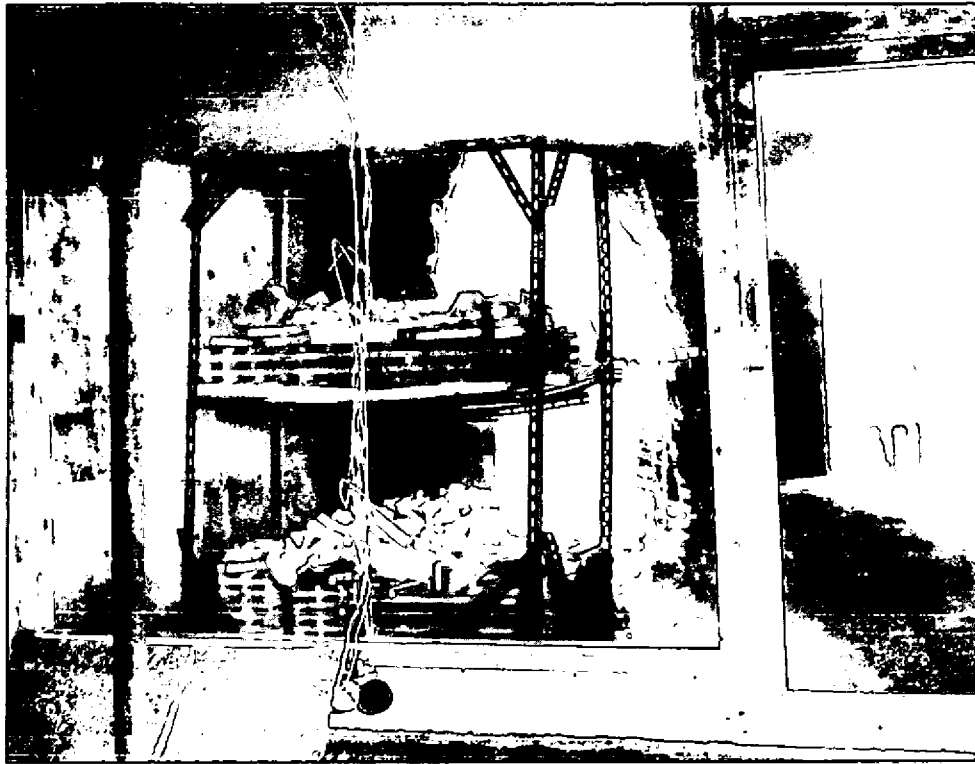
PLATE 3. EARLY STAGES OF TEST 121, 55 SEC FROM IGNITION

Plate 3 shows the early stages of test 121 with the cribs and polystyrene clearly visible on the display rack, the polyurethane cushions and the wood wool shavings beneath them well alight. Plate 4 shows the later stages of the same test with the sprinklers containing and even reducing the fire as well as wetting some of the glass. Two long cracks are visible on the left side.

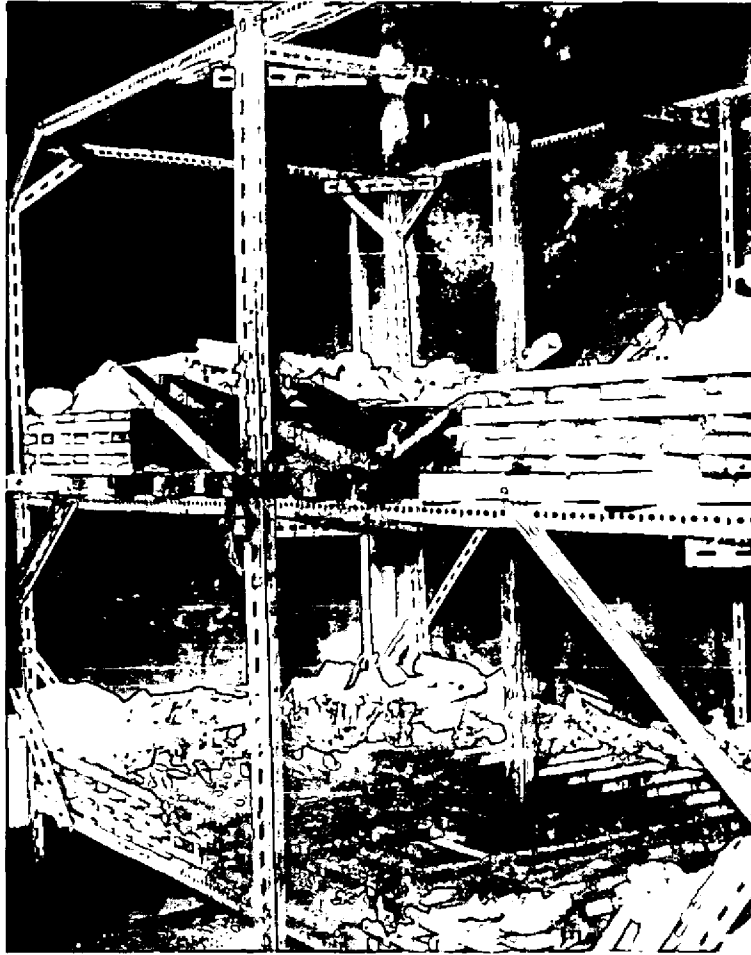
PLATE 5. TEST 122 AFTER SPRINKLERS HAD
EXTINGUISHED THE FIRE

Plate 5 shows the rack after test 122, the damage to the contents was never less than shown here in any of the other tests.

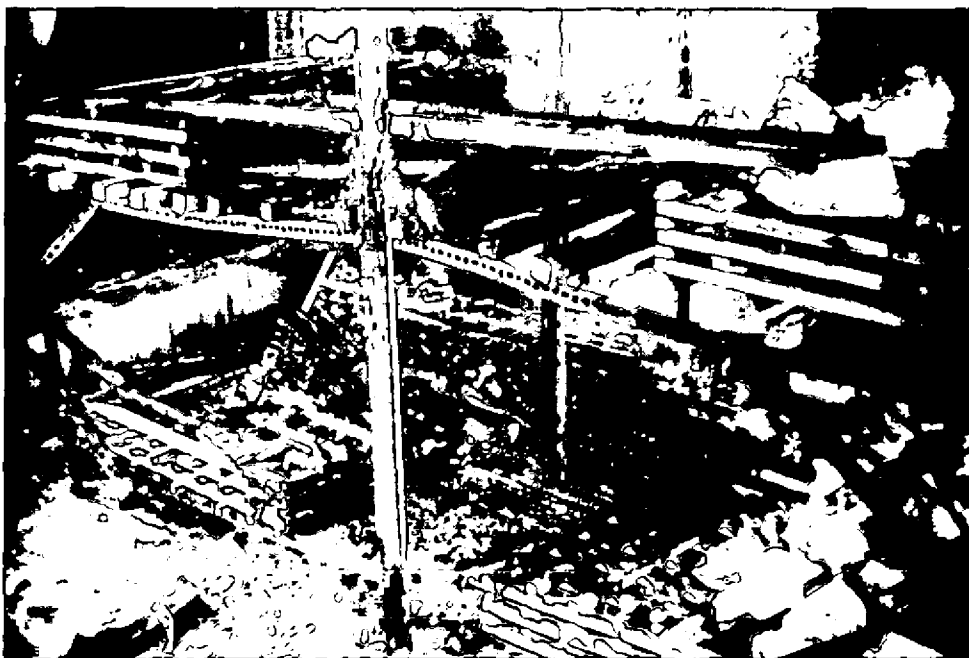
PLATE 6. AFTER TEST 130

Plate 6 shows the rack after test 130, while Plate 7 shows the main window after the same test with over half the glass fallen out.

09	00	Fire decreasing slightly.
10	00	Fire spreading in cribs towards window in spite of sprinklers.
15	30	Fire practically out.
After test		Glass in door intact, cracked in fanlight, at least half main window missing. Damage to rack contents greater than in test 121 with all the central parts burnt out on both shelves. Around the edges the cribs were undamaged and wet. A little polystyrene was left on these outer parts of the cribs.
