Fire Research Note No 995

EFFECTS OF DECOMPOSITION PRODUCTS OF
PVC IN FIRE ON STRUCTURAL CONCRETE

W A MORRIS and J S HOPKINSON

February 1974

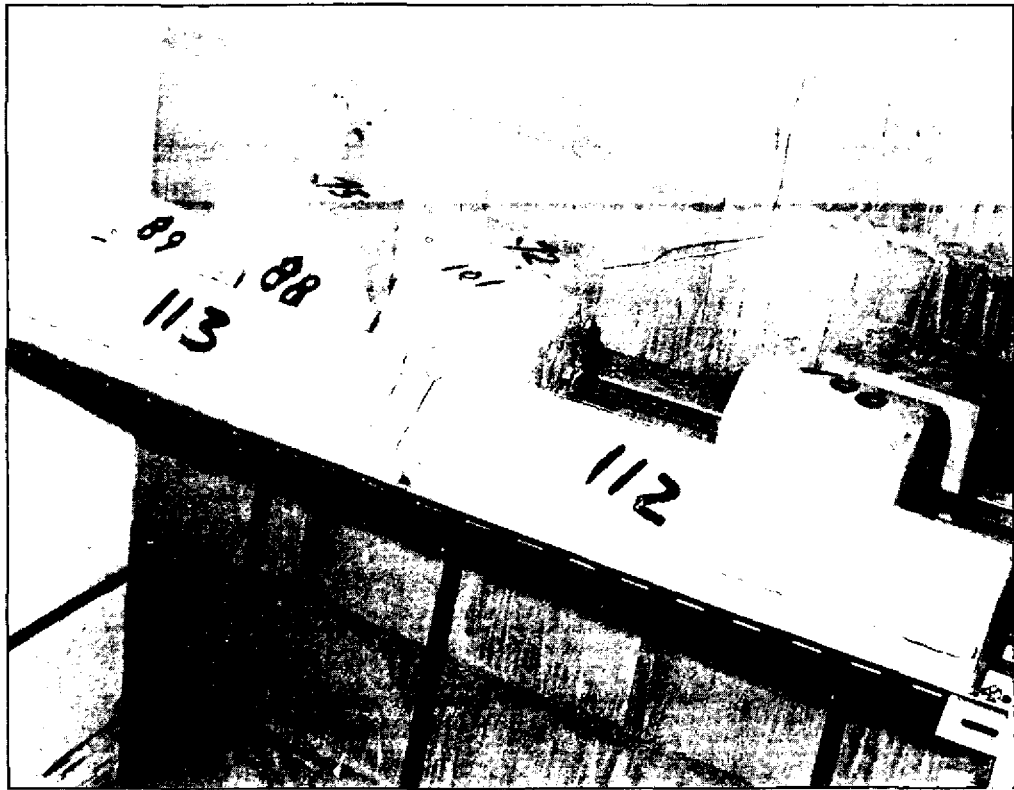
PLATES 4 and 5. CONCRETE SAMPLES MOUNTED ON STANDS - BEFORE AND AFTER TEST

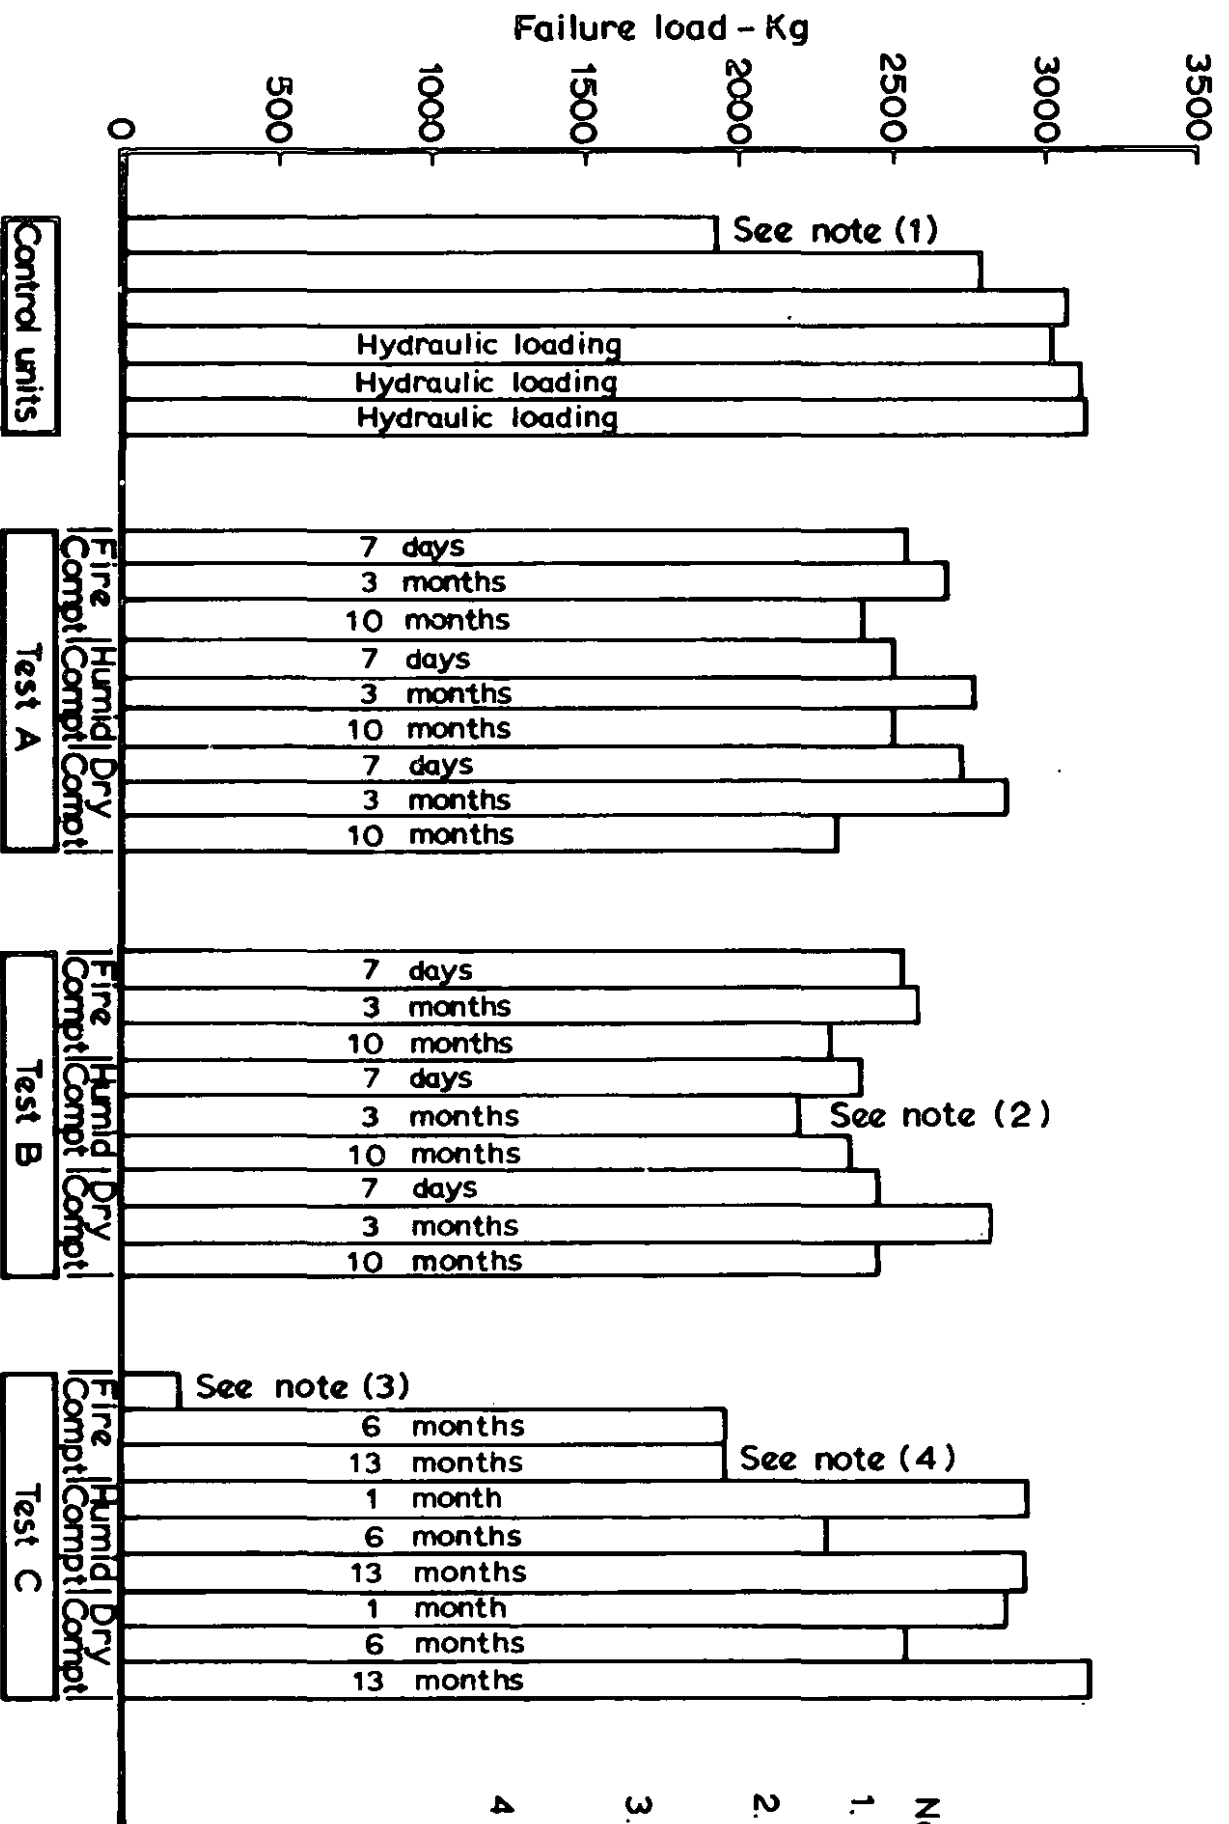
After removal, each unit was simply supported at its ends and a uniformly distributed load consisting of cast iron weights was applied until failure occurred (Plate 8). The loads sustained by each unit at failure and the deflections produced are given in Table 1. A histogram of the failure loads is given in Fig.7 and typical load-deflection curves are shown (for Test C) in Fig.8.

Figure 7 Results of loading tests on prestressed units

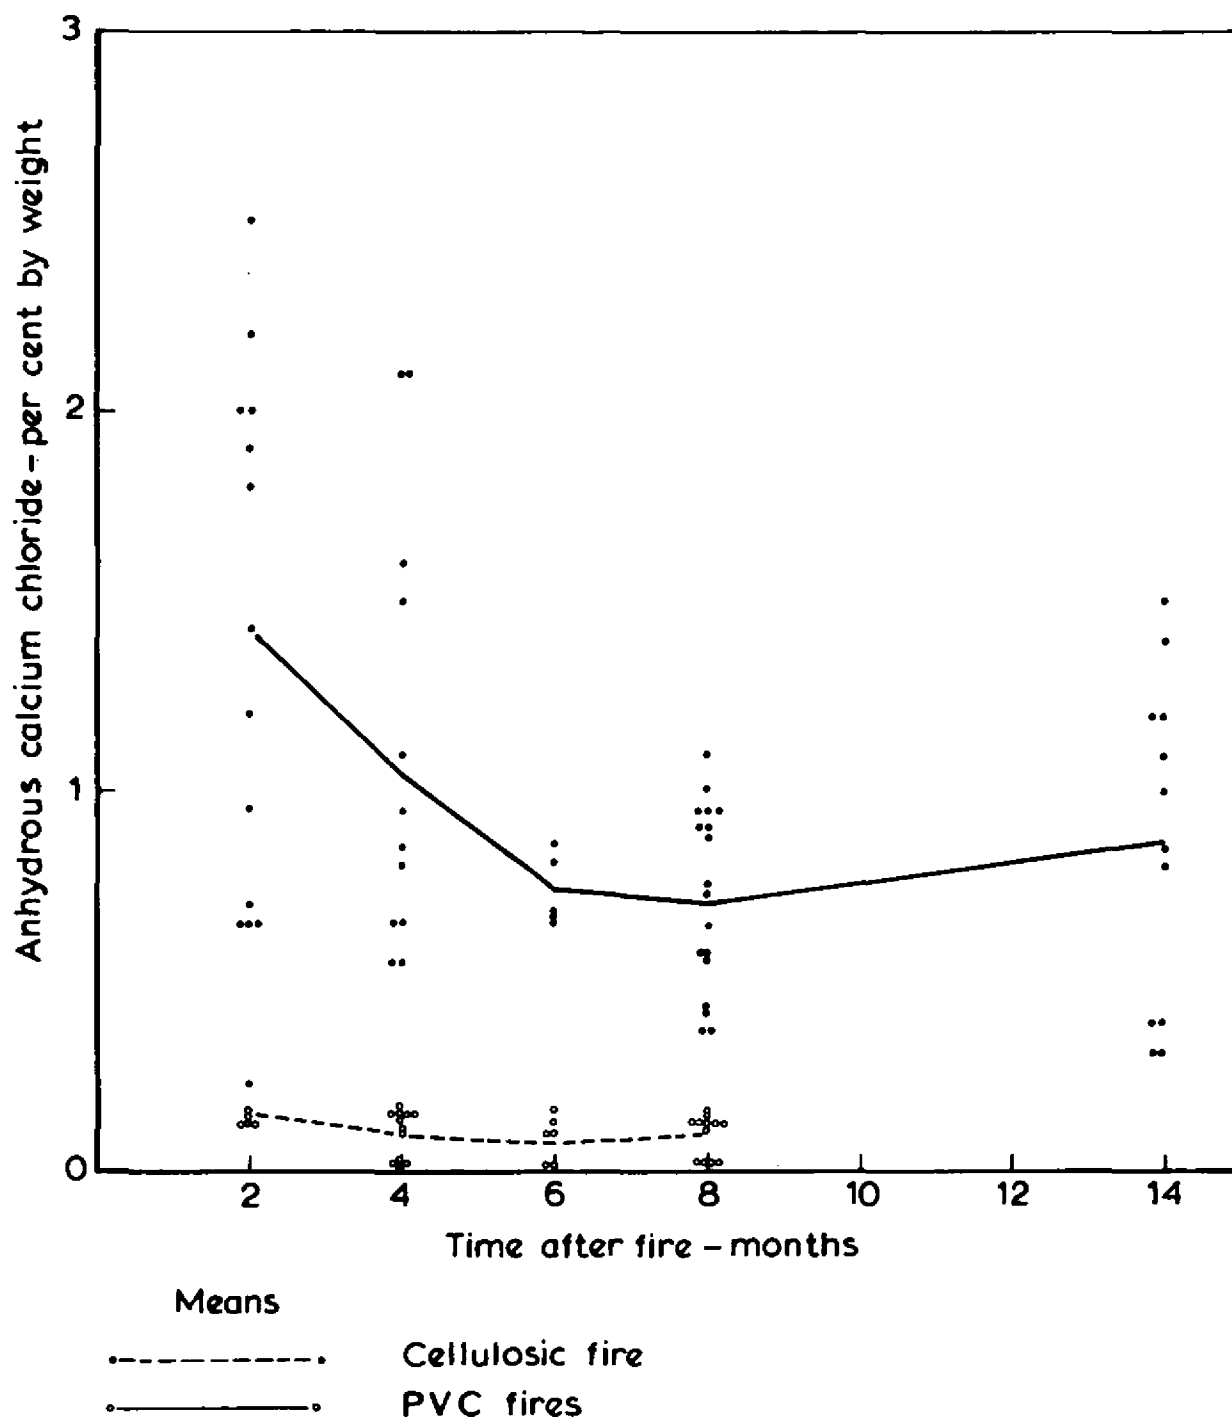
CP 110 : Part 1 : 1972 paragraph 6.2.4.2 recommends that the level of anhydrous calcium chloride in the cement should be zero for prestressed concrete and should not exceed 1.5 per cent by weight of cement for reinforced concrete. The level of calcium chloride on the exposed surface of the units was found to be between 0.5-1 per cent.

Figure 10 Chloride concentrations – Exposed surfaces of prestressed units

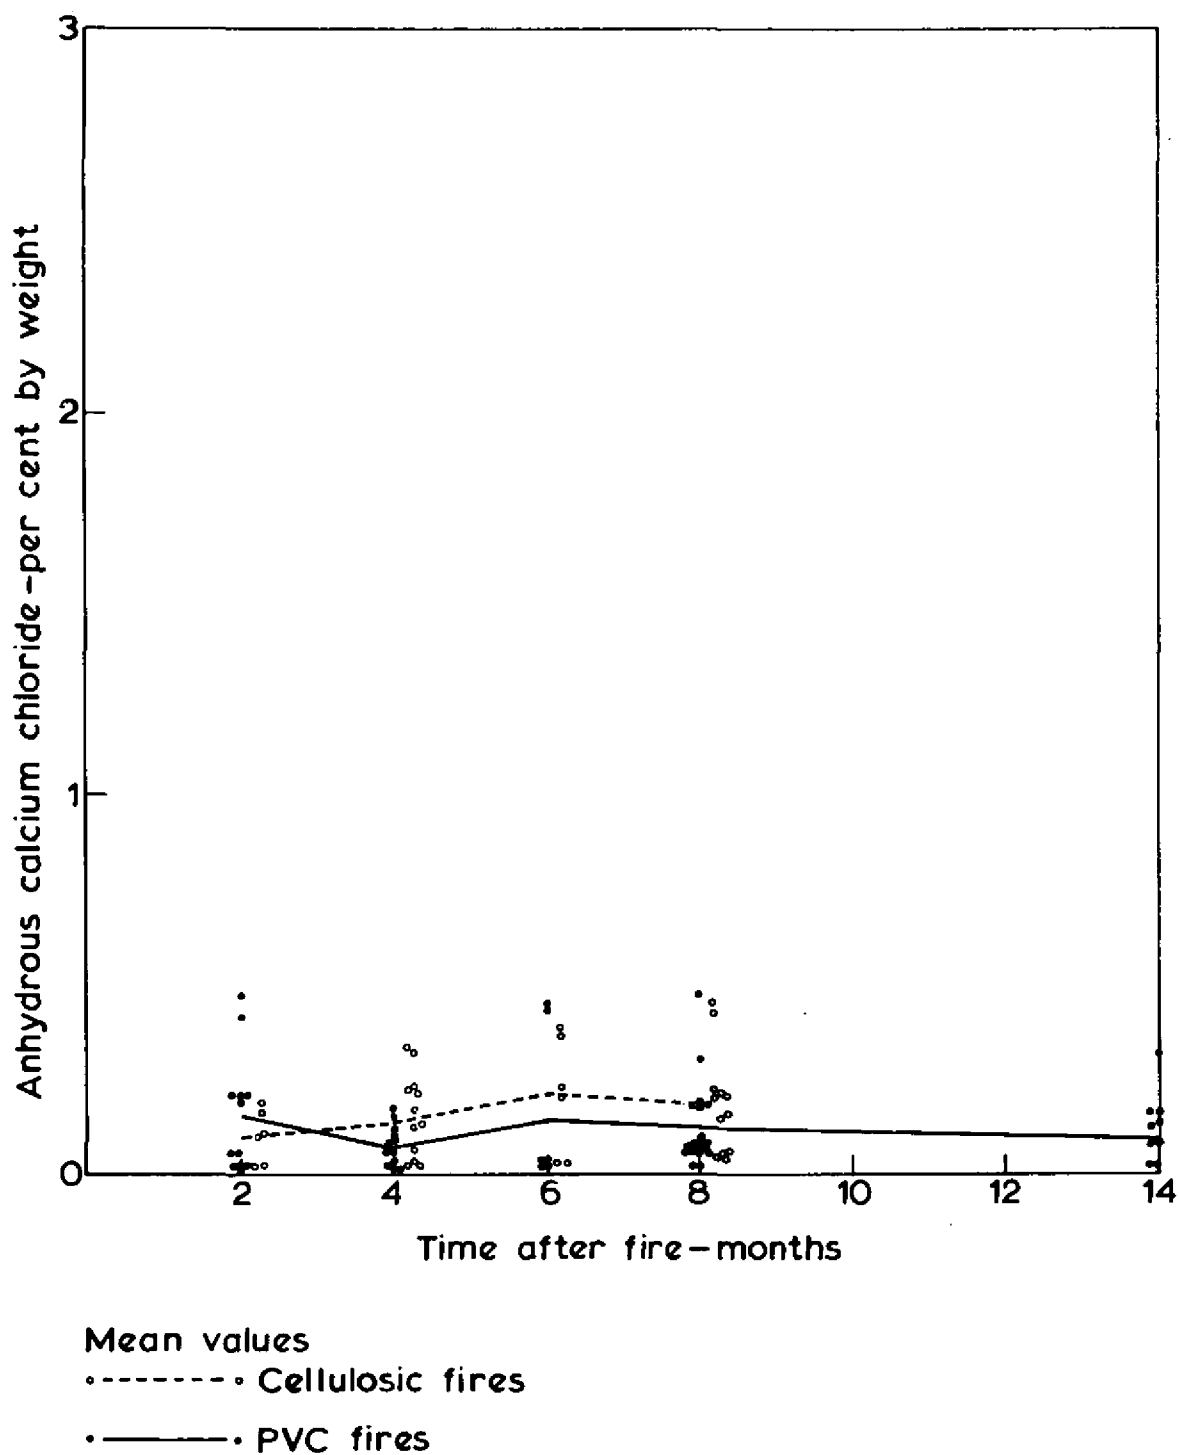
Figure 11 Chloride concentrations—
internal surfaces prestressed units
