Electrical Receptacles - Overheating, Arcing, and Melting

Matthew Benfer and Daniel Gottuk
Hughes Associates Inc
3610 Commerce Drive, Suite 817
Baltimore, MD 21227

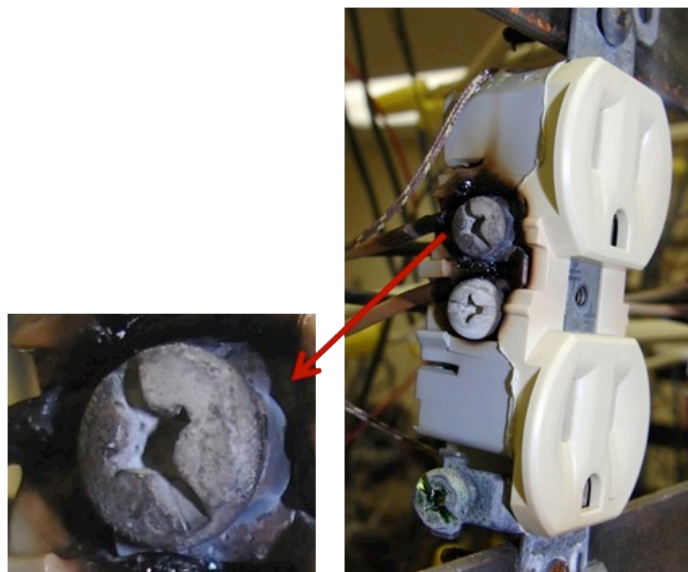
It is well accepted that oxidation of copper conductors at a loose connection can lead to overheating and potentially glowing at the connection. This oxidation is typically dark grey or black in color. Dark oxidation was observed to have formed on a large portion of receptacles in conjunction with the development of the overheating connections. Discoloration, charring, and melting of the receptacle materials also occurred as a result of overheating. It was quite common for receptacles to show multiple signs of overheating at multiple terminals. Figure 1 shows a PVC receptacle exhibiting multiple signatures of overheating, including oxidation (likely CuO), discoloration of the PVC body, discoloration of wiring, and loss of nickel plating on the terminal screws. Discoloration of this sort was common for the PVC receptacles and spread radially outward from the overheating screw connections and along the wiring.

Fig. 1. Oxidation, discoloration, loss of plating on screw from an overheated PVC receptacle.

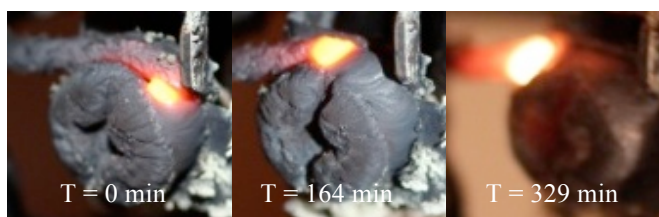
For cases where glowing was developed at the screw terminal, it took one of two forms. Either a reddish-orange glow of the entire screw terminal and conductor developed, or a bright glow spot at some point along the conductor at the screw terminal developed. In some cases, the glowing transitioned from a localized spot to an overall glow at the terminal or vice-versa. Temperature measurements were taken for some glowing connections using a handheld thermocouple reader and a 1.6 mm (0.0625 inch) diameter Type-K thermocouple. Temperatures of up to 600°C and 1100°C were measured at overall glow and localized glow spots, respectively. Some measured temperatures were higher than the melting point of copper (1085°C) and brass (930°C). Despite local temperatures above the melting point of brass, none of the receptacles where glowing was observed had the brass receptacle contacts show signs of melting. It is expected that the size and arrangement of the brass contacts allowed the heat from the glowing conductor to dissipate and the brass to remain below its melting temperature.

Fig. 2. Movement of glow spot on receptacle connection at various times, T.

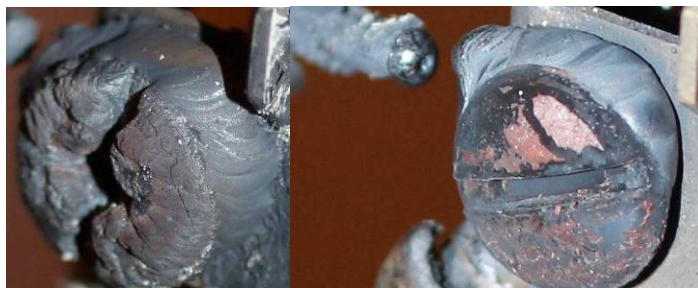
Development of glowing was quite fickle and usually began without any apparent stimulus. In some cases, glowing would start after several small arcs occurred when power was cycled for the receptacles. In other cases, glowing would appear seemingly at a random time when the receptacle was energized. Glowing could last for days, would disappear if power was removed, and often reappeared within an hour or more after power was re-applied to the circuit. In addition, glowing sometimes stopped and re-started days later for no apparent reason. When the localized glow spots remained for extended periods (i.e., hours), the glow spot would migrate in a counterclockwise direction around the screw head as shown in Figure 2. As the glow spot moved, the copper conductor would melt at the spot location and re-solidify (i.e., weld). In some cases, this motion created curved striations in the welded conductor. Two examples of curved striations on welded conductors are shown in Figure 3. These striations were similar in appearance to the layers of the “nuggets” produced by Korinek et al [7]. The curved striations in the welded conductor are a clear indication that a glowing connection was present. Approximately 80% of receptacles having welded conductors (41) had only one welded conductor. In ten receptacles, two welded conductors were observed on the same receptacle; the two welded conductors were always on the same side of the receptacle (i.e., neutral or hot side) and shared a common brass contact. A total of 61 welded conductors were observed; 37 had curved striations.

Fig. 3. Curved striations on two welded conductors.

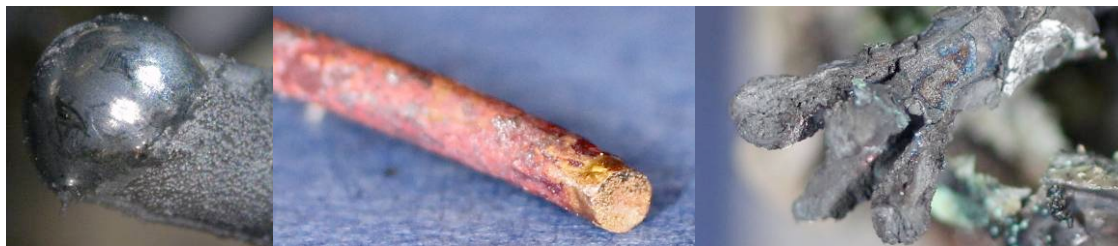
Once the glow spot had moved to the part of the conductor not underneath the screw head, the conductor would begin to neck. As a result of the necking, the conductors typically severed, sometimes accompanied by a parting arc. The severing of the conductor at the glow spot produced various characteristic ends on the conductors such as those shown in Figure 4. Some severed ends had round and sometimes dimpled globules, others had flat ends with no globule, and others had irregular shaped

necked or split ends. Further examination of the round conductor ends revealed that they were comprised of a flat head beneath a rounded cap of solidified copper oxide.

Figure 4: Various severed conductor ends from glowing connections.

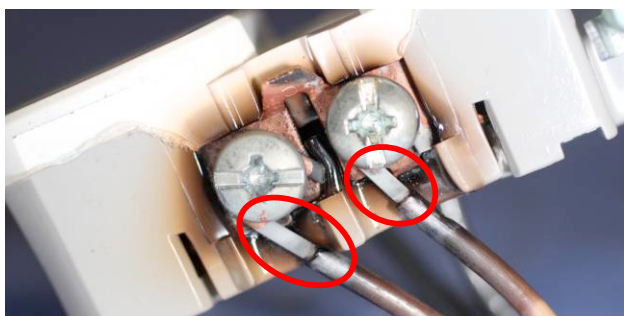
Copper and copper alloys are resistant to corrosion by dry gasses at ambient temperatures or lower [16]. However, copper alloys are more vulnerable to corrosion from liquid/vapor chlorine environments and at elevated temperatures. Figure 5 shows a receptacle that has a white colored deposit on the surface of the wires. The deposits were generally present along the length of the exposed section of wire and were distinct layers atop the copper wire that stopped at the boundary between the exposed wire and the intact wire insulation. The white colored deposits were only observed on the PVC receptacles, while copper oxide deposits were found on PVC, polypropylene, and thermoset receptacles. Scanning Electron Microscopy with Energy-dispersive X-ray Spectroscopy (SEM/EDS) analysis of the white deposit revealed that it was primarily chlorine solids. The chlorine deposits were a result of vapors released from the thermally degraded PVC receptacle bodies. When PVC is heated, hydrogen chloride (HCl) gas is generated; HCl combines with atmospheric moisture to form hydrochloric acid. Copper has a fair resistance to corrosion by hydrochloric acid [16]. White corrosion products were also found on the brass contacts where dezincification was present. Although the resistance of the corrosion products were not measured, it is likely that they increased the electrical resistance at the connections, much like the copper oxides do.

Fig. 5. Photograph showing white chlorine deposits on the wires of a PVC receptacle.

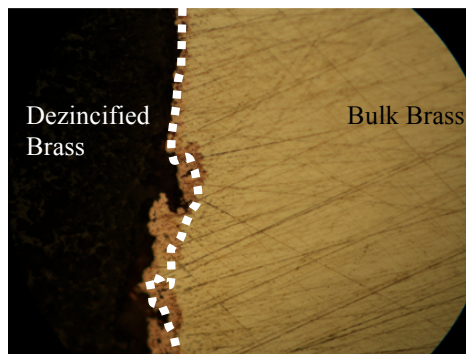
However, the copper that remains after dezincification is porous and mechanically weak [17]. It is unclear to what effect dezincification has on the electrical conductivity of the brass contacts. A receptacle's brass receptacle contacts which experienced dezincification were sectioned and polished. A microscopic image (500x) of the cross-sectioned brass contact, shown in Figure 6, reveals dezincification occurring on the

Another visual indicator of overheating and corrosion in receptacles is the change in appearance of the brass receptacle contacts from yellow to a coppery color. This is an indication that the zinc from the brass has been selectively leached from the surface due to the corrosion [17]. Selective leaching of zinc from brass due to corrosion is referred to as dezincification. The hydrogen chloride vapors produced by the heated PVC provided the corrosive atmosphere. The overall dimensions of the dezincified brass contacts did not appear to change.

surface of the contact. There is a visible line of demarcation between the bulk brass (yellow) and the dezincified brass (copper colored). The dezincified brass is a relatively porous layer approximately 5 microns (1.9×10^{-4} inches) in thickness compared to the 0.76 mm (0.03 inch) thick brass contact.

Fig. 6. Image (500x) of a polished and sectioned brass contact showing dezincification.

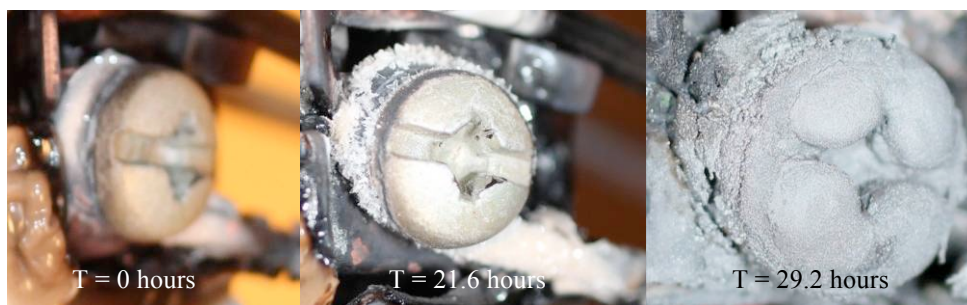
In twenty-eight cases, a heavy layer of corrosion developed on the screw terminals of receptacles with failure events. This was termed an enlarged screw head and was a clear indication that a glowing connection and chlorine corrosion were present. In one receptacle, three enlarged screw heads were found. Of the 28 enlarged screw heads observed, 22 had welded conductors and only 4 had curved striations present. For the enlarged screw heads, rather than a dark oxidation of the copper conductor causing the overheating at the terminal, the layer of white corrosion previously described was deposited on the conductor. This layer eventually developed into a crystalline deposit which corroded the screw; this progression is shown for a receptacle in Figure 7. This specific series of events was observed in a limited number of cases, but due to the number of receptacles tested it was not possible to determine whether this development occurred for each of the other cases where an enlarged screw head was found. The enlarged screw heads had a black, grey, or reddish color, and fine surface porosity though the surface was relatively smooth; in general, the screw slots remained visible.

Fig. 7. Development of an enlarged screw head on a PVC receptacle at various times, T.

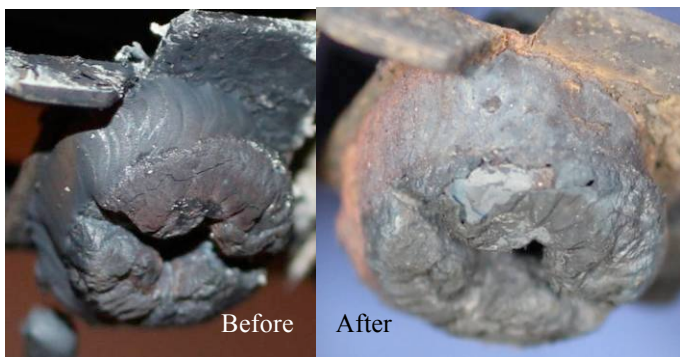
Of the 21 furnace test samples, twelve receptacles had a total of thirteen combined welded conductors. Of these thirteen welded conductors, 11 had curved striations visible prior to fire exposure. After the fire exposure, all of the welded conductors remained identifiable. However, the curved striations could only be identified on 9 out of the 11. In general, the curved striations became more difficult to see after the furnace exposure. Figure 9 shows a welded conductor with curved striations before and after fire exposure.

Fig. 9. Welded conductor with curved striations before and after fire exposure.

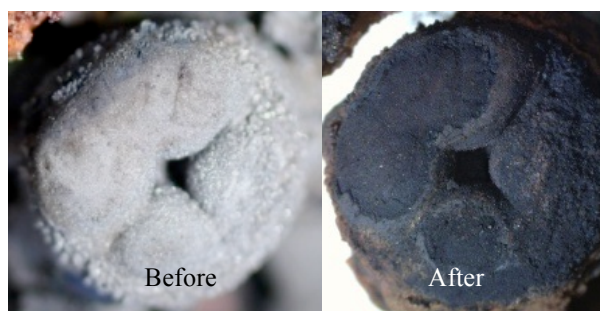
changes to an enlarged screw head before and after the exposure.

Fig. 10. Enlarged screw head before and after furnace exposure.

Five receptacles with enlarged screw heads were placed in the furnace fire test. After the fire exposure, 4 out of 5 of the enlarged screw heads remained identifiable. In general, the shape of the enlarged screw heads remained, but the color changed. The one case where the enlarged screw head was not identifiable after the furnace exposure only had a partial surface buildup prior. After the furnace fire exposure, the buildup on the enlarged screw head was not distinctly different from the screw head that was not enlarged prior to testing. Figure 10 shows the

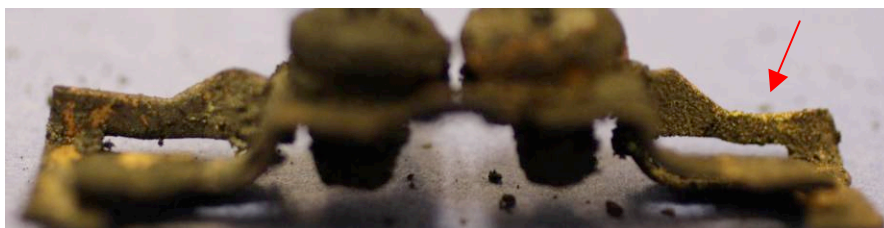
After the furnace exposure to receptacles with prior overheating, a number of PVC receptacles were observed to have internal contacts that were severely thinned by oxidation and overheating. Due to the plastic that had remained on the receptacles after the failure events, these contacts could not be seen in their entirety prior to the furnace exposure. An example of the thinned portion of the contacts is shown in Figure 11 (see arrow). The thinning of the contacts occurred in the vicinity of the screw connection that was overheating and was relatively uniform over the contacts. This thinning was not in the vicinity of the locations where arcing was observed to occur. In general, the thickness of the contacts was reduced to about half of the original thickness. Since the thinned contacts could only be viewed after the furnace exposure, it is unclear whether or not they had changed due to the furnace exposure.

Fig. 11. Photograph showing thinning of brass receptacle contacts.
