Fire Performance of a Full-Scale Building Subjected to Earthquake Motions: Test Specimen, Seismic Motions and Performance of Fire Protection Systems

Jin-Kyung Kim¹, Brian J. Meacham¹, Haejun Park^{1,2}, Tara Hutchinson³ and Elide Pantoli³

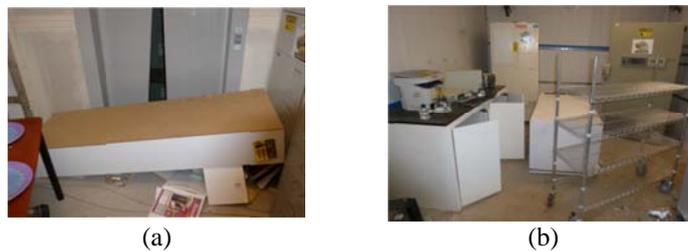
A range of contents reflective of the occupancies on Floors 2, 4 and 5 were located in the specimen. Some contents were anchored while others were not. Displacement of unsecured contents (potential fuel items) was experienced on each floor during motion tests, with the extent of displacement increasing with the size of the simulated events (see [11] for details on motions, contents and anchorage, and resulting acceleration, drift and displacement). As an example, Floor 2 included chemical laboratory and storage equipment in one space and living room contents in another. Only minor displacement of the smaller items such as cups and dishes on the dining table were observed during all the seismic motion tests leading up to FB-4. Following the largest seismic motion tests of FB-5 and FB-6, not only did small items such as cups and dishes get displaced and shattered but also large items such as a fully loaded bookshelf and anchored TV were displaced. The glass beakers and testing tubes fell off the workstations and shattered on the ground. Pictures of the Floor 2 areas with displaced contents following FB-6 are shown in Fig. 11.

Fig. 11. Displaced items on Floor 2 following FB-6 (a) living room space (note large gap in elevator door in background) (b) chemical lab and storage space.

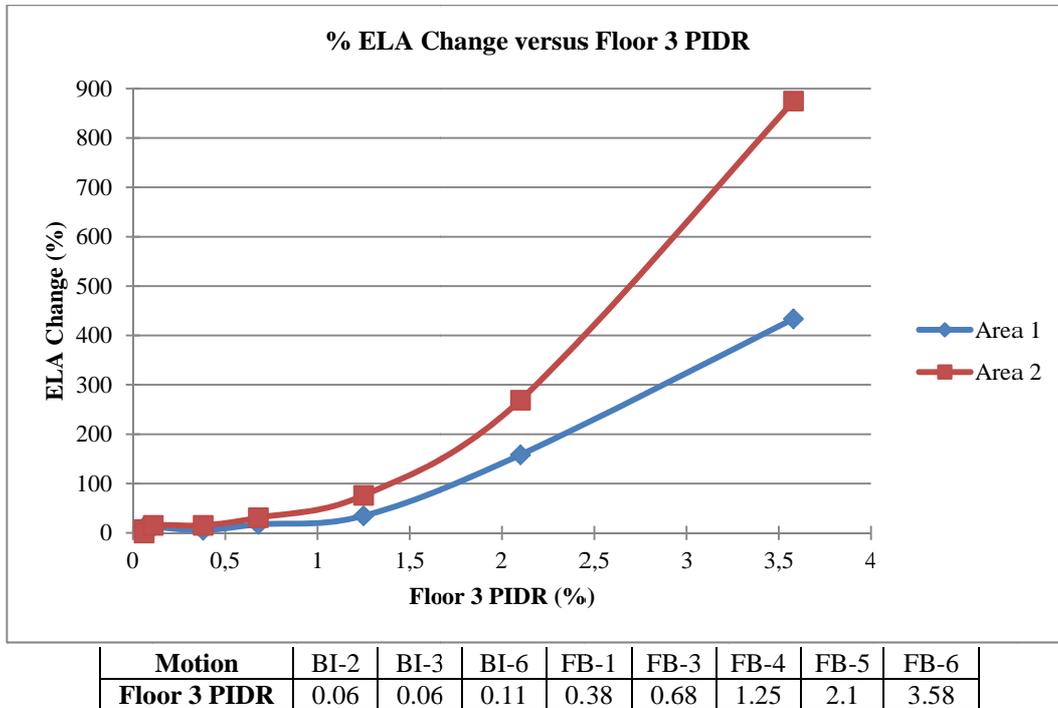
Given the brief period of time between each motion test and subsequent building inspection, only one set of ELA data was able to be collected for each building damage state. Fig. 15 shows a plot of the change in ELA as a percentage, relative to the ELA measured before BI-1, versus the Floor 3 PIDR values of the building specimen from the motions. These ELA values are determined by performing a linear regression analysis on the five to seven readings of the fan flow rate and the pressure difference recorded during each test. This plot shows there was not much variance in the ELA for the smaller amplitude earthquake motions. Initially, the ELA of Area 1 was greater than the ELA of Area 2 up to FB-4, which was attributed to the leakage areas formed in the partition wall at the edges where the fire door frame was installed. A significant increase in the ELA for both testing areas is seen following the larger amplitude earthquake motion tests of FB-5 and FB-6. With more gaps created during the larger motion tests and taking into consideration the great disparity in size between the two compartments, the ELA of Area 2 surpassed the ELA of Area 1 following FB-4 [10].

Fig. 15. Plot of % ELA change relative to 'Before BI-1' versus PIDR of Floor 3

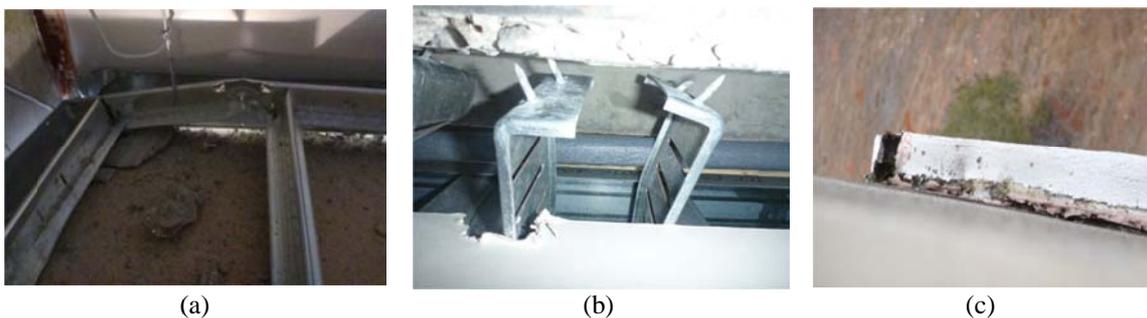
As a result of the large inter story drifts imposed during FB-5 and FB-6 [9], damage to compartment barriers became significant. The balloon framed façade system for Floors 1-3 developed large gaps in joint areas, particularly where the interior sides (gypsum board) met floor slabs, columns, ceiling systems and any perpendicular bracing walls. Examples of wall-ceiling system joints, façade connection to floor slab, and exterior façade separation are shown in Fig. 16a-c.

Fig. 16. Issues affecting compartment integrity (a) Gap formed at North balloon framing and ceiling joint of Floor 3; (b) detached balloon framing connection clips; (c) gaps developed at the EIFS façade.

- While the ceiling system on Floor 3 performed generally well, with the exception of gaps forming at wall joints (Fig. 16a), the ceiling system on Floor 1 showed progressive damage with increased earthquake motion intensity. Damage to ceiling systems can allow for smoke and fire spread.
