Fire Performance of Full-Scale Building Subjected to Earthquake Motions: Fire Test Program and Outcomes

ABSTRACT

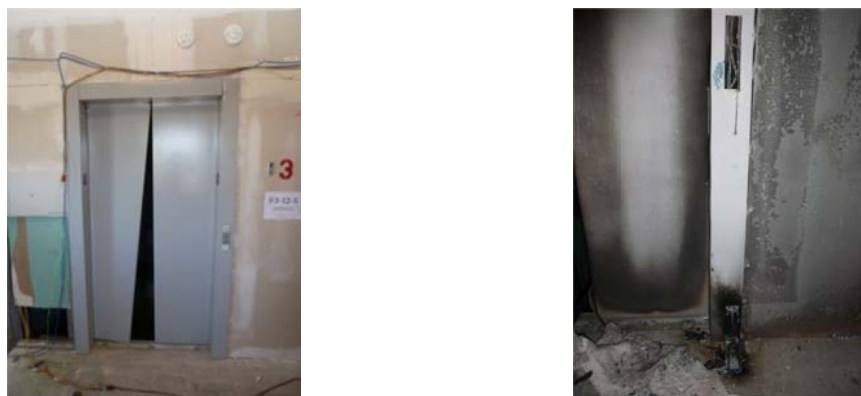
The elevator was not operational after the largest ground motion test due to the distorted elevator doors, especially from the 2nd to 4th floor. The elevator door damage on the 3rd floor is shown in Fig. 4 (a). In EL-1 fire test, the elevator button panel melted and wires behind the panel were burned as shown in Fig. 4 (b). Even without the door damage, elevator could be malfunctioned due to the short circuit by the burned wire. Since elevators can be included as an acceptable means of egress during fire conditions with additional fire safety measures and communication systems, its operability is critical for safe and efficient evacuation. It may be necessary to provide thermal protection to the wires behind the panel or incombustible button board for better elevator performance in fire conditions.

Fig. 4. Damaged elevator door after motion tests (a) and melted elevator button after EL-1 (b)

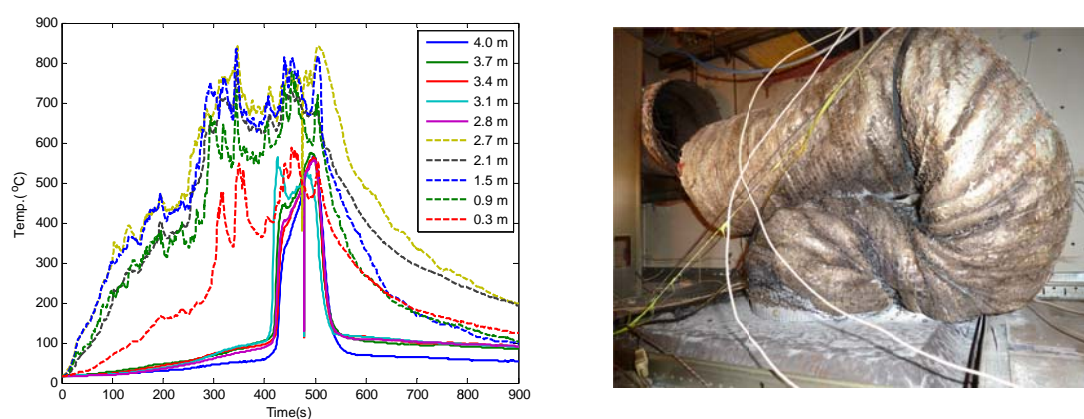
Although powered fan unit was not attached to HVAC ductwork, various parts were assembled together to establish a comprehensive HVAC subsystem. One ends of ducts were connected to supply / return vents in the compartments and the other ends were open to air in the 4th floor allowing hot smoke to leave the compartment driven by buoyancy. In the LBR-2 test in which the upper gas temperature reached over 800°C as shown in Fig. 5 (a), the flexible duct connecting vents and metal duct was ruptured as shown in Fig. 5 (b). The legend in Fig. 5 (a) indicates the heights from the 3rd floor surface with solid and dotted lines for the spaces above and below the ceiling, respectively. Despite the fire-rated ceiling and lighting assemblies and their good performance during the LBR-2 fire test, the failure of the flexible duct allowed hot gases into the plenum space. This provides a good lesson for fire safety, which shows the entire system performance can be limited by the weakest link, in this case the flexible duct.

Fig. 5. Temperature increase in the space above LBR ceiling (a) and flexible duct rupture (b)

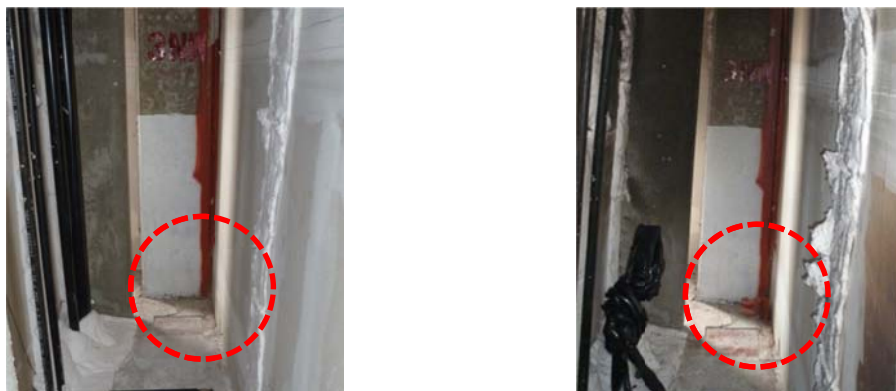
The fire stop applied to gypsum wall to column joint had minor damage with several holes which seemed to be created by different drift amount of the interior wall of the balloon framing and the column during motion tests. The fire stop, however, was found completely detached and fell to the floor after the ES fire tests as shown in Fig. 6 (a) and (b). This result revealed that fire stop can be deteriorated after earthquakes which may not be clearly identified by visual inspection, but may not perform as intended during fire conditions.

Fig. 6. Fire stop sealant before ES (a) and its fall-down after ES (b)

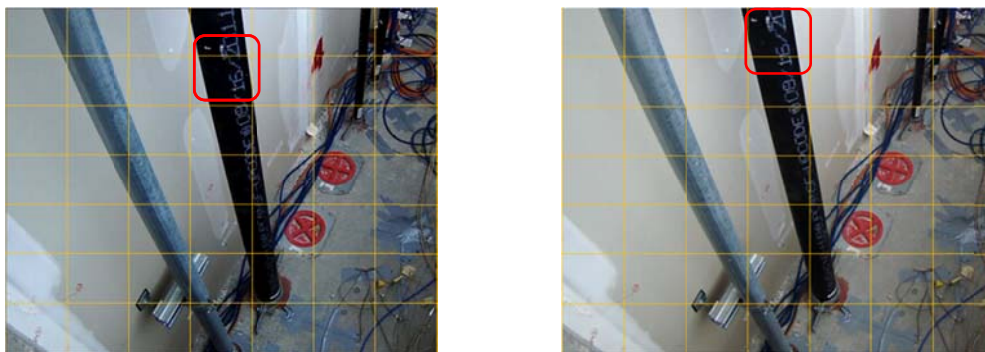
Another concern of fire stop performance was raised by thermal expansion of metal pipes. As shown in Fig. 7 (a) and (b), which were taken from the 4th floor, the black metal pipe was elongated during the ES test by thermal expansion which can be identified by the different locations of the letters on the pipe. Note that all other contents are located in the same position in the grids, but the red boxes which contains the same letters on the pipe is at different height in Fig. 7 (a) and (b). This lifted the fire stop sealants a few millimeters, although this did not seem to decrease its functionality. The temperature measurement between the fire stop sealant and the surface of the black metal pipe and video clips substantiated good performance of fire stop sealants. However, the exposed metal pipe length to the fire environment was only 4m which is the floor height. In conditions where long metal pipes are exposed to high heat environments such as in vertical shafts or near the ceiling over wide floor area, the thermal expansion would become significantly larger, which may influence the performance of fire stop sealants. American Standard Test Method subcommittee E06.21 is currently developing a test method for measuring relative movement capability of penetration fire stop systems.

Fig. 7. Metal pipe's thermal extension: before ES (a) and during ES (b) from the 4th floor

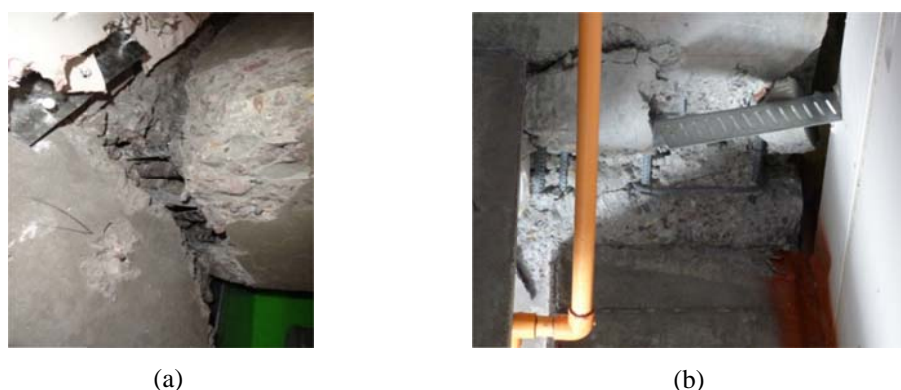
After the largest motion test, serious structural damage occurred in several joint areas in the 2nd floor where the largest inter-story drift was recorded. The rebar was exposed with the loss of concrete cover due to repetitive hinge motion between the north center column and the northeast beam, and between northeast column and the 3rd floor slab as shown in Fig. 8 (a) and (b), respectively. Fire tests were not intended to examine the performance of structural building components, but based on the test results, their performance can be postulated.

Fig. 8. Structural damage after the motion tests in the second floor: north center column and east beam connection (a) and northwest column and the 3rd floor slab connection (b)

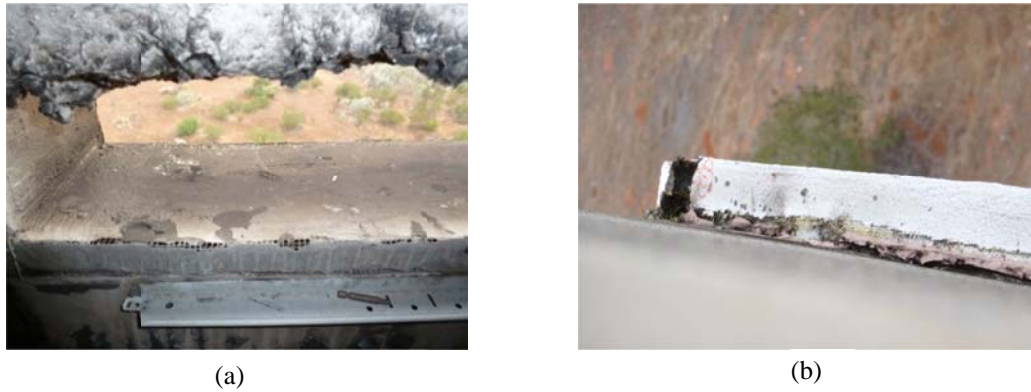
environment when flame extension through window openings occurred in LBR-2, EL-1 and EL-2. The insulating material were burned as shown in Fig. 9 (a), but no flame spread was observed.

Fig. 9. Burnout of EIFS on window 4 opening (a) and smoke residue on damaged balloon framing (b)

Significant smoke spread, however, through the balloon framing was observed. Since the balloon framing covered with EIFS ran from the 1st to the 3rd floor being attached to the floors with vertically aligned steel brackets, the space surrounded by the interior gypsum wall board, EIFS, and steel brackets can be a channel for the smoke spread. For the ES fire test, smoke spread was observed through the gap on top of damaged balloon framing façade and the cracked corner near the first floor. The gap on top of the damaged balloon framing is shown in Fig. 9 (b). The latter case shows possibility of downward smoke spread to remote locations following the channel inside the balloon framing. As the fire tests were conducted on the third floor and the balloon framing ending at the 4th floor level (to the top of 3rd floor), smoke spread to other compartments inside the building could not be identified. However, based on the downward smoke movement to the first floor, it can be highly probable.

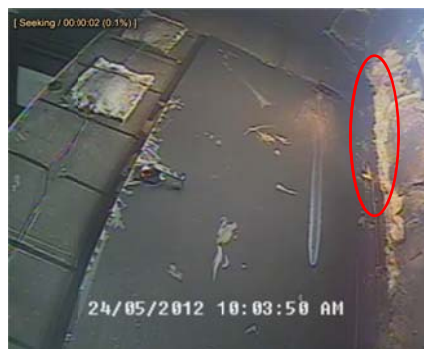
From the motion tests, about 0.025m wide gap was formed along the joint between the interior wall of balloon framing and the wall between the LBR and the SBR. In LBR-2 fire test, flame extended to SBR through this gap. The location of the gap is marked using the red circle in Fig. 10 which is taken from the northeast corner of the SBR. Although flame spread did not occur as no fuel item was located in SBR, flame extended several times to SBR with hot smoke. In conditions such as a fabric curtain being located near the gap, flame spread could have occurred as the gas temperature near the gap in SBR was over 350°C for more than 1 minute as shown in Fig. 11.

Fig. 10. View from the northeast corner of SBR to door 1

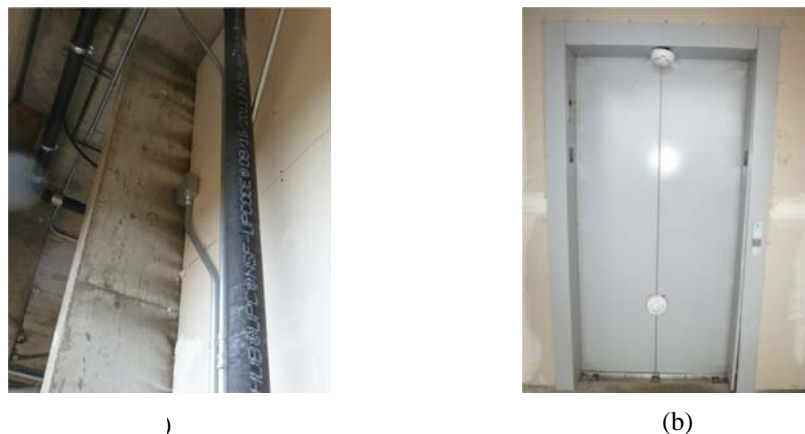
A significant amount of smoke spread was observed to the fourth and fifth floor through the elevator shaft in the EL-1 fire test. Soot deposits on the concrete shaft wall and elevator door edges are shown in Fig. 13. As the opening size becomes bigger in upper floors, the neutral plane height becomes low, which contributes to smoke spread to upper floors and entrains more smoke into the elevator shaft [14]. This showed that smoke spread through the elevator shaft can be a critical problem for fire safety.

Fig. 13. Smoke spread through the gap of elevator shaft joint (a) and the gap of elevator door (b)
