Investigation of a Large Wooden Gymnasium Fire

- Its documentation, estimation of the fire scenario by experiments and evaluation of the structural properties of surviving timber elements

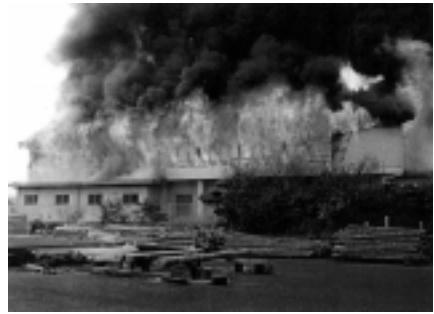
PHOTO 1 Fire-damaged building in flames

A fire broke out at a gymnasium of a junior high school in Fukuyama City, Hiroshima Prefecture in October 2000 (Photo 1). It is the first blaze in Japan that has totally burned a large-scale glue-laminated timber structure.

of the fire-fighting squad. From Table 2 it can be seen that the whole indoor sports arena had a FO within 9 minutes after fire detectors went off. The arch members seem to have been directly exposed to flames for 20 to 30 minutes in the vicinity of the fire source and for 12 to 20 minutes at a place far from that point in the sports arena. Although the whole building suffered from the fire, it is still self-supporting.

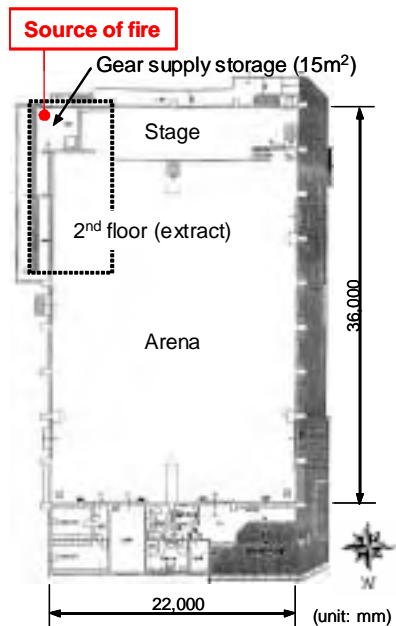
FIGURE 1 Plan of the gymnasium

gymnasium with its main structure made of large-scale glue-laminated timber and its interior construction consisting of wooden materials. Table 1 shows major inner finishes. The first and second floors of the building are respectively made of reinforced concrete (RC) and wood, with a total floor space of 979m². Wide lofts, about 15m², were located on both wings of the stage. Of these, the one on the southeast side was used as a gear supply storage (Figure 1) where the fire started.

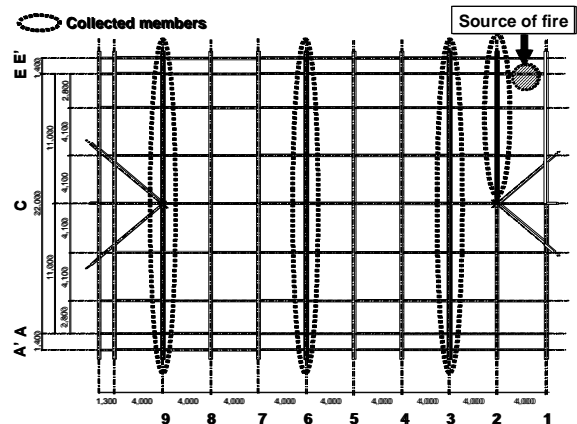
FIGURE 2 Position of the collected members

Figure 2 shows the position of the collected members. Because of restriction on the period of the dismantling and

maximum carrying capacity of the truck for transport, 4 parts of members were collected for estimating of the fire spread from the source of fire to whole building.

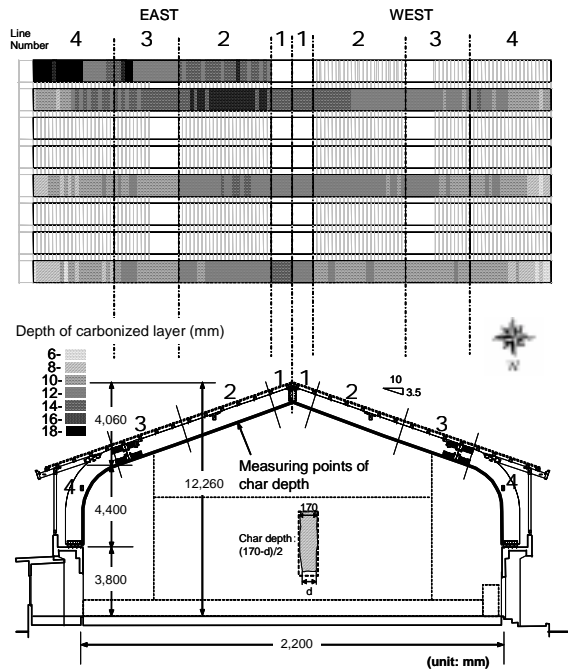
FIGURE 3 Depth of carbonized layer

Figure 3 illustrates the depth of the carbonized layers. The nearer the carbonized layers to the source of the fire or the higher their location except where the gear supply store is located, the deeper they become. That corresponds to testimony of the eyewitness that the windows broke and the flame was ejected from the stage side to opposite one of the gymnasium.

The carbonization speed of 0.6 mm per minute for glue-laminated timber is normally used based on fireproof heating tests [1]. However, the depth of the carbonized layers almost corresponds to the value obtained by multiplying this carbonization speed by the estimated duration of fire in the vicinity of the fire source and in the gymnasium.

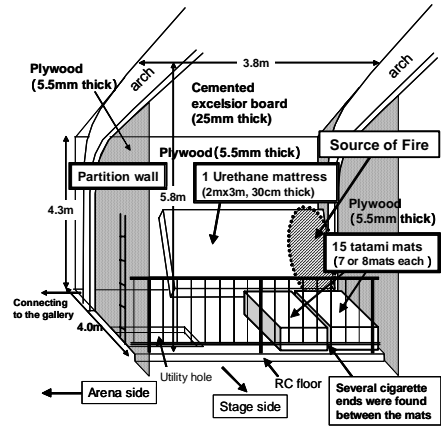
FIGURE 6 Source of fire and its surroundings

The fire began is the southeast corner of the gear supply storage on the east side of the second floor. There were 15 athletic tatami mats and one urethane mattress (3 m x 2 m x 0.3 m) in the gear supply storage when the fire broke out. The urethane mattress was rested against the wall. From the testimony of those concerned, it seems that this mattress caught fire (Figure 6).

The storage where the fire started was open to the stage side, but it was surrounded by the plywood wall on the remaining 3 sides. The ceiling of the store was enclosed by a cemented excelsior board and its floor was made of reinforced concrete (RC).

- 1) To fire proof the finish of the partition wall for the gear supply store
- 2) To control flammable materials near the stage
- 3) To install sprinklers near the stage
- 4) To fireproof urethane mattress

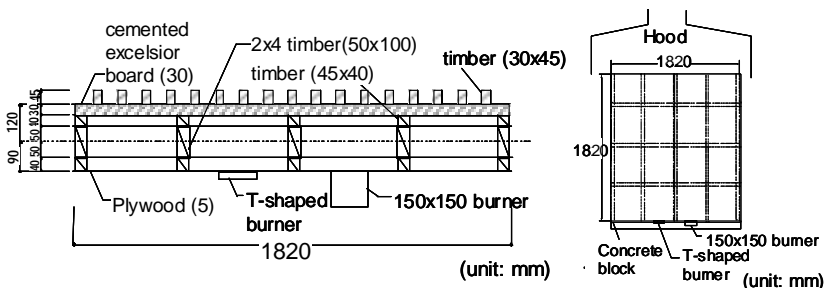
FIGURE 7 Section of the partition wall specimen and experimental setup

A partition wall between the gear store and the arena, which also comprises part of the proscenium, was reproduced according to its drawing and specification. As shown in Figure 7, the partition wall has 5 mm-thick plywood on the front of the gear supply storage side, and on the back of it are 2 x 4 studs at 45 cm intervals. The surface of the arena side has a cemented excelsior board with glue-laminated timber finish vertically pasted at 10 cm intervals.

The test was performed with a nonflammable block placed on the bottom of the wall and the gaps were filled with a fireproof bond to prevent leaking of air into the hollow section. The wooden wall close to the source of the fire in the fire-damaged building was 5.8 m high and its upper part was closed. At the burning test, however, the height of the wall was set at 1.82 m due to the limited height of the testing device and the upper part of the wall was left open because it was not possible to prevent the spread of flames after their passing through the hollow section.

One-piece wall specimen measuring 1.82 m x 1.82 m was produced and subjected to 2 burning tests under different testing conditions. At Test 5, the T-shaped, perforated pipe burner was installed at a height of 5 cm from the lower end of the wall. But the combustion did not spread beyond the studs and therefore Test 6 was made by reusing the intact specimen and installing a 15 cm-square diffusion burner just in front of a row of the neighboring studs and at a height of 5 cm from the lower end of the wall.

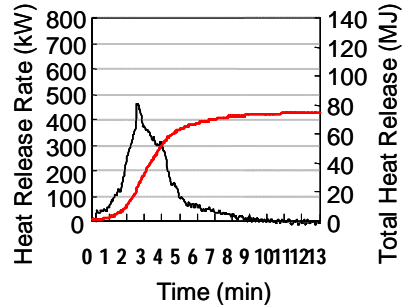
FIGURE 8 Test 1 - Urethane mattress (1/12 of the actual size)

Test 1: As the specimen heated, it flared up and black smoke developed. Two minutes thereafter the top of the flame reached 2.3 m high. The burning area spread rapidly from the fire source and spread in all directions, almost completely burning the specimen 6 minutes thereafter.

From Figure 8 it is clear that the heat release rate in close proximity to the fire source sharply rose to its peak 2 minutes after the start of the testing, resulting in rapid burnout.

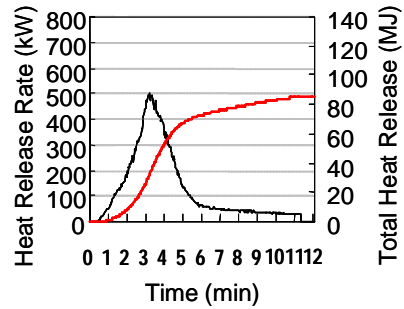
FIGURE 9 Test 2 - Urethane mattress (1/6 of the actual size, horizontally placed)

Test 2 and Test 3: Figure 9 and Figure 10 respectively show the heat release rate and the total heat release (THR) at Test 2 where the urethane mattress was horizontally placed and at Test 3 where it rested against the wall.

As at Test 1, the specimen flared up into flames in 2 or 3 minutes, but it is obvious that the peak heat release rate was greater than at Test 1. However, the heat release rate was greater and the spread of the flames faster at Test 3 than at Test 2.

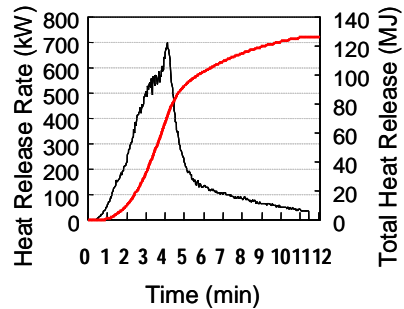
FIGURE 10 Test 3 - Urethane mattress (1/6 of the actual size, rested against a nonflammable wall)

As far as the surface of the flammable materials is concerned, the difference is considered due to the faster spread of the flames on the wall surface than on the upward plane surface, as well as being responsible for the mechanism of the flames.

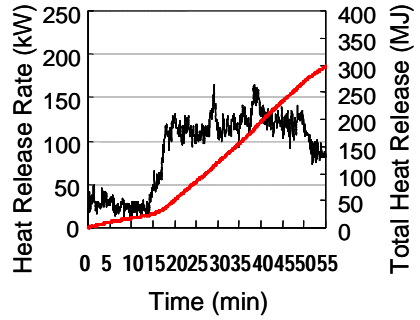
FIGURE 11 Test 4 –Athletic tatami mat

Test 4: When burning and heating began, the height of flames was 0.3 m - a phenomenon not particularly unusual. The flames spread from the surface to the inner part horizontally over a long period. From Figure 11, it is clear that the heat release rate remained at a low value for 15 minutes after the specimen caught fire.

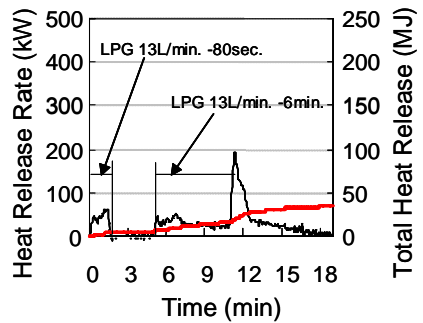
FIGURE 12 Test 5 – partition wall

Test 5: The wall surface started burning first when an ignition burner was brought into contact with the wall. But again there was no fierce flare-up. When heating was discontinued at 80 seconds thereafter, the flames died down in approximately 40 seconds. When the specimen was reignited 3 minutes, 40 seconds thereafter, the flames spread to the upper end of the surface of the specimen in 1 minute.

After the surface burned out 6 minutes thereafter, the hollow section between studs that was in contact with the burner started burning out and the flames continued fiercely. Once the surface of the wall burned out, the flame quickly spread to the upper end of the wall. Heating was discontinued 6 minutes, 30 seconds after re-heating, and the specimen continued burning until it finally died down at 10 minutes, 30 seconds thereafter.

After the tests, the inner part of the wall was checked and it was found that the flames had not spread beyond the studs, with the cemented excelsior board on the reverse side not suffering from serious damage. This phenomenon is reflected in the history of the heat release rate shown in Figure 12.

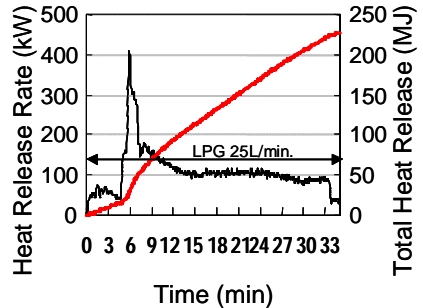
FIGURE 13 Test 6 – partition wall

Test 6: A burnout occurred about 5 minutes after the wall caught fire, resulting in fierce flames. Smoke developed from the cemented board 21 minutes after heating. The burner was turned off 33 minutes, 30 seconds after heating and the inside of the wall was checked.

There was no evidence of the spread of the flames to the studs, but the cemented excelsior board was slightly burned out. Figure 13 shows that the heat release rate climbed sharply to 420 kW 5 minutes after ignition and then declined gradually.

From these test results it is apparent that although it takes some time for the laminated wall to burn out after its ignition, the flames spread rapidly after the burnout. The time required for the burnout to take place will be reduced if the gas flow at the source of
