Historic Industrial Fires and Their Influence on Contemporary Fire Protection

Robert Zalosh
Center for Firesafety Studies
Worcester Polytechnic Institute
Worcester, MA 01609, USA

Brief accounts of five large industrial fires are presented to show how they stimulated advances in fire protection. The five fires reviewed are the 1911 New York City garment factory fire, the 1953 Livonia, Michigan automobile transmission factory fire, the 1977 Cologne, Germany automobile parts warehouse fire, the 1986 Basel, Switzerland chemical warehouse fire, and the 1987 Hinsdale, Illinois telephone exchange fire. Investigations and repercussions of these fires helped lead eventually to several key fire protection developments including: extensive revisions in and awareness of building egress and fire resistance requirements and capabilities, scientifically based laboratory flammability testing, significantly enhanced warehouse sprinkler protection, less hazardous flammable liquid containers, and improvements in the prevention and control of electrical cable fires.

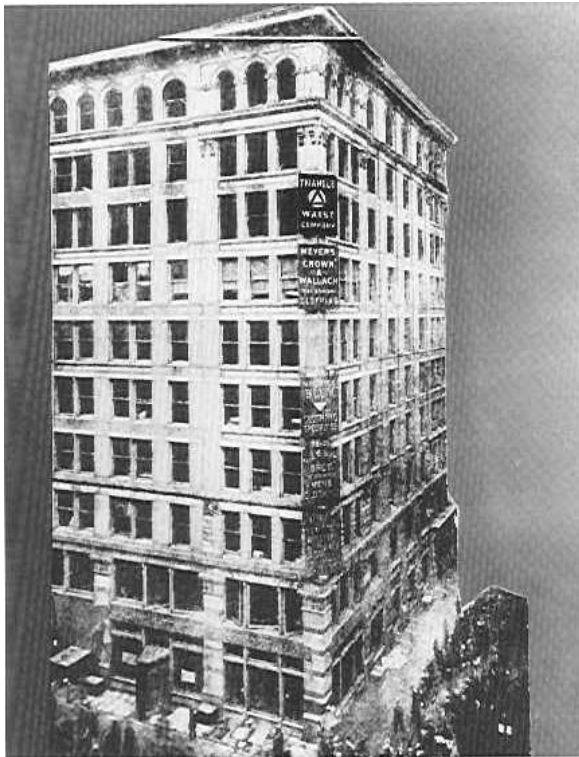
The Triangle Shirtwaist Company operated a ladies garment factory on the top three floors of the 10-story Manhattan building shown in Figure 1. There were two stairways and elevators at opposite ends of each floor as shown in the ninth floor layout in Figure 2. However, the stairway doors opened in toward the work area because of limited space on each staircase landing. There was an external fire escape, but it ended at the second floor and was situated directly over a basement skylight in a completely enclosed courtyard. There was no automatic sprinkler system even though sprinkler systems were available in 1901 when the building was constructed. The following description of the workspace and the fire is based primarily on Leon Stein's 1962 book [2], and on Grant's 1993 paper [3].

Figure 1. Triangle Shirtwaist Company occupied top three floors of the Asch building, photograph from Cornell University Kheel Center for Labor-Management Documentation and Archives

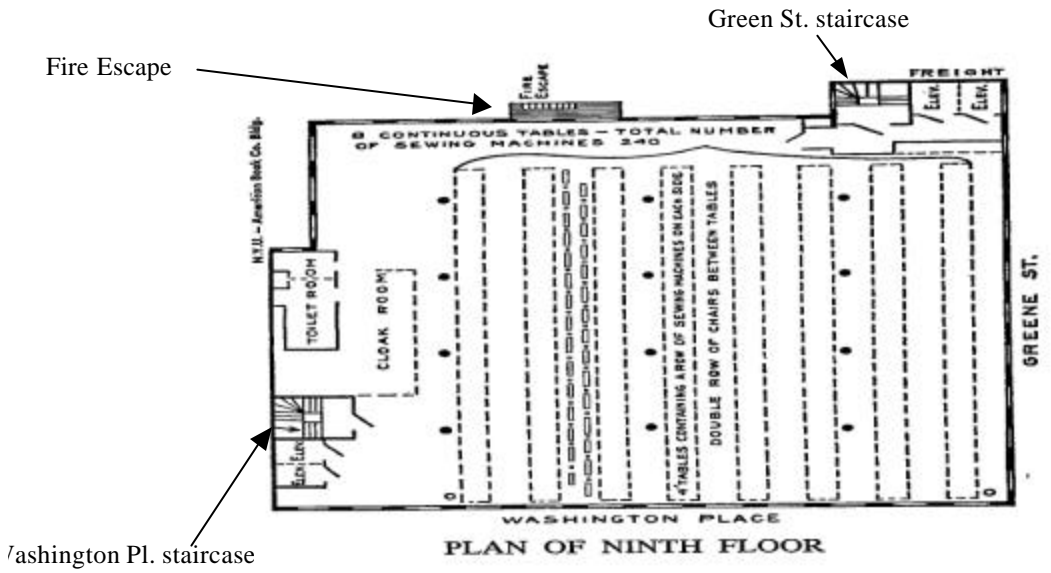
Most of the sewing of the fabric pieces occurred on the ninth floor. There were about 240 sewing machines on 23 m long, 1.2 m wide tables as illustrated in Figure 2. The narrow aisle width (0.76 m) between tables was filled with a double row of chairs. The sewing machines were driven by leather belts connected to a flywheel on a rotating shaft in a trough between two tables. The shaft was powered by electric motors located at the Washington Place (south) end of the tables such that there was no aisle at the south end of the floor. The machines and motors were lubricated with oil stored in a barrel near the

Figure 2. Triangle Shirtwaist Factory Floor; based on drawing from Stein [2].

Employee egress from the developing fire was severely restricted by several obstructions. The exit doors to the Washington Place stairway were locked and either the keys were not available or were lost in the panic that ensued. Passage down the Greene Street stairway was limited by the 0.84 m stairway width with tapered turns, as well as by the inward opening door. Women attempting to flee via the fire escape ladder found they couldn't readily get below the second floor, and their cumulative weight overloaded and distorted the fire heated ladder as shown in Figure 3.

The NFPA Committee on Safety to Life was formed in 1913. Two of the first Committee projects were the writing of the 1916 NFPA report "Outside Stairs for Fire Exits," and the 1918 NFPA report "Safeguarding Factory Workers from Fire." According to the preamble to the current NFPA Life Safety Code [4], these reports "served as a groundwork for the present Code." The chapter on Industrial Occupancies in the current Life Safety Code includes required provisions for the following features pertinent to the Triangle Shirtwaist fire: exit doors, exit stairs, fire escape ladders, clear widths of exit pathways, and fire alarm systems. Exit door technological developments since the Triangle fire allow for doors to be locked providing they are equipped with a manual release device near the egress side of the door, and a sensor to automatically unlock when

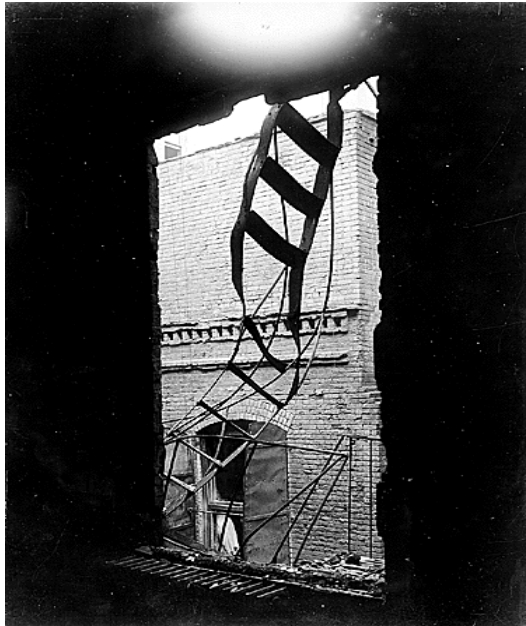
Figure 3. Triangle Shirtwaist fire escape ladder. Reproduced with permission from the Franklin D. Roosevelt Presidential Library.

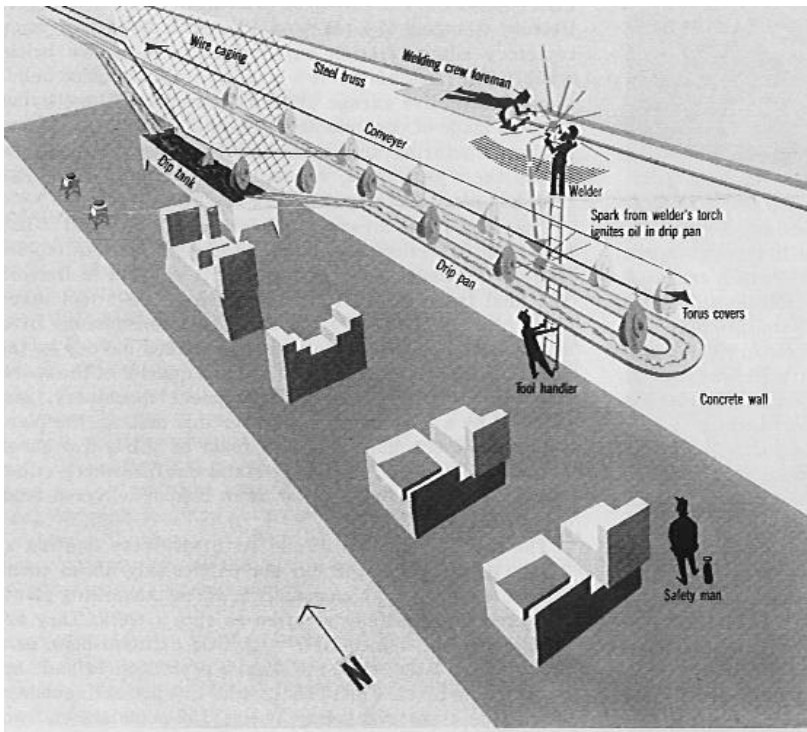
The fire outbreak at 3:50 PM on August 12, 1953 is illustrated in Figure 4. A cutting and welding crew was working on steam piping above an elevated conveyor (3.4 m above the floor) used to transport transmissions to and from a rustproofing dip tank. A drip pan under the conveyor had accumulations of the rustproofing liquid, which had a flash point of 37°C (98°F). Weld splatter fell into the drip pan and ignited the liquid. When the crew members at floor level saw the fire start, they handed carbon dioxide fire extinguishers to the welders on the ladder. The pan fire was almost extinguished at 3:54 PM when heat and smoke accumulating under the ceiling forced the men to descend from the ladder. Flames then began to spread over the entire 36.6 m (120 ft) length of the drip pan.

Flames from the drip pan ignited oily condensate on the steel roof truss. At 3:55 PM, the drip pan warped and spilled burning liquid onto the oil-soaked wood floor and the dip tank. In addition, the asphalt-saturated roof insulation ignited and dripped down through joints between the heat-deformed steel deck plates. The fire then spread over the roof and the oil coated equipment on the factory floor. Shortly later, electric cable shorted in conduits near the fire, and electric power was lost throughout the building. Livonia firefighters arriving at 4:05 PM could not see

- 1) The absence of fire walls and roof vents allowed uncontrolled fire and smoke spread throughout the plant and rapidly prohibited access for manual fire fighting within the building.
- 2) Inadequate sprinkler protection (only 20% of the plant was sprinklered) prevented fire control and suppression.
- 3) The automatic carbon dioxide system on the dip tank should have been extended to the drip pan, where manual fire fighting was difficult because of the pan elevation and length.
- 4) Unprotected and un-insulated structural steel columns, trusses, and decking promoted early roof collapse and fire spread via molten asphalt.

Figure 4. Initiation of GM Livonia Factory Fire, from Fortune article [6].

In 1954, General Motors announced [8] that all new G.M. manufacturing facilities were to include fire barriers in the form of fire walls, parapets, and draft curtains, and virtually 100% sprinkler protection supplemented by spray nozzles for dip tanks, quench tanks, and drip pans. Many other industrial organizations also adopted these new construction requirements for their new facilities.

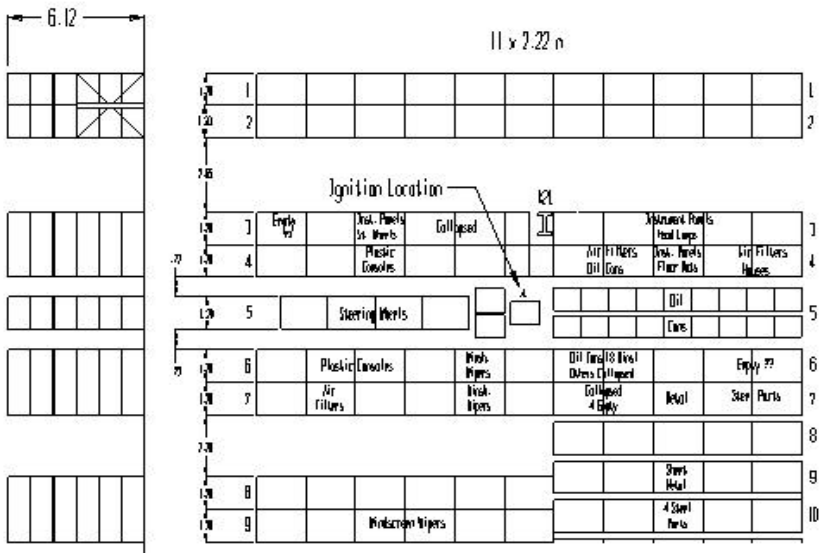
Storage in the area of fire origin included ABS plastic consoles, polyurethane foam padded steering wheels, rubber bladed windshield wipers, air filters (plastic and paper in cartons), and motor oil in small metal containers. Most of these commodities were stored in baskets stacked to a height of 5.8 m to 6.1 m (19 to 20 ft). The water supply curve shown in Figure 6 satisfied the NFPA 231 requirements for a Class IV commodity, which was probably the appropriate classification for the original storage when the warehouse was built in 1962 and expanded in 1967. It does not satisfy the current NFPA sprinkler requirements [9] and CEN requirements for exposed plastic storage 6.1 m under a 9.1 m high ceiling, as indicated in Figure 6.

Figure 5 Area of Fire Origin in Cologne Warehouse Fire

The fire on October 20, 1977 started (probably by a discarded match or cigarette) in the vicinity of some plastic consoles stored in the aisles. Approximately four minutes after the fire started, a small hose stream was applied from a distance of 6 m, but was not effective in controlling the growing fire. Five ceiling sprinklers were flowing five minutes after fire discovery, and about 24 heads were flowing two minutes later. The water pressure at this flow rate corresponded to a sprinkler discharge density of 16 mm/min (0.40 gpm/ft²), which is significantly lower than the density needed to control a 6 m high plastic commodity high. Eleven minutes after the start of the fire, the increasing number of open sprinklers reduced the discharge density to 6 mm/min (0.15 gpm/ft²).

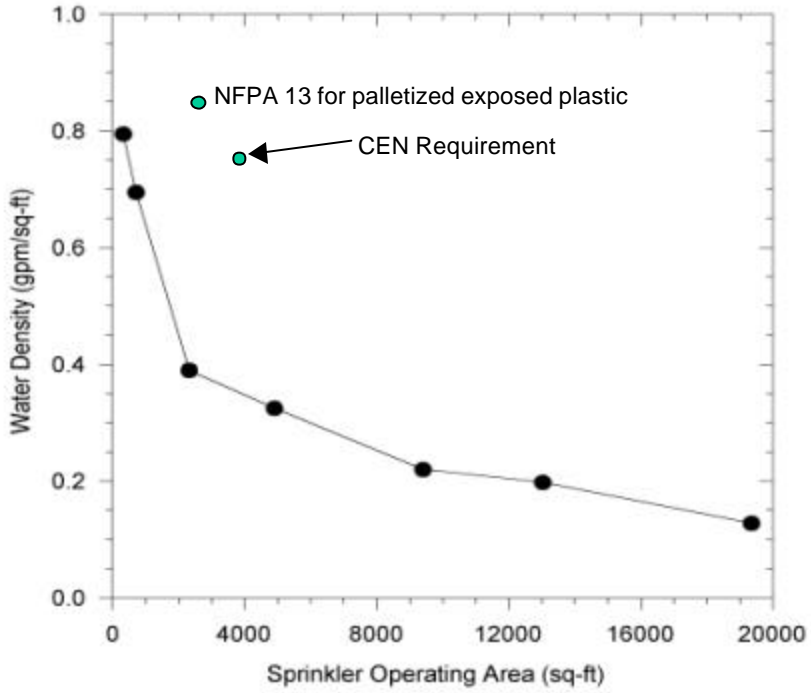
The Ford Cologne warehouse in 1977 consisted of a 75,600 m² (814,000 ft²) area and a 51,000 m² (550,000 ft²) area separated by a double brick cantilevered fire wall. Building construction consisted of steel columns and beams supporting steel purlins and a 9.1 m (30 ft) high ceiling with a steel deck roof in one area and a concrete slab roof in another area. Ceiling sprinklers were 12.7 mm (0.50 in) orifice with a water supply as represented in Figure 6.

Figure 6 Water supply for Cologne Warehouse Fire

One primary cause of the sprinkler system failing to control this fire is the inadequate sprinkler discharge flow rate as numerous sprinklers actuated. Another important limitation of the sprinkler discharge is the small drop size produced from the 12.7 mm-orifice sprinkler head. It is very difficult for these small drops to penetrating the upward flowing fire plume and reach the burning commodity. In the years following this fire, Factory Mutual research personnel began developing larger orifice sprinklers. As a result of this research and development, the 16.3 mm diameter Large Drop sprinkler became commercially available in the early 1980s, and the first 17.8 mm diameter Early Suppression Fast Response (ESFR) sprinkler became commercially available several years later. Most warehouse storage sprinkler systems being designed and installed now in North America utilize these and other larger orifice sprinkler heads.

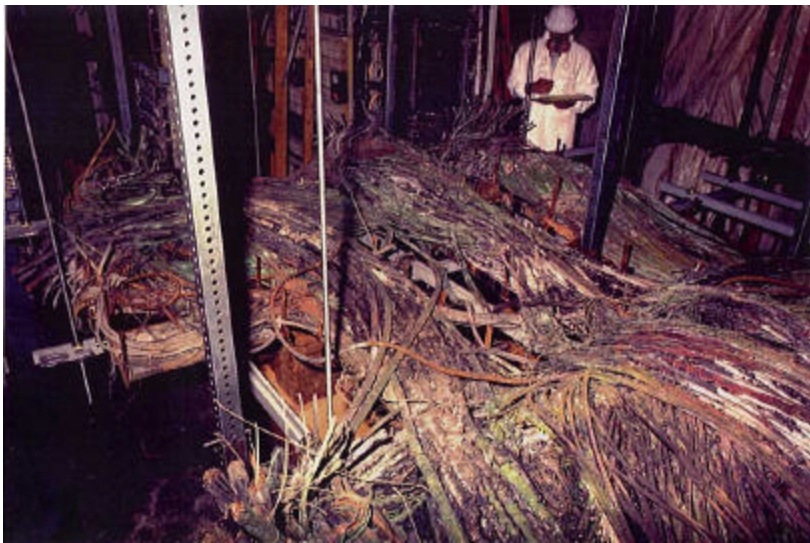
Figure 7. Burned cables in Hinsdale telephone exchange fire, reproduced with permission from FTI report [12].

Figure 7 shows the lowered cable trays during the fire investigation. There was a random mix of burned power and communication cables that had been installed over a period of thirty years prior to the fire. Based on the physical evidence and

numerous fire simulations, investigators [12] concluded that the 1988 Hinsdale fire was probably started by a short circuit due to electrical contact between a power cable with damaged insulation and the grounded metal sheath of an armored cable. They hypothesized that the short was of insufficient current to trip circuit fuses, but generated sufficient heat to ignite adjacent cable insulation. The insulation damage was judged to have occurred two months before the fire when some obsolete cables were removed from the densely packed trays. The fire break out on May 8th was presumably due to the unusually high telephone usage that day.

Reports of the Hinsdale fire and its cause stimulated several important changes in both the telecommunications industry and the fire protection community. Telephone companies revised the power controls in their telephone exchanges to facilitate rapidly de-energizing electrical equipment when needed. They also provided redundant switching capability to avoid the extensive telephone service outages in the weeks following the Hinsdale fire. In addition the fire motivated revisions to the U.S. National Electrical Code that created new categories of reduced cable flammability, required removal of unused cable from trays, and prohibited the random mixing of power cable and signal cable in cable trays. The fire also rejuvenated interest and funding for cable flammability testing, more sensitive and more reliable smoke detection, and new clean agent fire suppression agents. These important developments have allowed for improved fire protection at many industrial facilities with critically needed electric cable runs and electrical equipment.

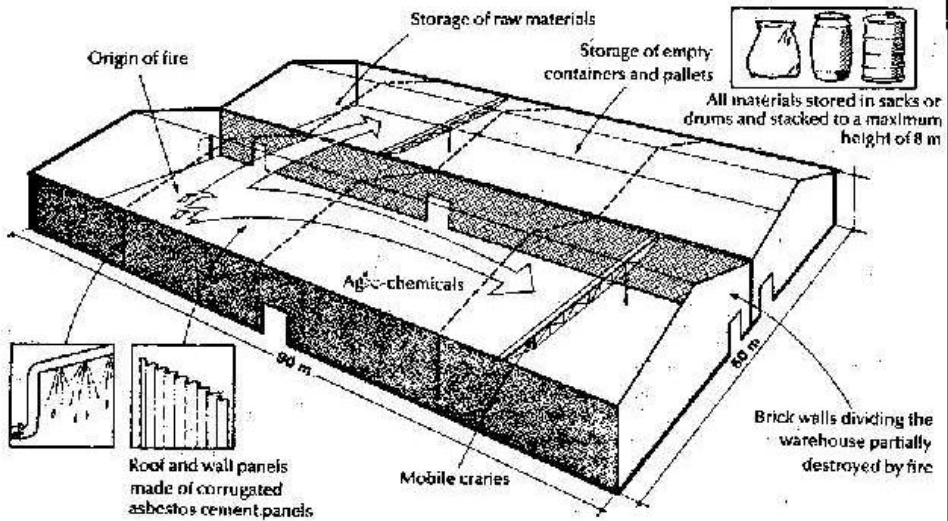
Building 956 at the Sandoz plant on the Rhine River near Basel was 90 m long, 50 m wide, and had two sections divided by a brick wall as illustrated in Figure 8. It had a structural steel frame with a 12 m high twin peaked roof made from corrugated asbestos cement panels. There was neither an automatic fire detection nor an automatic fire suppression system, but there was an on-site fire brigade headed by a fire chief who had a residence on the plant site.

Warehouse operations on October 31, 1986 included shrink wrapping paper sacks of product on pallets. Apparently, a flame heat source for the shrink wrapping process ignited a sack of powdered pigment, and the pigment started smoldering without being noticed by the workers. At 12:19 AM on November 1, 1986, a fire was observed when flames started shooting through the roof of the warehouse.

Figure 8. Storage and fire progression in Sandoz chemical warehouse (reproduced from Fire Prevention, 1987).

Since the 1986 Basel warehouse fire, there have been important revisions to flammable liquid codes, such as NFPA 30 [16], requiring extensive drainage and containment provisions to cope with the expected water runoff. There have also been extensive fire test programs to determine effective automatic sprinkler protection for liquid warehouses. These tests have involved flammable liquid containers of various sizes and types including metal drums. One of the benefits of these tests has been the demonstration that thermally-sensitive pressure-relieving devices on metal drums can prevent the drum/container rocketing that was such an important factor in the Sandoz Basel fire. NFPA 30 now provides an incentive to utilize these pressure-relieving devices by allowing for less stringent automatic sprinkler protection in flammable liquid warehouses where they are used. Implementation of the NFPA 30 and similar guidelines will instill confidence that we are much better prepared to deal with fires in large chemical warehouses.
