Maintenance Testing of Sprinkler Heads: Qualitative Analysis Causes of Failures

SERGE ZHUIYKOV, Ph.D.* and VINCE DOWLING
*Materials Scientist
CSIRO, Manufacturing and Infrastructure Technology
Industrial & Research Services
37 Graham Rd.
Highett, Victoria 3190, Australia

ABSTRACT

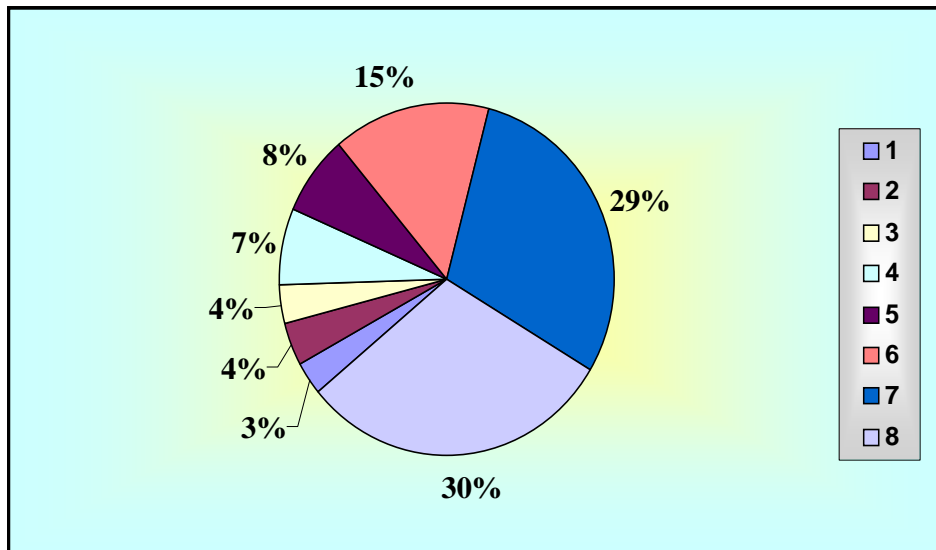
Fig. 4. Comparison of different failures for the Sprinkler Heads:

1 - "O-ring adhesion" of the sprinkler head; 2 - Undetected rupture of bulb wall; 3 - Systems "dosed" with sodium silicate in order to overcome small leaks; 4 - Heavy deposits of hardened sediment; 5 - Heavy build-up of dirt and debris on the frame, heat-sensitive element and deflector; 6 - "Intergranular" corrosion of the lead-tin-bismuth "eutectic solder"; 7 - Unlisted sprinkler heads; 8 - Extensive deposit of paint on the deflector and the glass bulb or fusible link.

500 failures among 6350 sprinkler heads tested during last few years have been analysed. Comparison of different types of failure for 500 investigated sprinkler heads failures is shown in Fig. 4. In many protected commercial properties, conditions exist that cause an accumulation of foreign material on automatic sprinklers so that operation of the sprinkler may be retarded or prevented. This condition is commonly called "loading" [7]. Any accumulation of foreign material on sprinklers tends to retard their operation as a result of the heat-insulating effect of the loading material. If the deposit is hard, it may physically retard or prevent the sprinkler from operating. Unless cleaning is done very carefully, deposits are likely to accumulate to such an extent as to interfere seriously with sprinkler operation. During our testing of the used sprinkler heads we found that, when they are subjected to the Operating Temperature Test, a high proportion of "fusible link" type heads (~15% among 500 heads) failed to release either when the maximum allowable release temperature was reached or when the maximum test bath temperature was reached. This problem is invariably caused by "intergranular" corrosion of the lead-tin-bismuth "eutectic solder" which fastens together the two halves of the fusible link. Such corrosion occurs when the heads are serving an area that is or was formerly regularly contaminated by acidic fumes such as those resulting from pickling and electroplating processes.

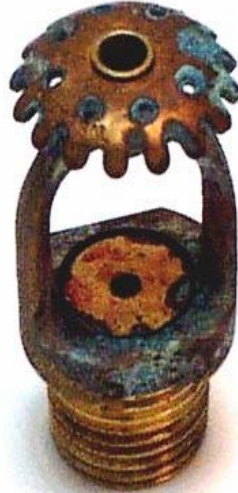
During our testing it is estimated that about 8% of the 500 failure sprinkler heads were found to have severely obstructed orifices due to heavy deposits of hardened sediment, or heavy build-up of water hardness salts, above the orifice disc. These heads usually fail the functional test due to failure of the seal disc to unseat, or to providing very distorted reduced-flow spray pattern. One of the examples of sprinkler head with extensive corrosion is shown in Fig. 5.

Fig. 5. Typical example of severe orifice seal corrosion of the sprinkler head.

Interestingly, the corrosion of this sprinkler was so severe that the orifice seal did not dislodge during the functional testing at pressure of 35 kPa after glass bulb eruption at 70°C.

Where sprinklers are subject to loading (accumulations of foreign material) or corrosion, perhaps only to a moderate or slight extent, they should be examined carefully and frequently. If the condition of sprinklers appears doubtful, a representative sample (six or more) should be removed, carefully packed to avoid damage in transit, and sent to an appropriate testing laboratory or to the sprinkler manufacturer. The results of their testing will indicate the condition of similar sprinklers remaining in the property.

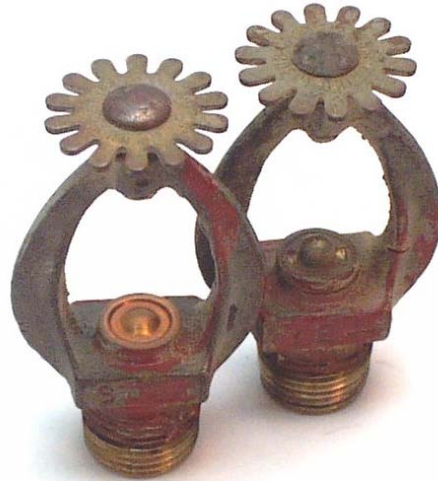
During the course of maintenance testing, FSG found that about 30% of the 500 failures were sprinkler heads with extensive deposits of paint, as shown in Fig. 6, or were completely paint-covered. When tested for operating temperature, these heads were invariably found to release well above the maximum allowable temperature. Paint-fouled deflectors were observed to severely degrade the spray pattern, when a functional test was performed. This defect translates to inadequate area coverage in a true fire situation, and a high likelihood of fire over-run of the sprinkler system. Those painted sprinkler heads, which shown in Fig. 6, failed to dislodge their orifice seals during functional test for 5 minutes.

Figure 6. Examples of painted sprinkler heads

There is no known method whereby paint under the seal-disc or on the fusible link can be removed adequately. Sprinklers that have been painted by anyone but the manufacturer *must* urgently be replaced with new units.

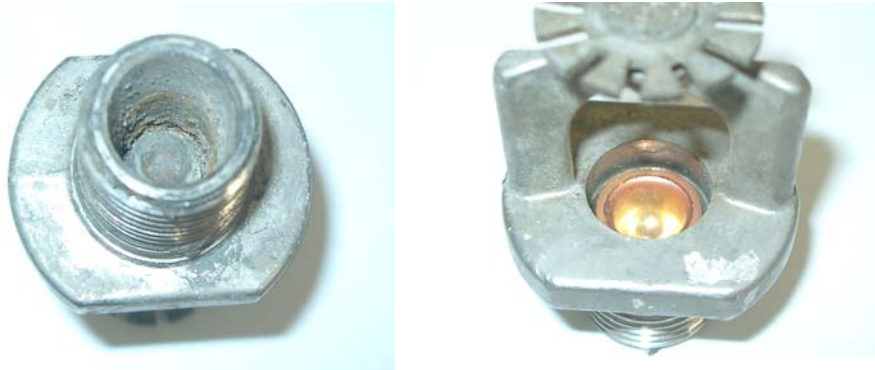
4% of the 500 failures were sprinkler heads which had been “dosed” with sodium silicate (“waterglass” or “egg preserver”) in order to overcome small leaks. In such cases, the orifice discs of the heads that were “weeping slightly” became “glued” to the seal seat, and will not release at anywhere near the required minimum system design pressure of 35 kPa. These sprinkler heads failed the functional test. Typical example of this failure is shown in Fig. 7. Systems with heads affected in this manner are likely to be over-run by a fire, resulting in greatly increased property damage and financial loss.

Fig. 7. Example of sprinkler head dosed with sodium silicate in order to overcome small leaks.

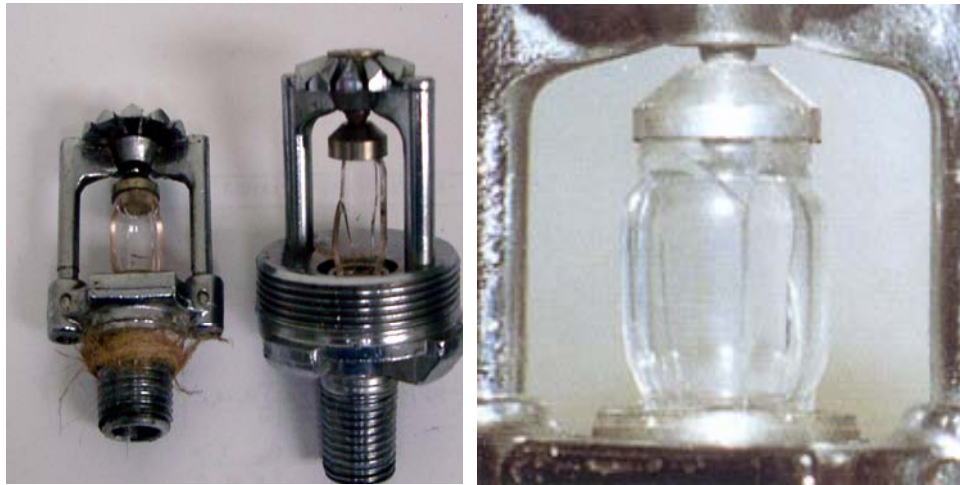
In addition to such failures as described above, FSG encountered samples of sprinkler heads which fail to activate due to apparently undetected rupture of the bulb wall. Approximately 4% among 500 failures were glass bulb type sprinkler heads which were found to have empty or partly empty bulbs. Examples of these ruptures are shown below. Figure 8a shows that the glass bulb had been accidentally broken but the sprinkler did not activate. In the second case (Fig. 8b), the bulb cracked and allowed the liquid inside to drain completely away without releasing water. These samples were taken from separate sprinkler systems which appeared to be fully operational.

In the event of a fire occurring, neither of these sprinkler heads would have activated. The danger is that if this was to occur in a critical location, the fire may spread through a larger area than it might otherwise have done. Equally, the fire hazard (smoke/toxic fumes) may reach a level hazardous to building inhabitants.

Sprinkler heads with the above type of defect shown in Fig. 8 will often pass the hydrostatic leakage test, but will always fail the operating temperature test and function test. When closely examined, these bulbs are generally found to be made of ordinary glass, rather than the much more reliable “quartzoid” type glass now always used, and the wall thickness is always found to be very uneven and, in places, extremely thin. Many “non-quartzoid” bulbs have failed the operating temperature test (usually by opening at too high a temperature) or the functional test (due to a large glass fragment remaining “bridged” between the orifice disc and the adjusting screw, or lodging on the deflector). Most, if not all, “non-quartzoid” heads have been found to have never been **listed**. Building owners should ensure that their glass-bulb sprinkler heads are not of the “non-quartzoid” type. All heads of this type that are discovered during system inspection should be replaced without delay. Importance of the regular inspection and testing the heads of old sprinkler systems is clearly demonstrated by these two examples discussed above.

Fig. 8. Examples of undetected rupture of glass bulb.

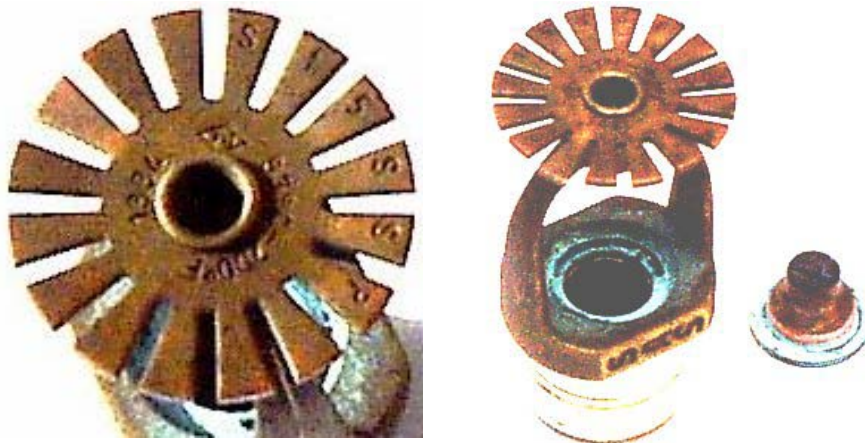
Fig. 9. Example "O-ring adhesion" of the sprinkler head.

A small number of FSG's sprinkler test failures have involved an orifice plug which is sealed by means of a small O-ring which sits in a groove in the plug's cylindrical surface and is pressed ("radially-squeezed") into contact with the wall of the outlet of the sprinkler orifice. Release of the plug requires the water pressure to act on the "tail" of the plug such that sufficient longitudinal thrust is developed to cause the compressed O-ring to slide along the orifice bore, in a similar fashion to the piston ring of an engine. During the Function Test, this design of orifice plug has often failed to dislodge, or even to move slightly, after the heat-sensitive element has actuated and cleared away. Hydrostatic pressures of 5 to 10 times the maximum allowable Function Test pressure have been needed to unseat these plugs. On close investigation of the orifice and plug, the cause of the functional failure has mostly been shown to be a phenomenon known as "O-ring adhesion." Some of the FSG test failures of this type appeared to be caused by a

“microscopic” ridge of salt-like deposit or corrosion product on the orifice bore, at the point of contact of the O-ring, rather than by “O-ring adhesion.” It is clear that there is an urgent need for sprinkler listing organisations to develop new test procedures for detecting any tendency towards sprinkler failure of the “plug adhesion” nature, particularly where a manufacturer has submitted a head which has an unusual orifice seal design. A typical example of such a design is shown in Fig. 9. This sprinkler head was only 9 years old at the time of the testing and, as clearly visible from the Fig. 9a, it was made in 1994 and was type-Approved by Factory Mutual Research Corporation (FM). The FM Approval implies that, at the time of the investigation and compliance testing by FM, this type of sprinkler head passed all necessary tests in order to be approved by FM and to be identified by the FM Approval mark.
