F.R. Note No. 243/1956 12 JUL 1956
Research Programme
Objective B1

FURTHER EXPERIMENTS ON THE TRANSMISSION OF HEAT FROM FLUE PIPES

H. L. Malhotra

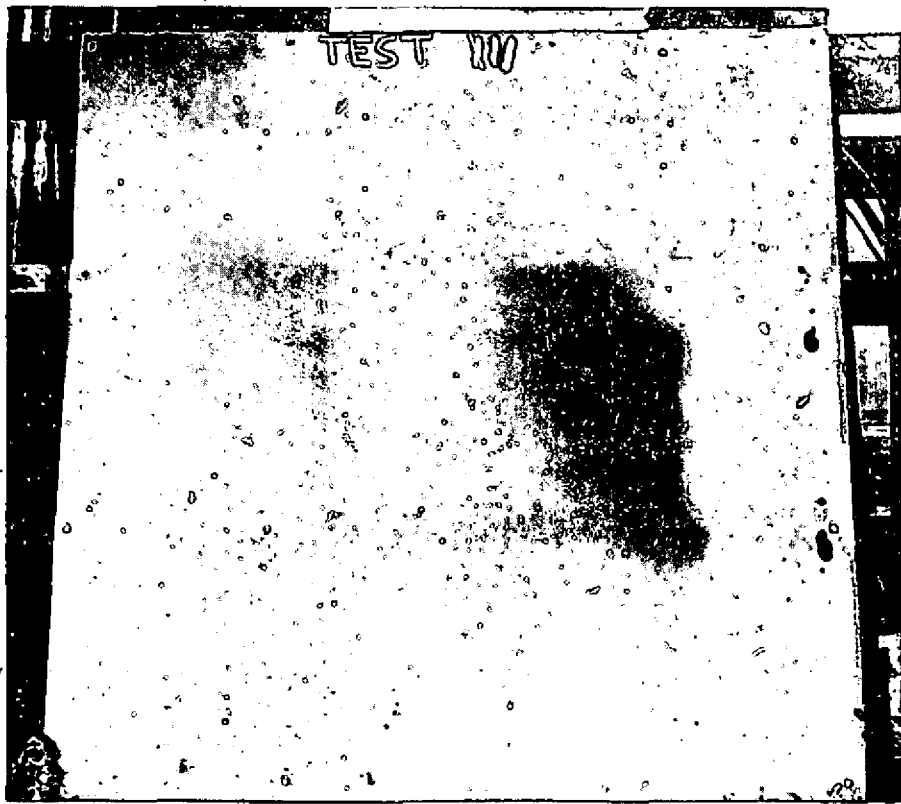
The increase in the air gap between the shield and the ceiling did not afford any greater protection to the ceiling joist.

FIG.9. APPEARANCE OF CEILING AFTER TEST 3

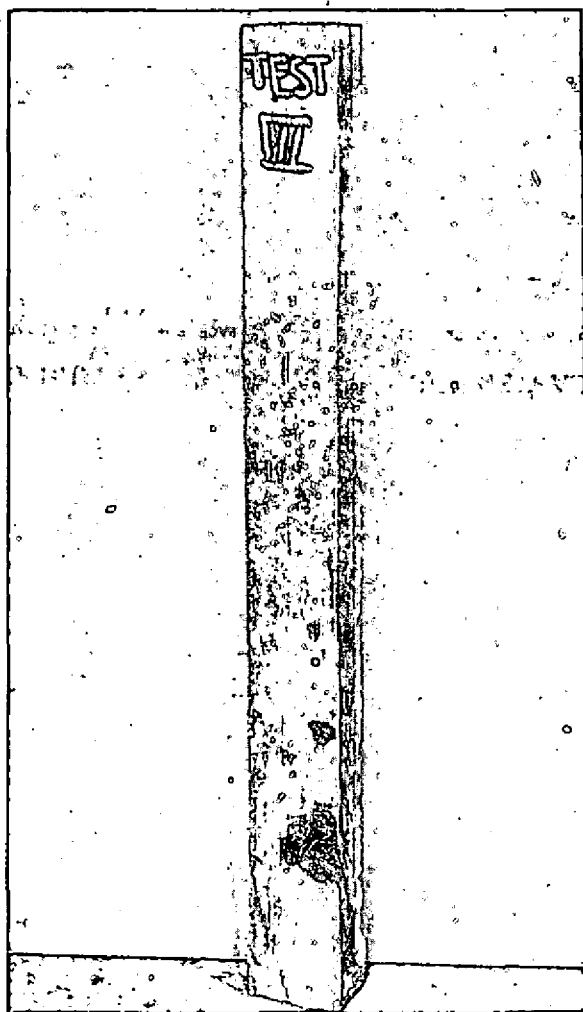
Provision of partial insulation only between the flue pipe and the sleeve raised the temperature of the sleeve and increased the rate of rise of temperature of the wall plate as shown by temperature curves in Figure 8. The wall plate temperature was 160°C compared with 150°C in test No. 1 where it occupied a similar position with respect to the flue pipe. Figure 10 shows that at the end of the test, after 120 hours, no significant charring of the wall plate had occurred.

FIG.10. APPEARANCE OF WALL PLATE AFTER TEST 3

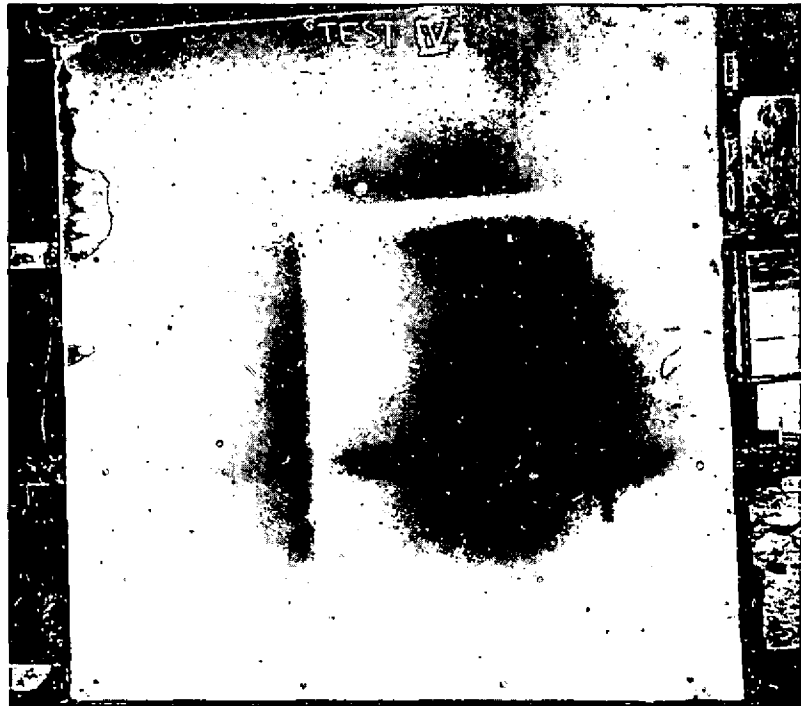
The temperature of the ceiling joist at the end of the test was 150°C. Figure 12 shows the appearance of the ceiling after test.

FIG.12. APPEARANCE OF CEILING AFTER TEST 4
