F.R. Note No.444.

THERMAL CONDITIONS IN SHIPS' LIFEBOATS ENVELOPED IN FIRE

P. Nash and R. H. Bignore

September, 1960.

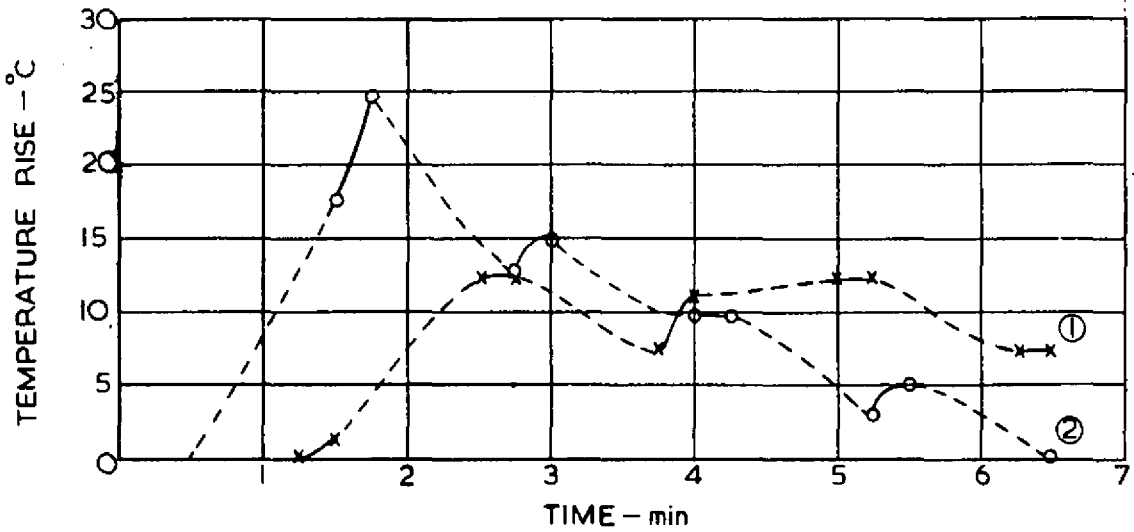
FIG. 1. THERMAL RECORDS OF TEST No. 1/A1

The boat was fully enveloped in fire for at least $4\frac{1}{2}$ minutes and was subject to severe conditions for the remaining $\frac{1}{2}$ minute. The engine continued to run throughout the test. The hull appeared to be relatively undamaged after the test although the paintwork was burnt off where the water sheet had been divided by the ribs supporting the canopy. The canopy showed a slight overall charring which was more pronounced where the supporting ribs tended to shed the water. At the corners, the canopy was severely charred and could be split easily. The water spray could not cover these areas due to the sharp angle between the side surfaces of the canopy and the end surfaces. The interior of the boat showed signs of sooting, but no charring anywhere.

The temperature records are given in Figure 1. The values recorded are lower than the actual temperatures in the boat because the leads were damaged by water seepage.

Temperatures plotted are unreliable because the leads were damaged by water seepage

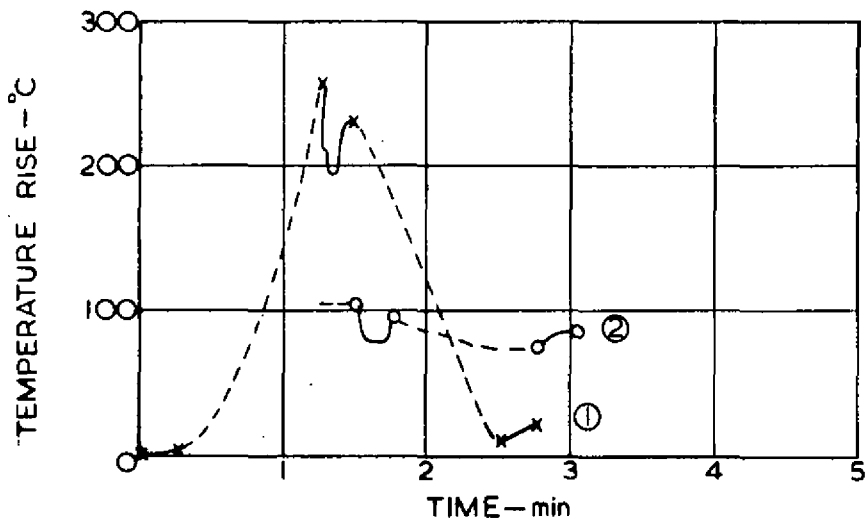
FIG. 2. THERMAL RECORDS OF TEST No. 3/A3

Owing to the failure of the water supply, foam was applied to the fire which was brought under control 2 minutes after it had been lighted. This did not affect the conclusions to be drawn from the test, as the whole canopy was burnt away and the conditions in the boat were lethal. The engine continued to run throughout the test. The whole of the inside of the boat was severely charred. The temperature records are given in Figure 2.

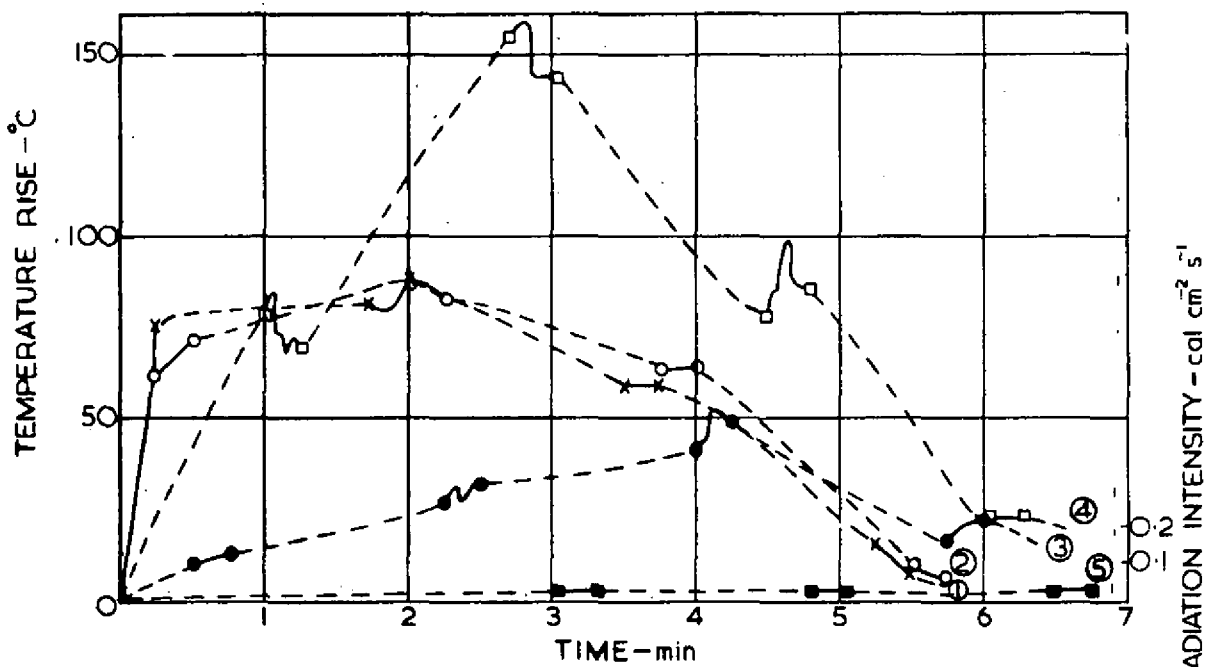
FIG. 3. THERMAL RECORDS OF TEST No. 10/C5

The boat was fully enveloped in fire for a full 5 minutes, and the flames subsided so that the boat was in full view after 5½ minutes. The canopy was remarkably free from damage and there were no appreciable signs of charring anywhere. The aluminium turtle-backs at the ends of the boat were undamaged, but a 2 ft square hole had been burnt in the stern of the boat on the port side, and ½ sq.ft hole on the starboard side where the water run-off had not adequately wetted the hull. The bow showed similar overheating but no holes had developed. The timber inside the boat was slightly charred adjacent to the holes but was otherwise undamaged.

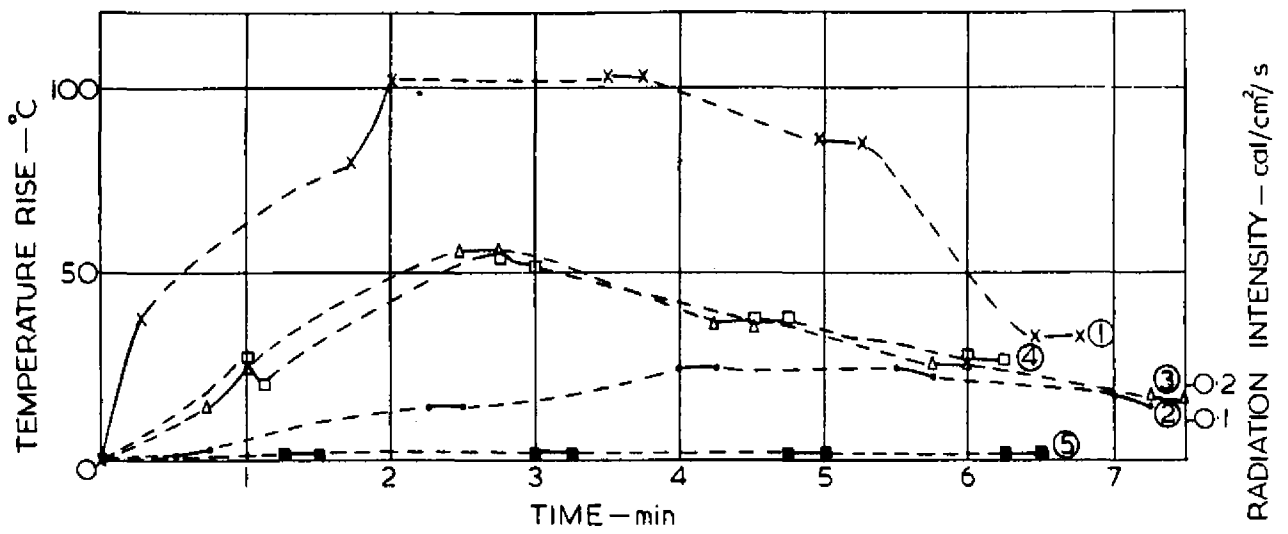
FIG.4. THERMAL RECORDS FOR TEST No. 8/B2

The water sprays were found to give good water coverage on the canopy and the sides of the hull. The additional sparge pipes at bow and stern gave good coverage in these areas, although the pipes were fitted rather far from the hull and projected the water above the horizontal, rather than below it, as required. Additional drillings in the saddle-pipes which fed the sparge pipes were invaluable in protecting the vertical ends of the G.R.P. canopy, which would have been severely damaged otherwise.

The boat was completely enveloped in flame for a period of approximately 5 minutes, when the fire was subdued by the use of foam. On inspection, the boat and canopy were found to be in very good condition where the water coverage had been adequate. The sectional covers were scorched adjacent to the joints where the G.R.P. cover strips had tended to shed the water and disrupt the coverage. The hull was also scorched in lines vertically below the cover strips, and also where the rope fittings had split the water sheet.

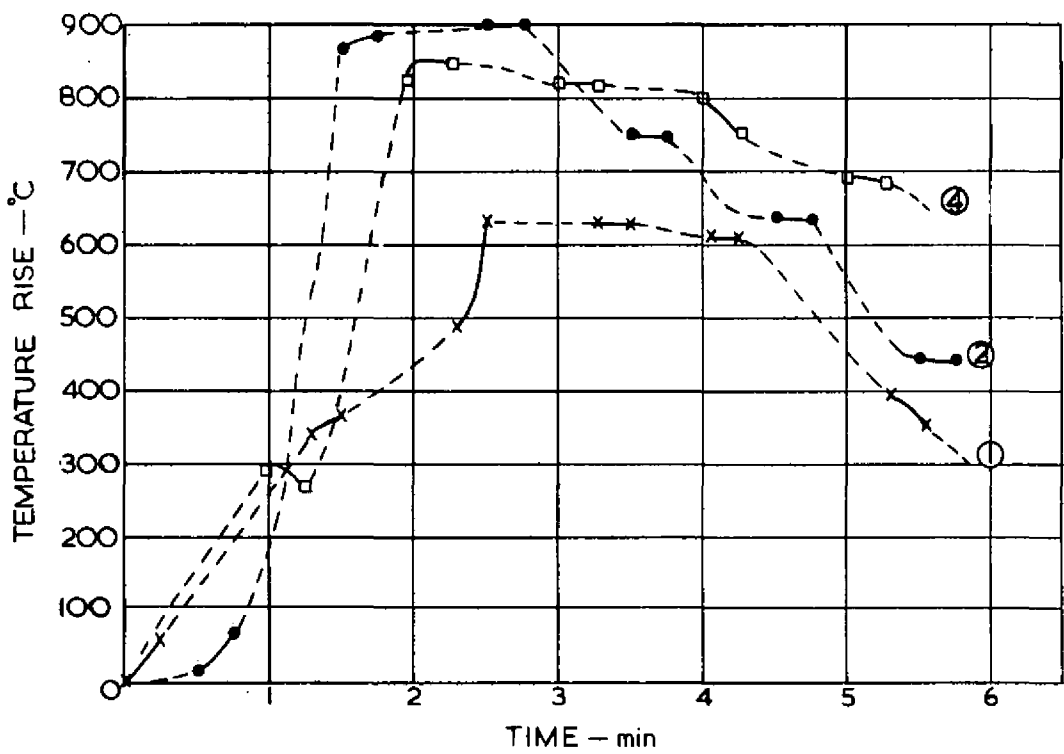
FIG.5. THERMAL RECORDS FOR TEST No.9/B2

The boat was completely enveloped in flames for approximately 5 minutes, when the fire was subdued with foam. The whole of the G.R.P. canopy was burnt off the boat, the conditions inside being lethal. The hull of the boat was charred and was left as a "spongy" mass of glass fibres with no plastic filler left unburnt. In its severely weakened condition it is very unlikely that it would have been seaworthy. It was easy to cut a hole through the hull with a penknife.

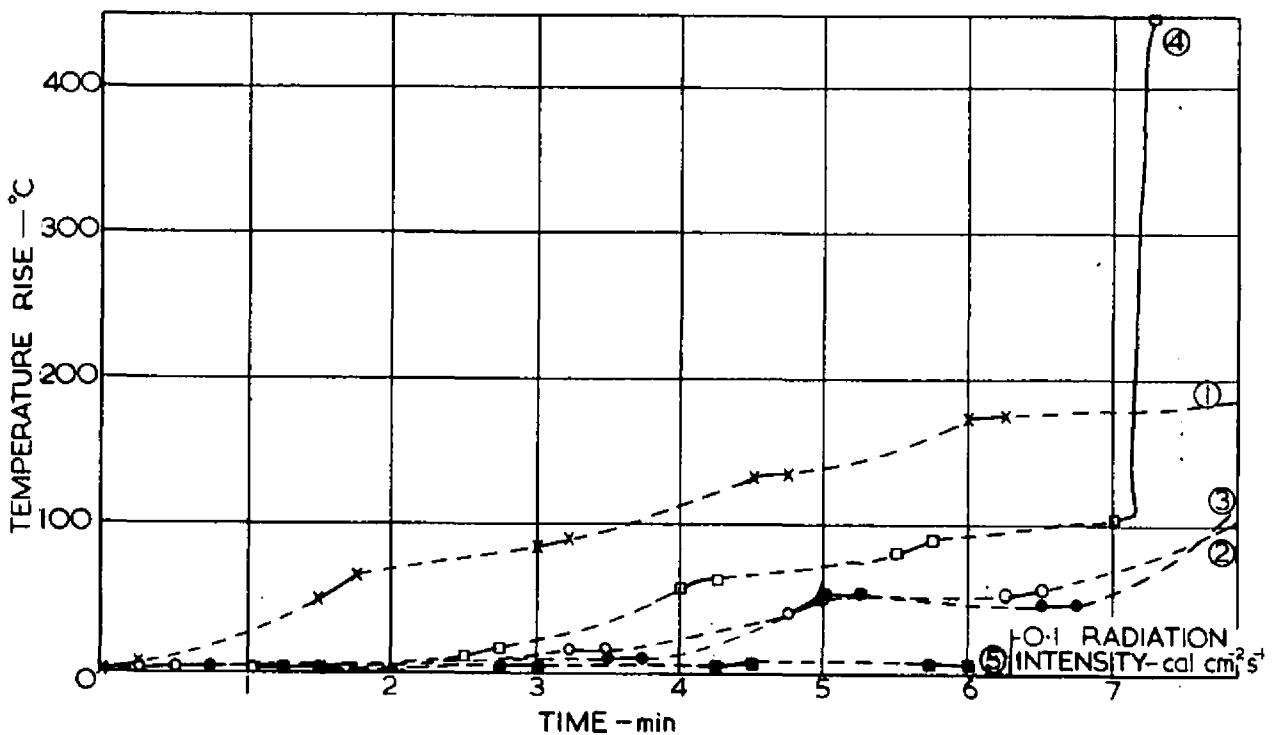
FIG.6. THERMAL RECORDS FOR TEST No.13/D6

The boat was fully enveloped in fire for approximately 5 minutes, when fire fighting commenced. It was seen that smoke and thick brown fumes were coming from within the canopy. The canopy and insulation were cracked in several places. On inspection, it could be seen that the timber inside the canopy was charred in some places.

Where the canopy was not cooled by water there would have been no chance of human survival, except in the boat with bonded-asbestos protection, (Test 13/D.6.) Here the temperatures within the boat were satisfactory during the 5 minutes of test, but after the fire had been subdued, there was a general increase which was not satisfactory. In the case of the hull, this was probably due to "heat soakage" or to an exothermic reaction in the bonded material. The increase in air temperature near the canopy roof was very rapid and it is probable that the combustible canopy was on fire. This suggests that there is a possibility for the use of a boat with a heat-insulating construction, but that it should be constructed of non-combustible materials, and should have a readily-openable canopy so that the interior of the boat can be vented after the fire.

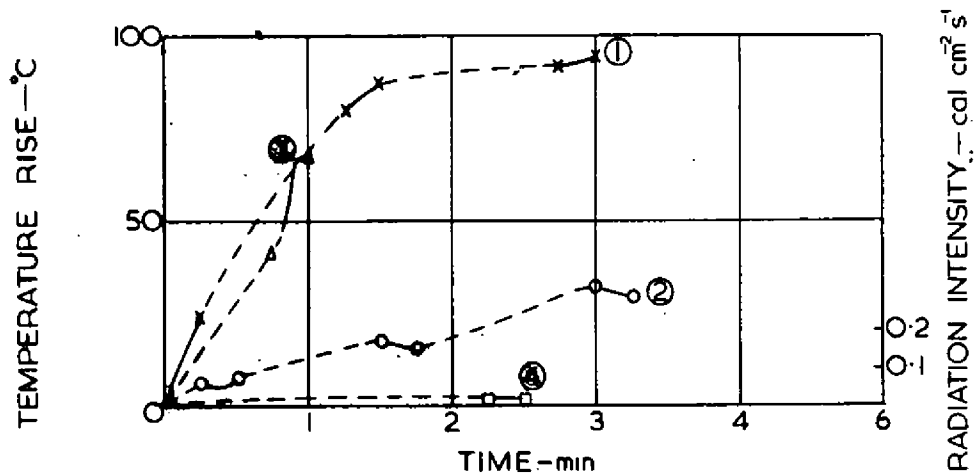
FIG. 7. THERMAL RECORDS OF TEST No.5/A3

In the test the boat was completely enveloped in fire for approximately 5 minutes, when fire-fighting commenced. The engine ran continuously throughout the test, although it was heard to splutter and backfire at about $4\frac{1}{2}$ minutes. After the fire, the canopy was found to be burnt through at some of the supporting ribs, the steel hull being relatively undamaged. The woodwork inside the boat had been charred previously, and it was not possible to deduce the degree of entry of hot gases by this means.

These readings only continued for $2\frac{1}{2}$ minutes as the subsequent readings were washed off the chart during fire-fighting operations.
