**Fire Research Note  
No. 816**

**THE THERMAL MOVEMENT OF CONCRETE FLOOR  
UNITS UNDER FIRE CONDITIONS**

**F. C. ADAMS and T. V. DAY**

**April 1970**

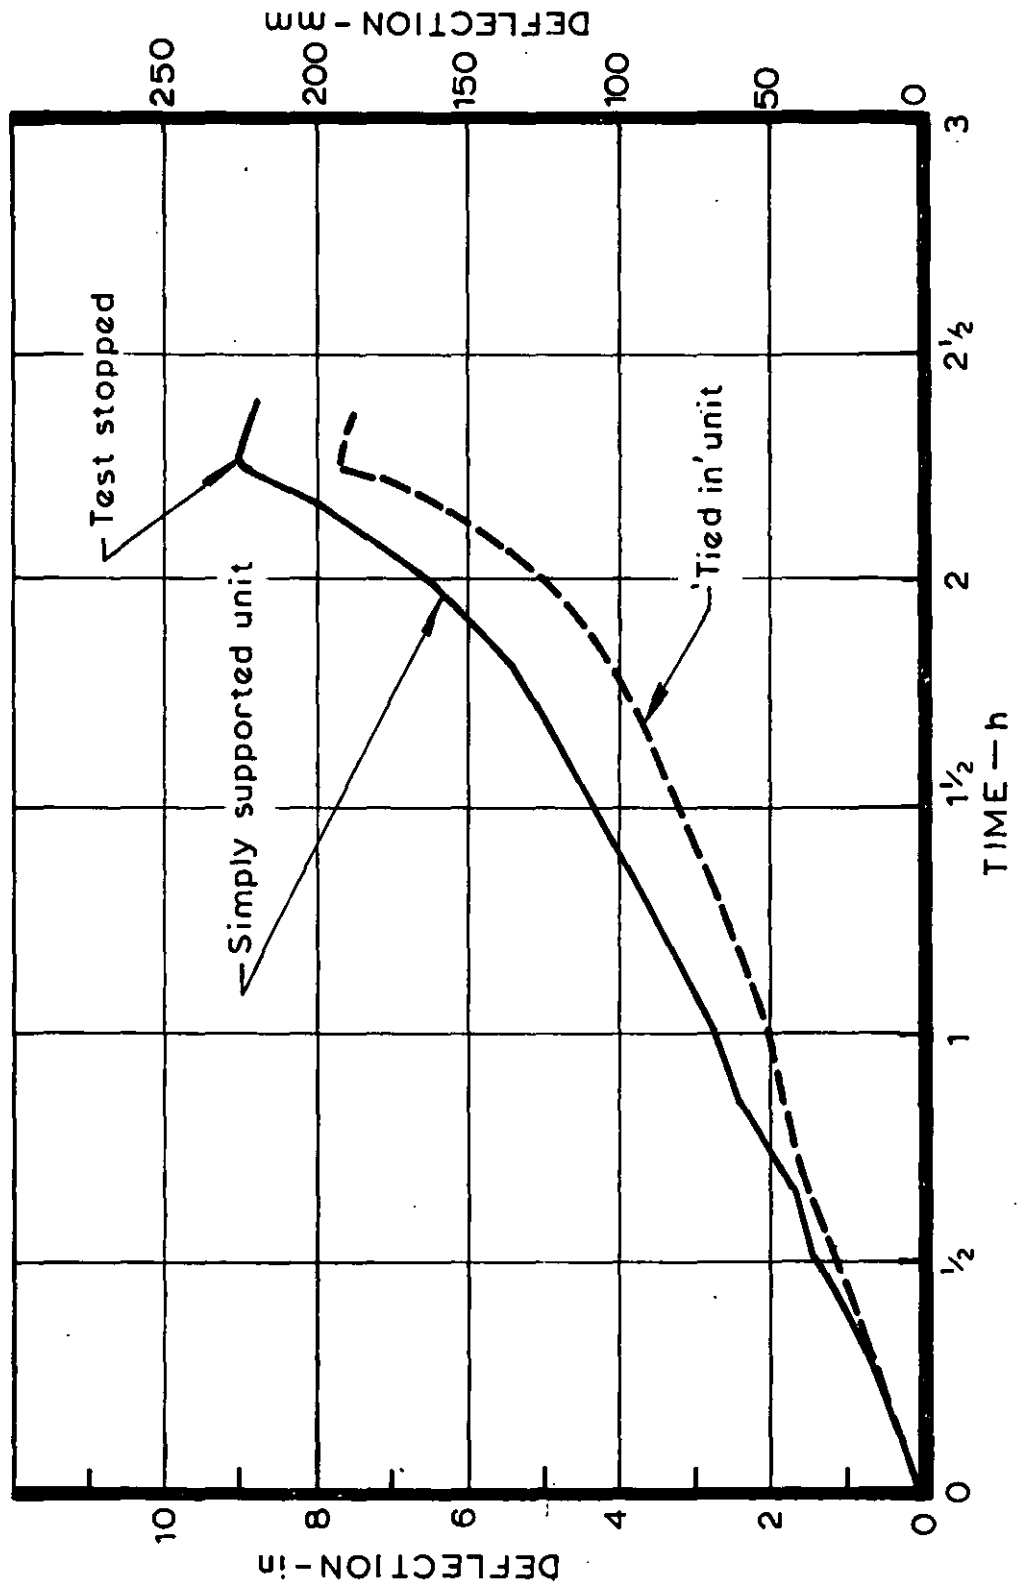
FIG.9 CENTRAL VERTICAL DEFLECTION

From Figure 9 it can be seen that although the test was continued until imminent collapse of the floor units, there was some recovery of deflection after the furnace had been shut off.

The simply supported floor slab showed greater vertical deflection than the tied-in slab soon after the start of the test; the greatest difference occurred at 2 hours when its deflection was 160 mm (6.3 in) in comparison with 125 mm (4.9 in) for the specimen with tied ends.

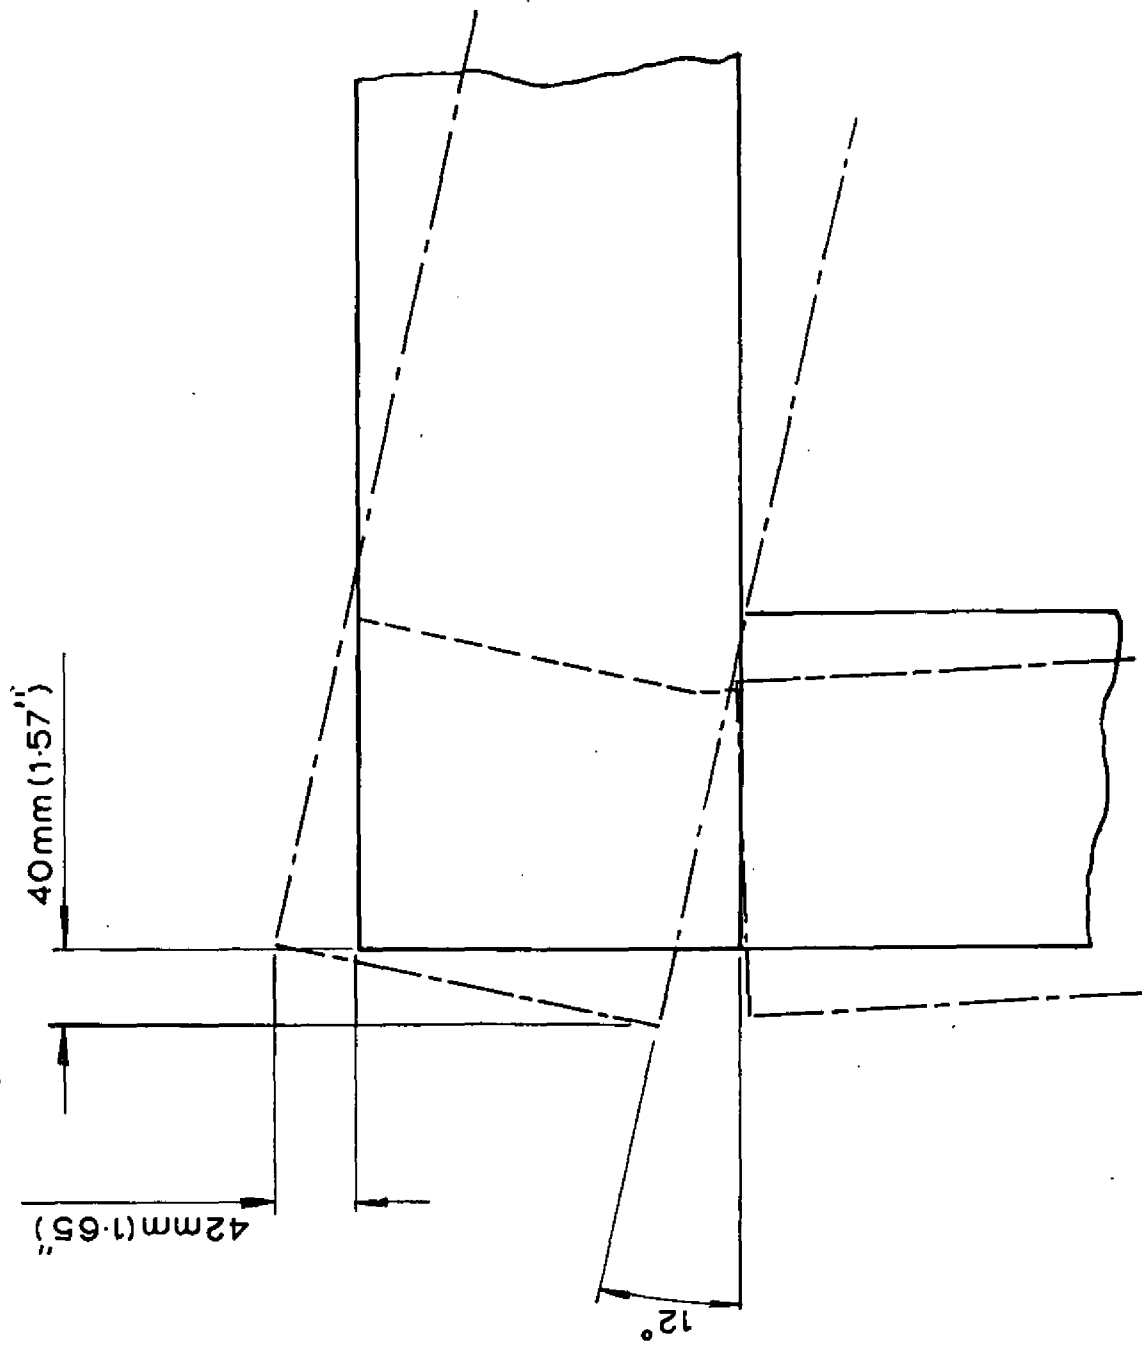
FIG.12 MOVEMENT OF FLOOR AND WALL UNIT—CONSTRUCTION 1

The relative movement of the floor junction with the wall not restrained in position is shown in Figure 12 at the end of the test when collapse of the floor was imminent. The maximum horizontal outward movement of the wall of 40 mm (1.57 in) was determined graphically from the data in Figure 10. This would result in an angular movement from the vertical of  $0^{\circ}-56\frac{1}{2}'$  in a storey high wall. The maximum vertical movement of the corner of the floor was similarly computed to be 42 mm (1.65 in).

The angular movement between the floor slab and the wall was due to the inadequacy of the fixity provided. Had the floor edge and the wall remained integral there would have been lower vertical deflection of the slab in the middle. There is no indication, however, that the horizontal movement would have been significantly affected had this been the case.

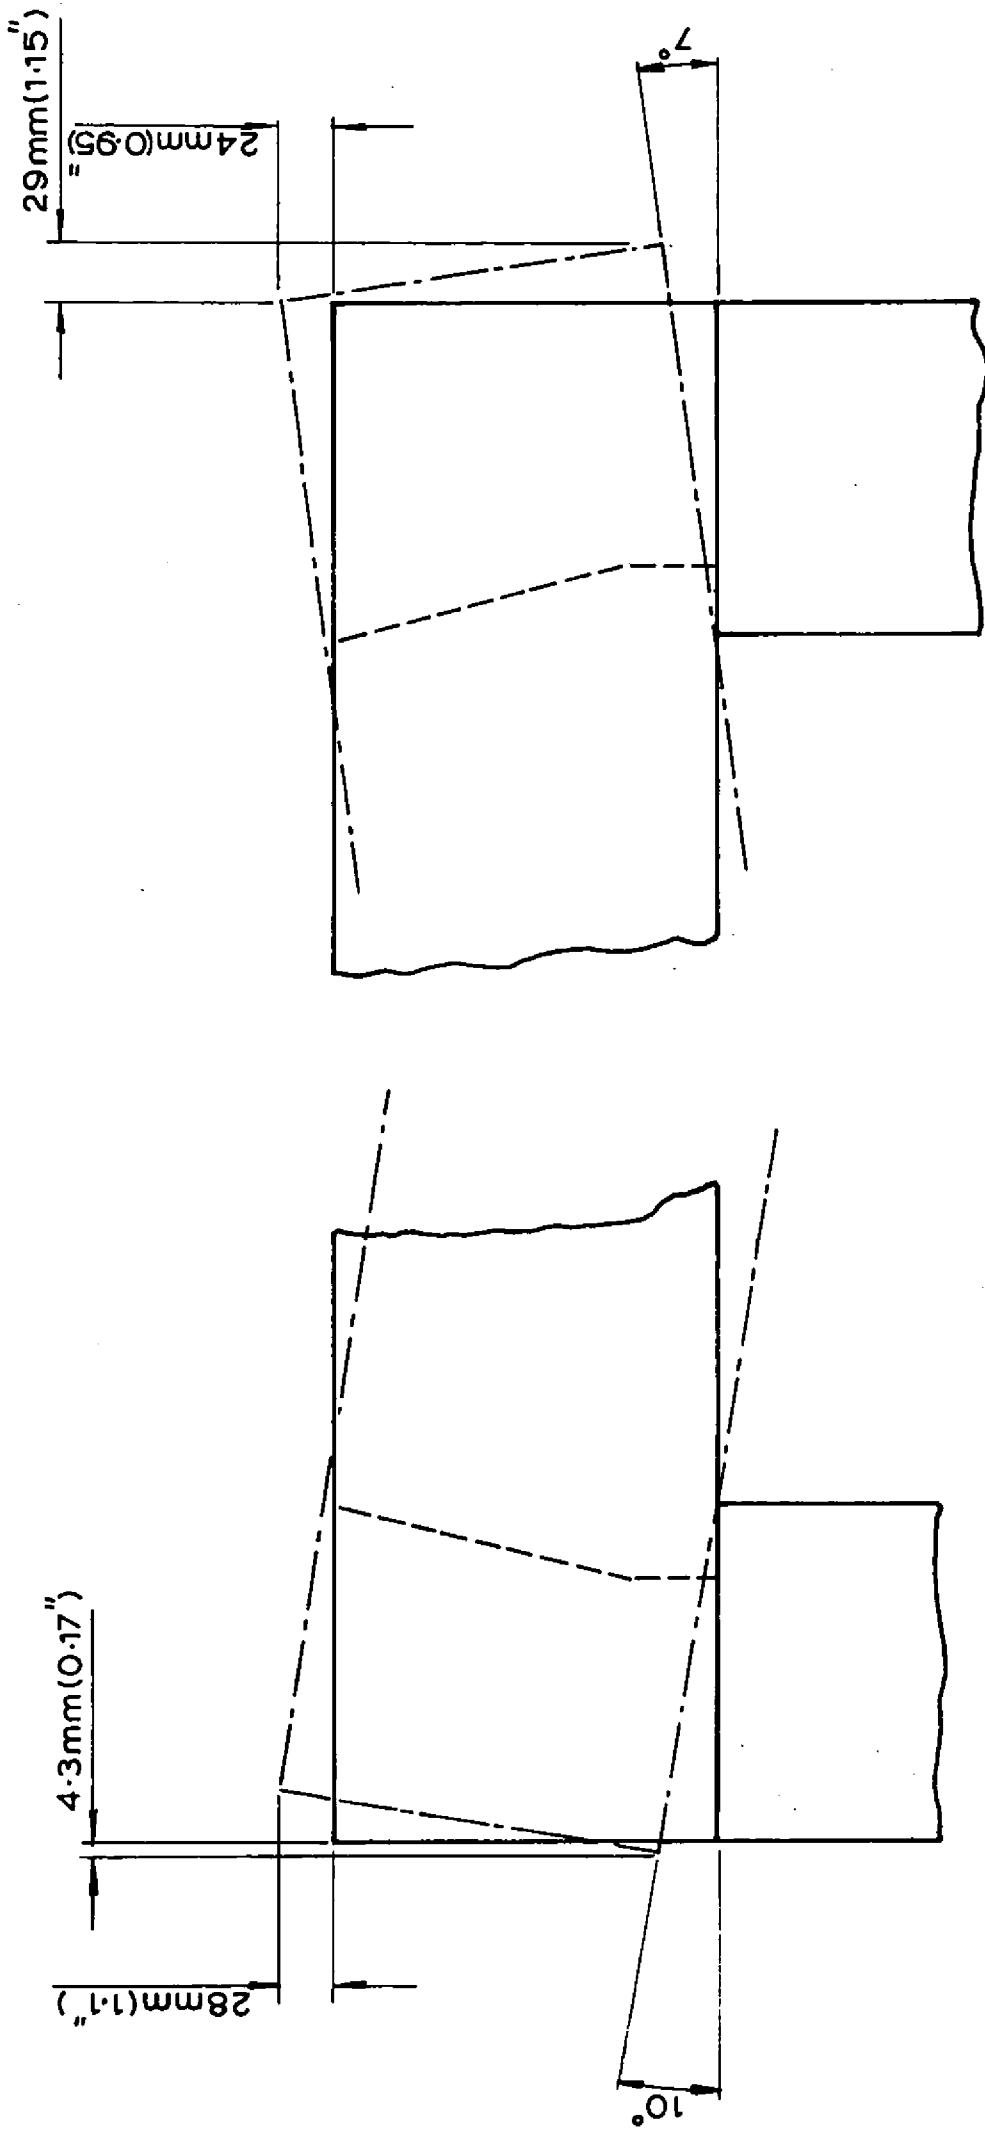
FIG.13 MOVEMENT OF FLOOR UNIT - CONSTRUCTION 2

As can be seen from Figure 13 most of the longitudinal movement occurred at one bearing edge and detailed examination showed that the floor unit had moved with respect to the wall unit by about 29 mm (1.15 in) and the bearing was on the floor unit itself and the ribs were not in contact.

Figure 13 shows the graphically determined movement of the slab that occurred at each end of the floor unit when collapse of the floor was imminent. At one end this was 4.3 mm (0.17 in) but at the other end outward horizontal movement of the floor unit was 29 mm (1.15 in). This would have resulted in an angular movement of a storey high wall unit from the vertical of  $0^{\circ}$ - $42'$  if it were not restrained in position. The maximum vertical movement of the floor edge was 28 mm (1.1 in).

The total horizontal movement of the floor edge of 33.3 mm (1.31 in) (29 mm + 4.3 mm) was 6.7 mm (0.26 in) less than the 'tied-in' construction, the difference was primarily due to the larger vertical deflection of the simply supported slab in comparison with the specimen with tied ends.

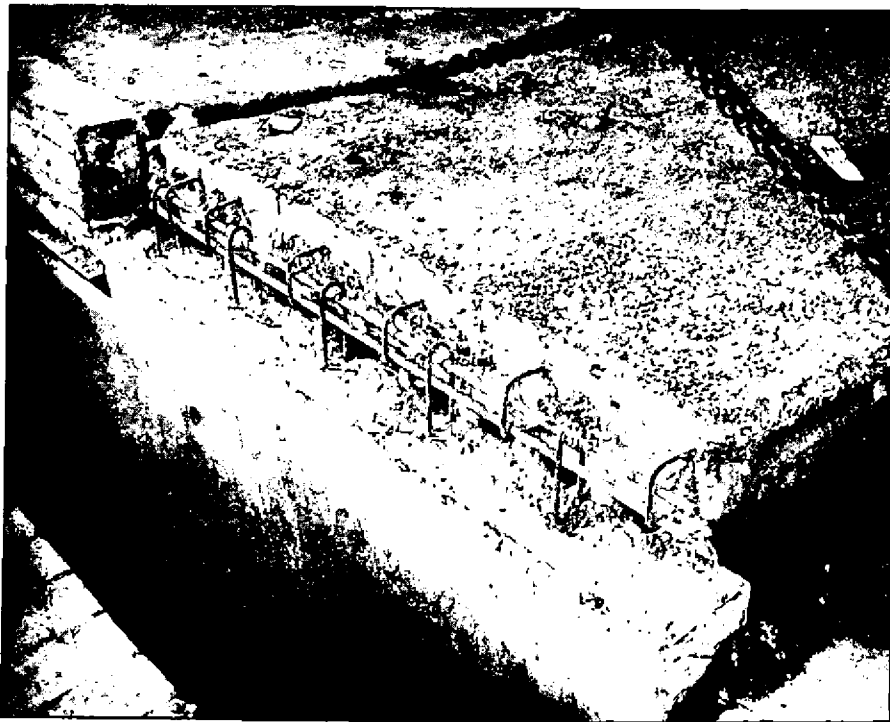
Severe spalling had occurred on the face of both wall units exposed to fire to such an extent that at the bearing where the wall unit was not restrained in position the ribs of the floor unit were no longer acting as bearing points. The in situ concrete was carefully removed and the cause of the horizontal crack between the wall unit and in situ concrete was found to be due to the steel links pulling out of the wall unit. There was no evidence of the steel having yielded.

The detail photographs Figures 17, 18 and 19 show the extent of the spalling and the deterioration at the bearing edge.

FIG. 17. DETAIL PHOTOGRAPH SHOWING BEARING EDGE  
DETAIL OF CONSTRUCTION 1 WITH IN SITU CONCRETE  
REMOVED AFTER TEST

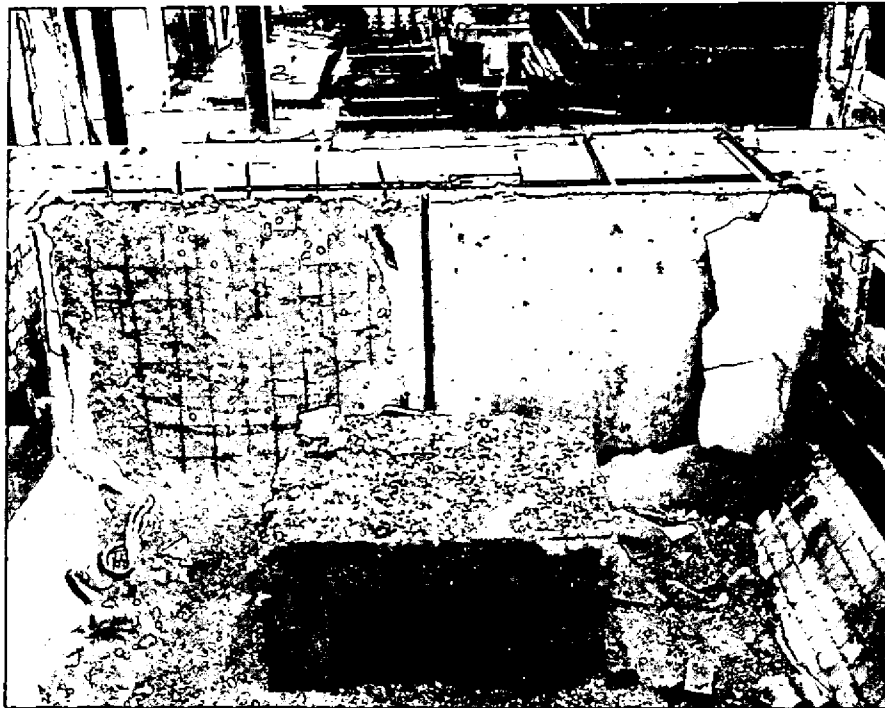
FIG. 18. APPEARANCE OF FACE OF WALL UNITS  
EXPOSED TO FIRE AFTER TEST  
(CONSTRUCTION 1 ON LEFT)

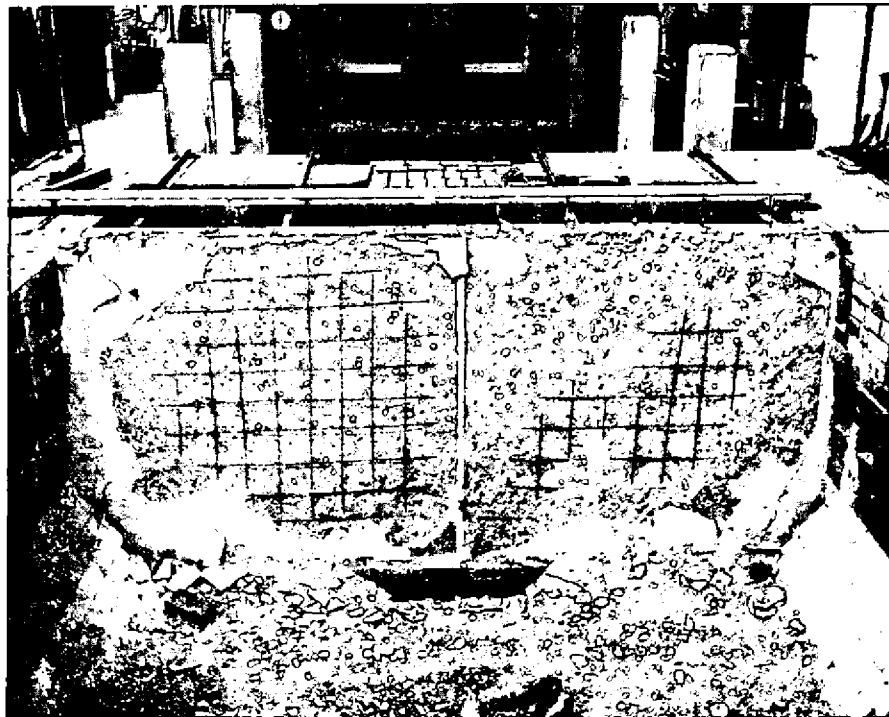
FIG. 19. APPEARANCE OF FACE OF WALL UNITS  
EXPOSED TO FIRE AFTER TEST  
(CONSTRUCTION 1 ON RIGHT)
