Cable-Fire Tests under the Raised Floor of Data-Processing Installations

KLAUS MARTIN

Allianz Versicherungs-AG
Munich, West Germany

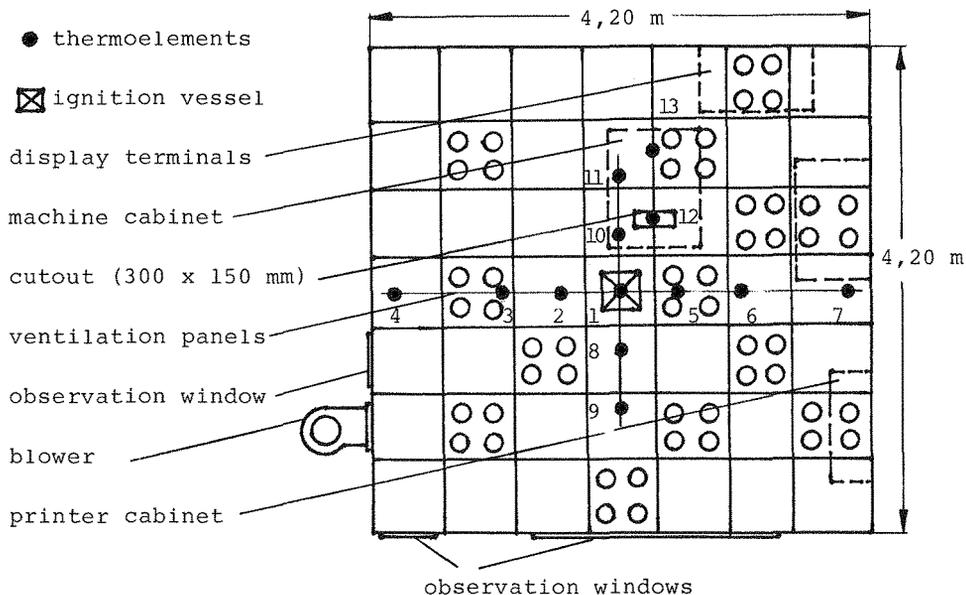
figure 1: Setup of the test environment

A raised floor measuring 4.2 m x 4.2 m (size of the floor panels 60 cm x 60 cm) was installed in the test room in such a way that it was enclosed at two sides by two of the walls of the room. The two open sides were closed off by means of plasterboard. A plexi-glass window in the plasterboard permitted observation of the fire under the raised floor. The clearance under the raised floor was 500 mm.

The floor panels rested on steel uprights with pressurecast aluminum supporting platforms. The floor panels themselves were made of highly-compressed chipboard with a zinc-plated steel lining glued to the bottom and carpet at the top. Two of the floor panels showed a cutout measuring 300 x 150 mm through which the cables were run. 30 % of the floor panels were ventilation panels (figure 1).

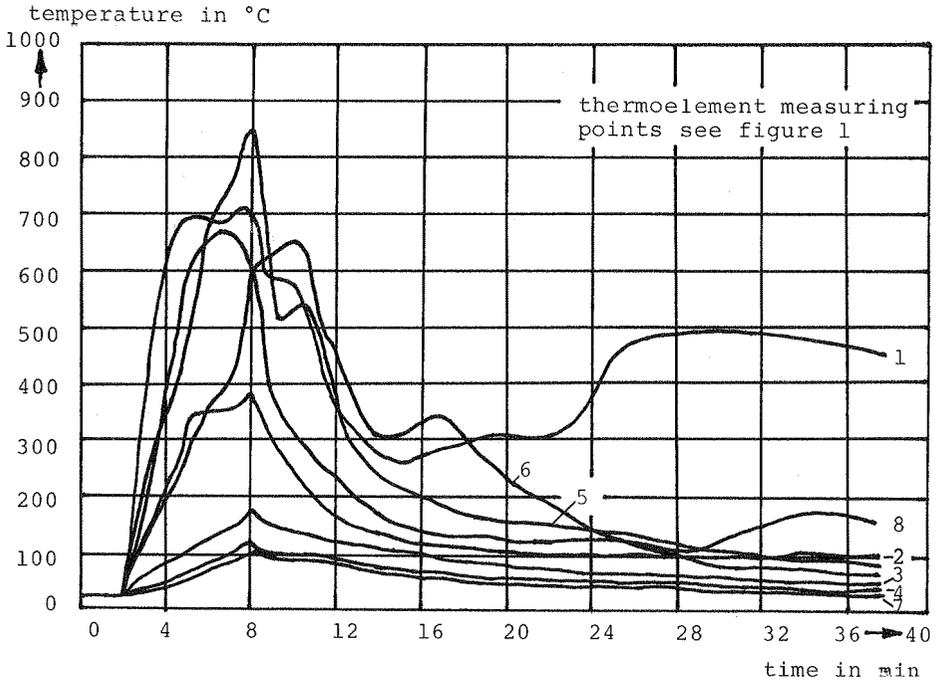
figure 2: Temperature-time-recordings (test 2, measuring points 1-8)

After some 20 minutes there was a real fire under the raised floor of the fire-test room, although the raised floor was still an uninterrupted surface. After the 23rd minute, the temperature over the ignition source, which had first fallen, began to rise again (figure 2: thermoelement measuring points 1 - 8, figure 3: thermoelement measuring points 9 - 13).

The evaluation of the recorded temperatures showed that temperatures ranging from 650 °C to 800 °C were maintained until all the hexane had burned away; subsequently the temperature fell up to the 15th minute to approximately 300 °C. From the moment when the floor panels began to burn, the temperature increased to approximately 500 °C and remained at that level until the fire was extinguished.

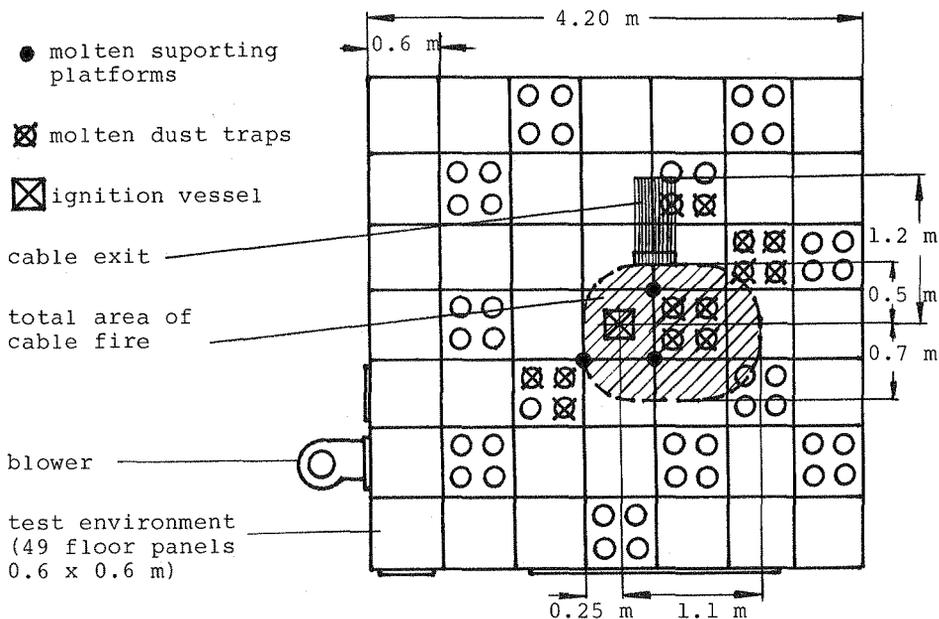
figure 4: Extent of damage in test 2

It is likely that at that time the floor boards began to burn. It appeared later that the metal sheeting on the underside had become detached. In the 30th minute some of the floor panels collapsed. One supporting platform of the steel uprights had melted completely, two others had disintegrated partly. In an area of 1.62 m² the cables were burned completely. In the direction of the airstream the damage was greater. The flames reached the cabinet over the cutout; it burned out completely and beyond repair. The cables emerging from the raised floor burned completely (figure 4).

- When the cables were flamed under the raised floor, fire damage to the cables was more extensive in the direction of the air flow (maximum damage at a distance of 1.1 m from the ignition vessel!). Outside this area, the cables under the raised floor were undamaged. The test was stopped after 40 minutes and the fire was extinguished with water.

- The cables spread the fire from the space under the raised floor into the test room; the cables burned out completely, and the cabinet that served to simulate a piece of DP equipment was roasted. We must therefore assume that - in the event of a fire - the equipment in the vicinity of the seat of the fire is bound to be damaged by the fire.

The tests showed that the fire protection of raised floors in data-processing installations requires at least the use of smoke detectors. Their number and position should be governed by the influence of the ventilation, and the display system must permit fast location of the source of the smoke. Damage resulting from corrosive fumes and intensive smoke must be expected after a relatively short time, and spreading of the fire to the equipment via the ventilation openings can be prevented only by an automatic fire extinguishing system. The tests have also shown that mechanical fastening of the metal lining on the underside of the floor panels will prevent the lining from becoming detached prematurely and the fire from spreading. The supporting platforms for the raised floor should be made of steel, because melting of the aluminum platforms causes the floor to collapse, which in turn can cause the fire to spread and constitutes a hazard to the firemen.
