## FIRES FOLLOWING THE GREAT HANSHIN EARTHQUAKE IN KOBE

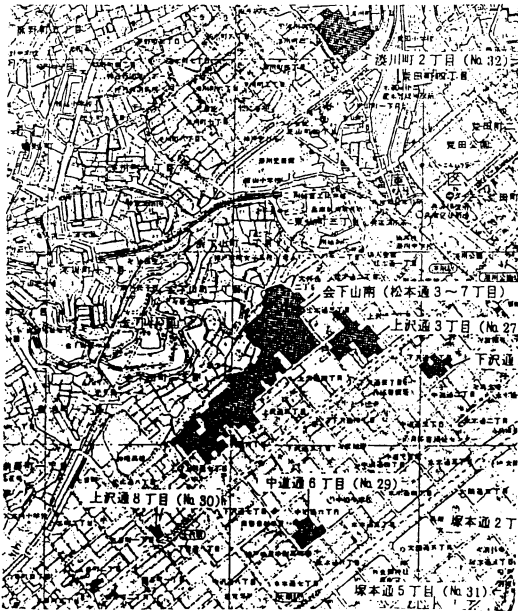
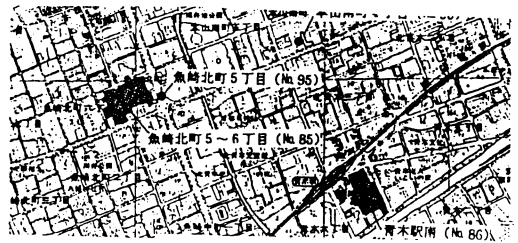
Figure 2. Large Conflagrations in Kobe City<sup>4)</sup>

Figure 2 shows large conflagrations which area is over 3,300 m<sup>2</sup> in Nagata, Suma, Hyogo, Nada and Higashi-Nada Ward.

Nagata and Suma Ward

Hyogo Ward

Nada Ward

Higashi-Nada Ward

Figure 3, 4, 5, 6, 7 and 8 show the buildings which were not burned or partially burned at fire-arresting lines of larger fire sites<sup>4)</sup>. Table 4 indicate the fire stop factors at the fire-arresting lines around the major large fire sites which area exceeds 33,000 square meters<sup>7), 8)</sup>.

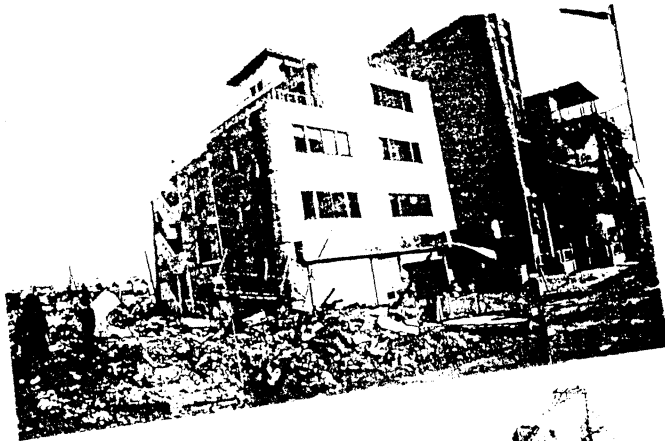
Figure 7. Buildings and rubble in the Fire Site around the Sugawara Market

① Survived buildings midst of the fire site.

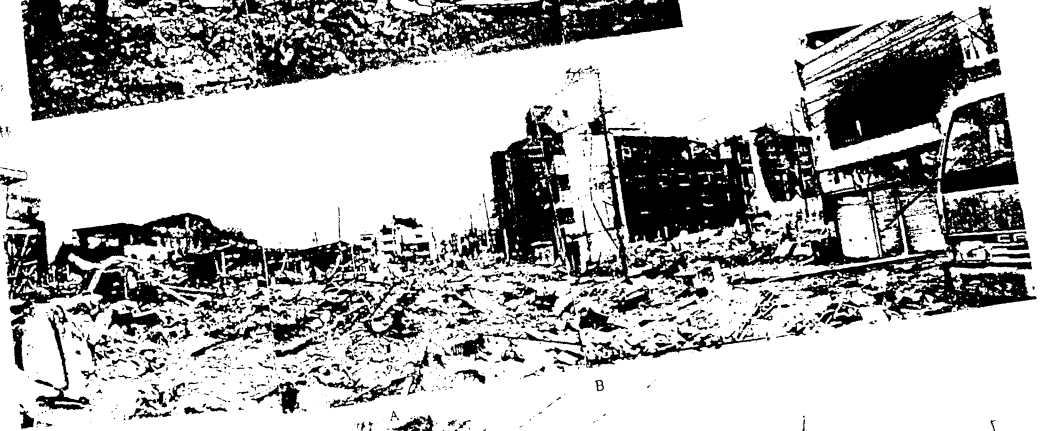
② Burned fire resistive buildings at the center were factories.

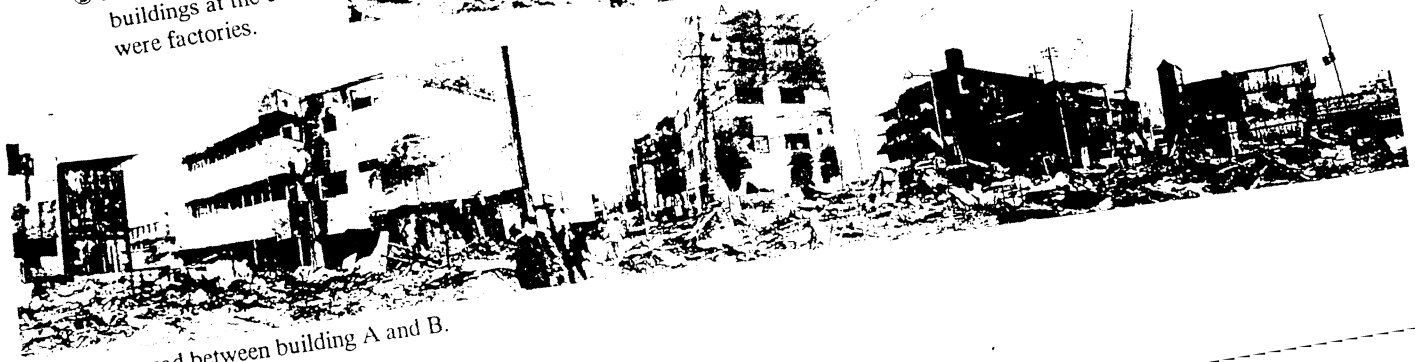
③ Fire spread between building A and B.

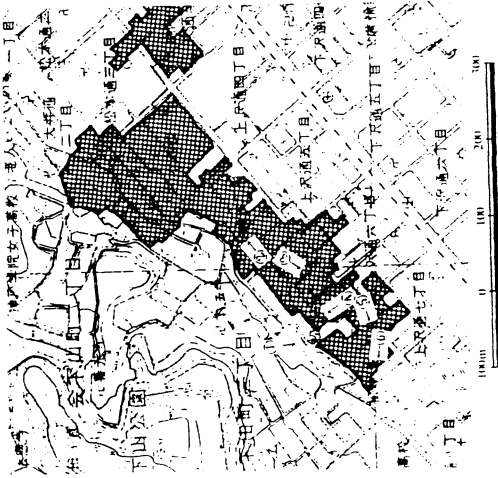
Figure 8. Buildings and rubble in the Fire Site of Eigeyama South

① Houses collapsed on the narrow street.

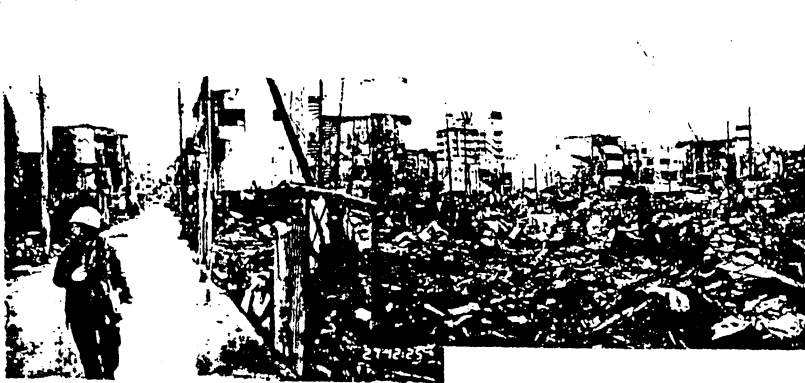
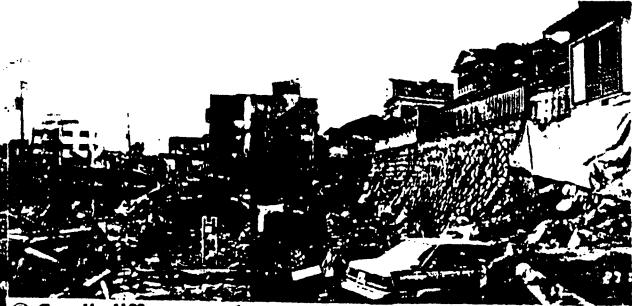
③ Small cliff was an element of fire-arresting line.

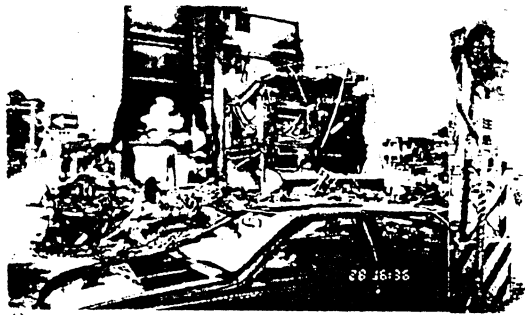
④⑤ Fire spread between fire resistive buildings.

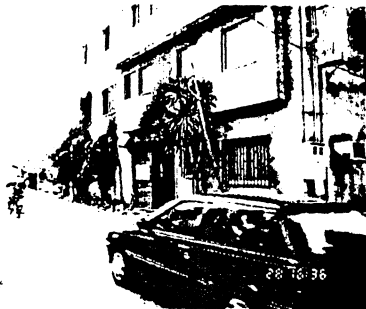
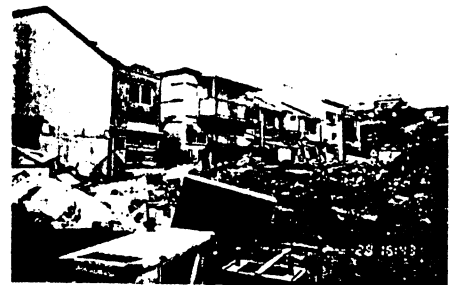
⑥ Change of wind direction contributed to make the fire-arresting line.
