# PERFORMANCE OF SOLID TIMBER EXTERNAL WALLS UNDER SIMULATED BUSHFIRE ATTACK

T. Wakefield and Y. He  
University of Western Sydney, Australia

Y. Liu and V. Dowling  
Commonwealth Scientific and Industrial Research Organization (CSIRO), Australia

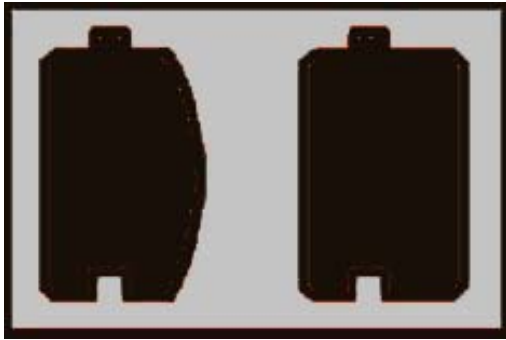
In North America there has been a surge in popularity of machined timber log homes referred to as “engineered log” homes over the past twenty-five years. These homes use various profiles of log. Presented in FIGURE 1 are two profiles which have a tongue-and-groove (T&G) configuration. These logs vary in thickness from 90 mm to 200 mm and are usually sealed in the tongue and groove with compressible PVC closed cell foam sealant tape. Timber species also vary from softwoods such as Western Red Cedar or Pine through to hardwoods such as Oak. This form of building has been

**FIGURE 1.** Engineered T&G log profiles

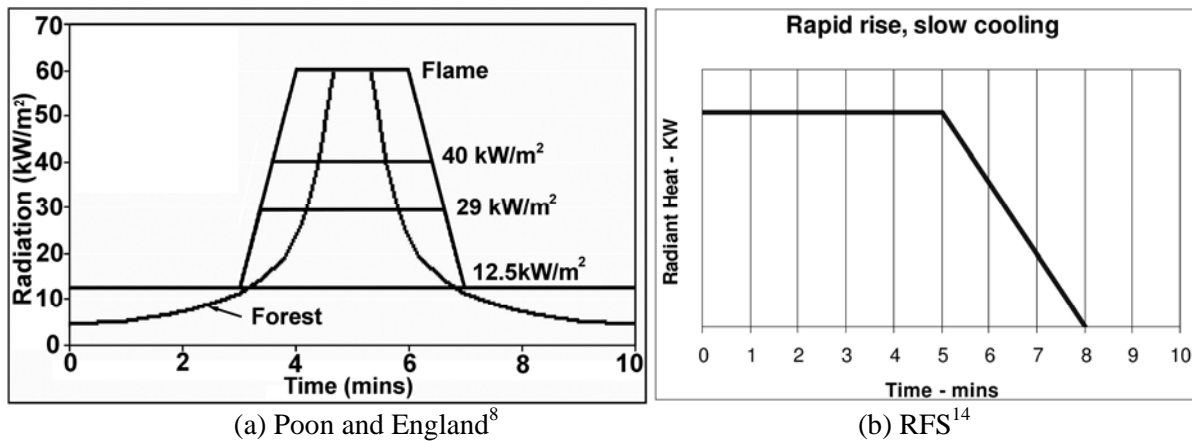
Independent Fire Test Laboratories have developed a test method for evaluating traditional and innovative construction in Bushfire Prone areas known as FSE 027 Part 1 Version 1.3<sup>17</sup>. The test provides an assessment of the performance of building elements when exposed to radiant heat, burning embers and burning debris as a means of simulating bushfire conditions. The imposed radiant heat flux profile simulates the transient peak from the fire front, a pilot ignition source is used to simulate ember attack, and timber cribs are imposed to simulate burning debris. There are three radiant heat profiles nominated for the test, a generic profile and two NSW Rural Fire Service profiles. The generic profile shown in FIGURE 2 is based on research work by Poon and England<sup>8</sup>. The NSW Rural Fire Service (RFS) profiles<sup>8</sup> are (i) slow rise and rapid cooling to a selected peak radiant heat flux and (ii) rapid rise and slow cooling to a selected peak radiant heat flux [see FIGURE 2(b)].

**FIGURE 2.** Radiation profiles for bushfire tests

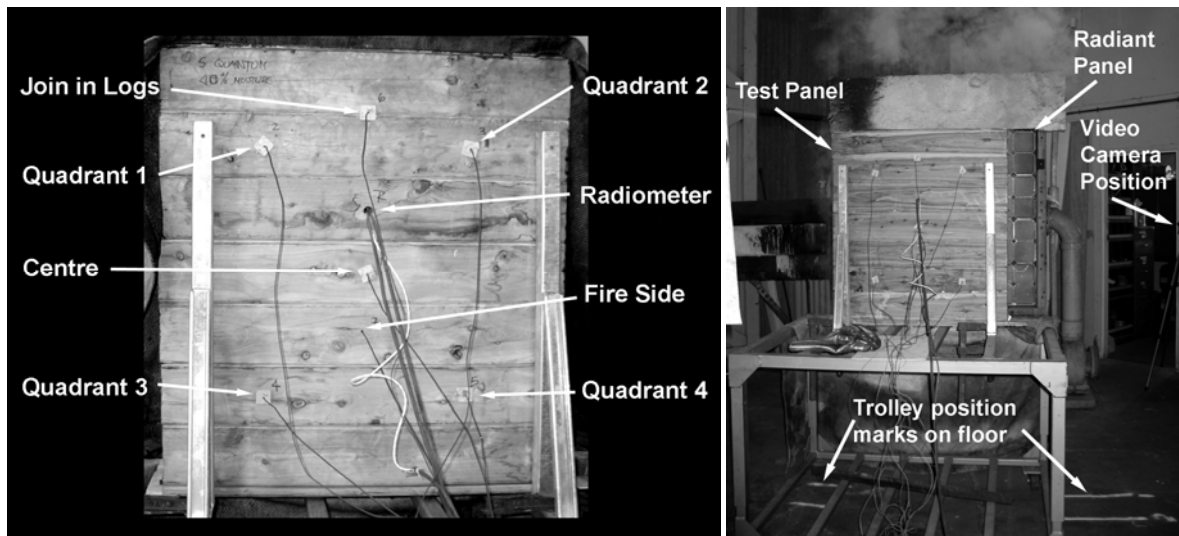
Samples were mounted on a moveable trolley using two steel brackets on the inside face to stabilise the panels. The trolley on wheels enabled heat flux to be regulated as specified. Mineral fibre blankets were used to shield the samples from radiant heat until the commencement of the tests. The experimental setup is shown in FIGURE 3.

Type K thermocouples were mounted in seven positions including the centre surface, each quadrant, on a join in the logs and fire-exposed face as shown in FIGURE 3. The fire exposed thermocouple was mounted by drilling through the third log along the centreline and packing with mineral wool insulation. A total heat flux meter was used to measure the heating profile. This meter was installed along the centre line of Log 5 by drilling a hole to allow the face of the meter to be flush with the outside wall. The hole was packed with mineral wool to protect the edges formed. Data logging with a Datalogger DT800 was used to record both the heating profile and the temperature profile of the wall section.

**FIGURE 3.** Experiment setup and instrumentation

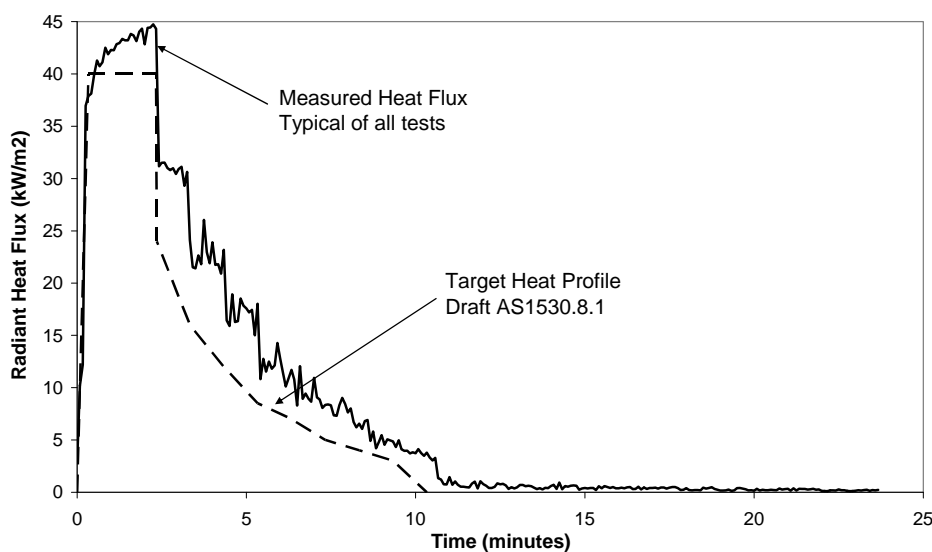
The standard radiant heat profile prescribed in Draft AS 1530.8.1 (shown as the dash line in FIGURE 4) with a peak flux of  $40 \text{ kW/m}^2$  was utilised. The radiant heat exposure by the sample panels was regulated by physically moving the trolley with sample mounted towards and away from the radiant heat panel. The radiant heat fluxes at various distances to the radiation panel were calibrated in a calibration test using the radiometer mounted at the central location of the panel and lines were marked on the floor indicating the required trolley position to achieve the correct radiant heat flux. During the experiment, the specimen was positioned at various distances for short periods so that an approximation of the standard radiant heat flux profile could be achieved as shown by the solid line in FIGURE 4. It is noted that the measured heat flux included the convective heat transfer component. Extracting the latter, the remaining radiant heat flux component would be even closer to the prescribed standard profile.

**FIGURE 4.** Radiant heat flux profiles

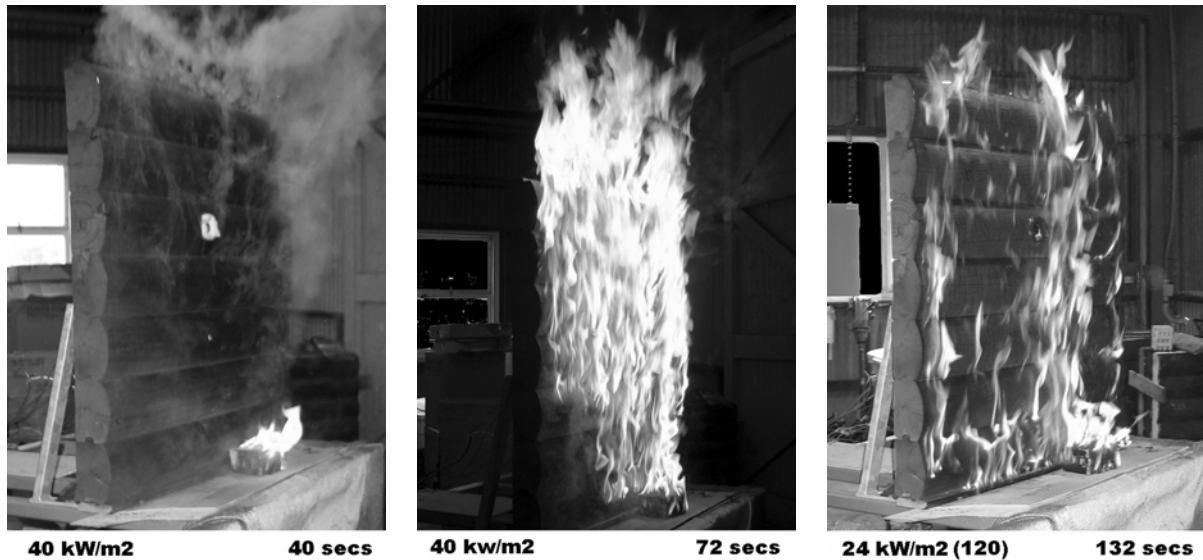
A series of photographs of the Sample #4 test provides a typical time line for significant events and can be found in FIGURE 5. As expected, the panel began to pyrolyse almost immediately once radiant heat was imposed. The pyrolysis or the charring pattern was somewhat uneven due to the

uneven radiant heating and the induced natural convective heat transfer. It was noted that quadrant 1 was subjected to slightly higher radiant heat than quadrant 2. The bottom section of the panel appeared to be affected by the presence of the crib fire. There was a V-shaped semi plume centred at the crib (40 sec shot). The hot air plume assisted the char formation at the surface of the panel. It was also noted that the presence of the decking board under the panel created an additional “crib” effect to the panel.

**FIGURE 5.** Pre-heating, ignition and flaming processes with Feast Watson Panel (Sample #4)

Flaming on the Sample #4 panel was significantly reduced when the imposed radiant heat flux was reduced from 40 kW/m<sup>2</sup> maximum to 24 kW/m<sup>2</sup>. Within seconds of radiant heat reduction, there was a dramatic reduction in flaming. The flaming of the logs ceased soon after the imposed radiant heat flux was reduced to 16 kW/m<sup>2</sup>. The sole source of flaming for the remainder of the test was the crib, and a small amount of flaming from the decking board under the panel. After 20 minutes from the beginning of the test there was no flaming on the fire side of the sample (including the crib which stopped flaming after 13 minutes). Heat flux from the log panel was low and it was possible to walk up to and remain within 250 mm of the panel comfortably 20 minutes after beginning the test.

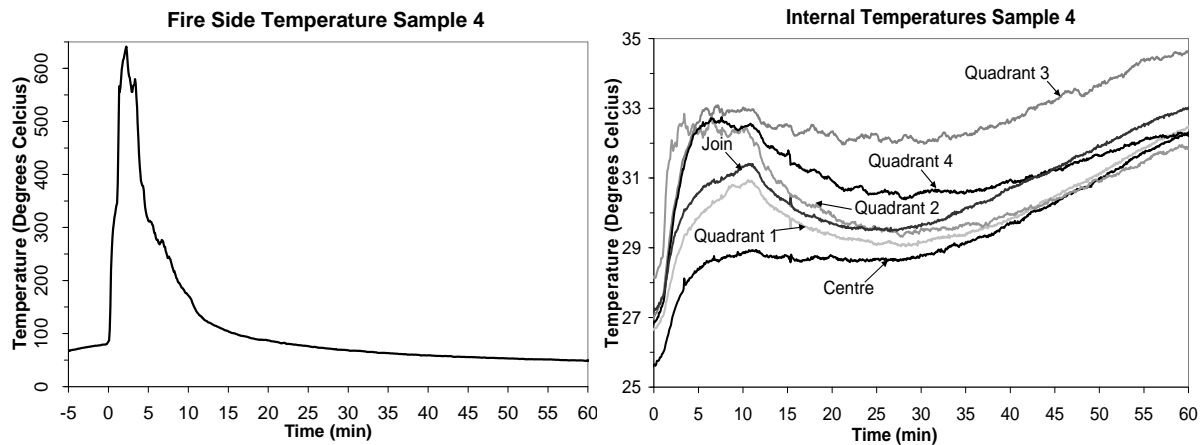
The results of temperature monitoring for Sample #4 test showed that external temperature peaked at 641°C and was maintained above 150 °C for 10 minutes during imposed radiant heating (see FIGURE 6). The corresponding temperature increase on the inside of the panel (which is influenced by an increase in ambient temperature as the sample was manoeuvred close to the radiant panel) was approximately 4 °C. The lag time for heat transfer through the panel can be seen after the imposed radiant heat is reduced (at 10 minutes) where ambient temperature drops, and surface temperatures increase by an average of 3 °C over the ensuing 50 minutes. An overall increase of approximately 10 °C from the start of the test was measured. The temperature results of this test were typical of all other tests.

The external temperature of the panel responds to the flaming of the panel, and is also influenced by the burning crib located near the thermocouple. The external temperature also reflects the sudden reduction in flaming when the radiant heat was reduced to 24 kW/m<sup>2</sup> dropping from 580 °C to 378 °C in one minute, and dropping a further 80 °C in one minute following a reduction to 16 kw/m<sup>2</sup>.

**FIGURE 6.** Fire side and non-fire side temperature profiles of Sample #4 test

Temperature measurements during the current experimental work show the very high thermal resistance of solid timber. Faced with external temperatures in excess of 600 °C and sustained temperatures above 150 °C for more than 10 minutes, internal temperatures increased by only 10 °C. This temperature increase was partly attributable to an increase in ambient temperature during testing. This makes a log wall a very efficient radiant heat shield.

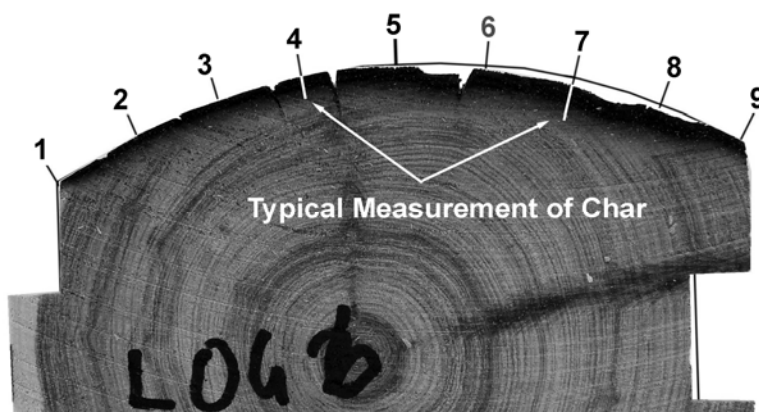
Analysis of char depths provides excellent insight into the performance of solid log walls and a typical char result adjacent to the crib is shown in FIGURE 7. Four panels were sectioned and analysed carefully. Results of char analysis are summarised in TABLE 3. As supported by visual monitoring, char depth analysis confirms that coating influences the fire performance of the log panels. The No Coat Panel (Sample #10) performs best among the four samples, and the Raincoat Panel (Sample #7) performs significantly worse. Nonetheless, even the worst performance has extremely low char depth. All the coatings are penetrating coatings and contain oils and pigment to protect the timber from weathering. The Raincoat product contains an oil-and-wax mixture and seemed to create stronger flaming which is supported by deeper char penetration. The Quantum Panel (Sample #5) was subjected to slightly higher and longer radiant heat flux (using radiometer to regulate heat flux without benefit of floor markings used later) and the results are conservative for this panel.

**FIGURE 7.** Typical char results

The current study also demonstrated the performance of T&G log walls in maintaining stability and integrity of the building envelop and preventing ember entry. Char depths were exceptionally low in the experimental testing, being less than 4% of the original wall thickness. Such a low degree damage can be simply repaired with surface treatment and using environmentally renewable resources. The significance of easily restored damage to the structural component of a house cannot be underestimated with considerations for insurance as well as environmental issues. Buildings damaged in a fire are normally completely (including footings) removed to landfill, and rebuilt from foundations upwards using energy intensive materials.
