DEPARTMENT OF SCIENTIFIC AND INDUSTRIAL RESEARCH AND FIRE OFFICES' COMMITTEE
JOINT FIRE RESEARCH ORGANIZATION

THE SPREAD OF FIRE IN U.S.A. TYPE TEMPORARY BUNGALOWS

October, 1954.

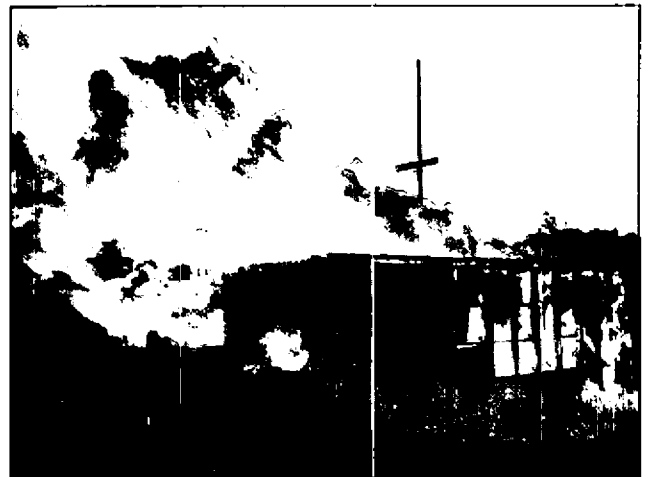
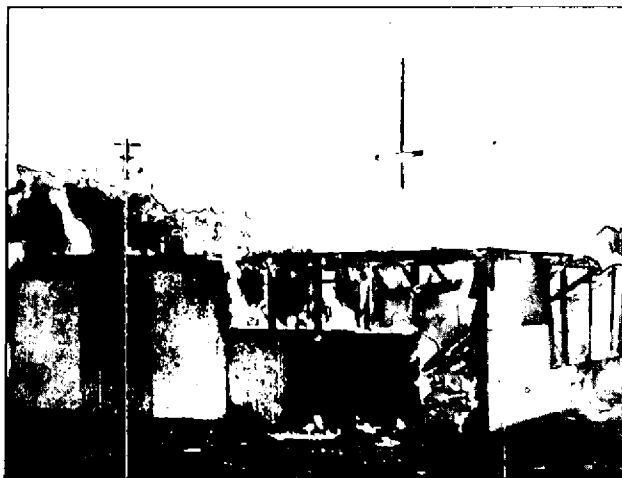
PLATE. I. FIRE IN EXPERIMENTAL BUNGALOW

Before fire

After 7 min

After 8 min

After 10 $\frac{1}{2}$ min

After 15 $\frac{3}{4}$ min

After 21 min

The stuffing in the armchair was set alight as well as some wood shavings and fibre insulating board between the armchair and the wall. The progress of the fire as noted by the observers is shown below, and photographs of the fire are shown in Plate 1.

TIME		PROGRESS OF FIRE
Mins.	secs.	
00	00	Ignition.
00	35	Fire alarm No. 1 (Living-room) operated.
01	15	Fire alarm No. 2 (Kitchen) operated.
01	20	Fire alarm No. 6 (Lobby) operated.
01	45	Flames spreading up living-room wall and reaching ceiling.
02	10	Fire alarm No. 4 (Bedroom No. 1) operated.
02	12	Fire alarm No. 3 (Bathroom) operated.
02	15	Flashover - living-room full of flame.
02	30	Most of glass in living-room windows cracked - two panes fallen out.
02	30	Bedroom No. 1 full of black smoke, not possible to see anything in the room. (This may have happened earlier but first visual observations were made at bedroom window at this time).
04	00	Kitchen windows cracking and large quantity of black smoke coming out
05	00	Flaming still confined to living-room but all other rooms filled with black smoke.
06	00	Windows of bedroom No. 1 cracking.
07	30	Roof above living-room burned through, big increase in flaming, flames about 20 ft. high from this part of bungalow.

<p>After this stage of the fire it was not possible to get nearer than about 40 ft. to the bungalow, and it was difficult to make any detailed observations.</p>		
09	08	Fire alarm No. 5 (Bedroom No. 2) operated.
11	00	Windows of bedroom No. 2 cracking and falling out.
12	00	Bedroom No. 2 burning.
20	00	Nothing but smouldering frame of building left.
