F.R. Note No. 150/1955

DEPARTMENT OF SCIENTIFIC AND INDUSTRIAL RESEARCH AND FIRE OFFICES' COMMITTEE
JOINT FIRE RESEARCH ORGANIZATION

EXPERIMENTAL FIRES IN 'BACK-TO-BACK' HOUSES IN BIRMINGHAM

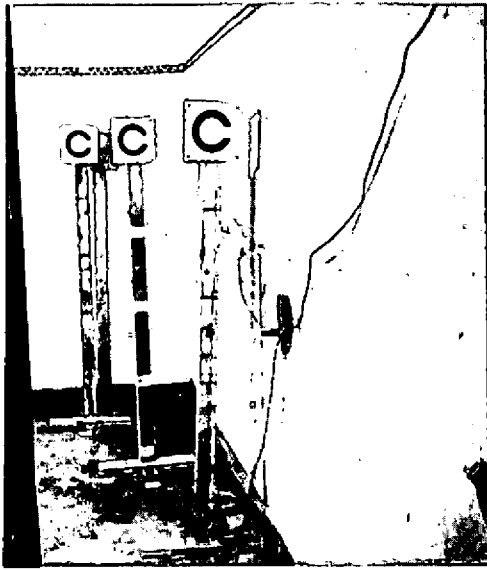
Before fire

10 min. After ignition

15 min.

20 min.

24 min. 15 s

24 min 50 s

The decrease in visibility in the attic was recorded by photographing illuminated cards printed with a black letter C of 5½ in. and 3½ in. external and internal diameter respectively on a white background, these were mounted at eye level at distances of 15, 12 and 9 feet from a camera sighted through an observation port in the party wall between the houses. Photographs were taken at 5 second intervals throughout the tests (Plates 2 and 3).

The decrease in visibility in the attic in the two tests can be seen from Plates 2 and 3. In test No. 1 the visibility did not become bad until after 24 minutes, that is 18 minutes after the first alarm operated. In test No. 2 with the stairs door open the visibility due to the collecting smoke was seriously reduced in 4 or 5 minutes, some 10 minutes before the first alarm. Visibility in the first floor bedroom deteriorated rapidly after 25 minutes (10 minutes after first alarm) in the first test and after about 6 minutes (8 minutes before alarm) in test No. 2.
