Internal Note No. 52  
CIB/CTF/60/27-(UK)

FIRST PROGRAMME OF TESTS ON EFFECT OF RESTRAINT ON FIRE RESISTANCE  
OF FLOORS

## EXTERNAL WALLS OF BUILDINGS - PART I

### THE PROTECTION OF OPENINGS AGAINST SPREAD OF FIRE FROM STOREY TO STOREY

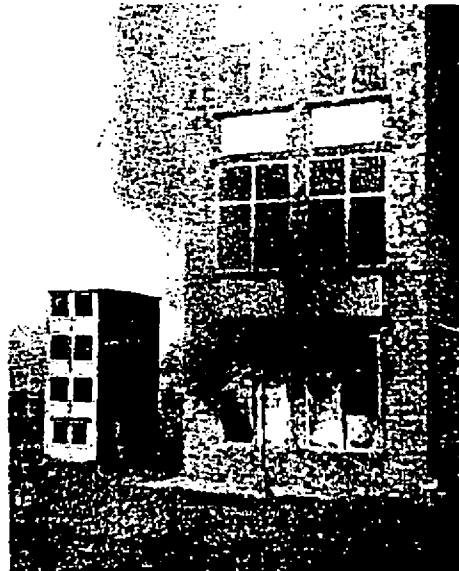
b. Emission of flames from  
ground floor room (12 min.)

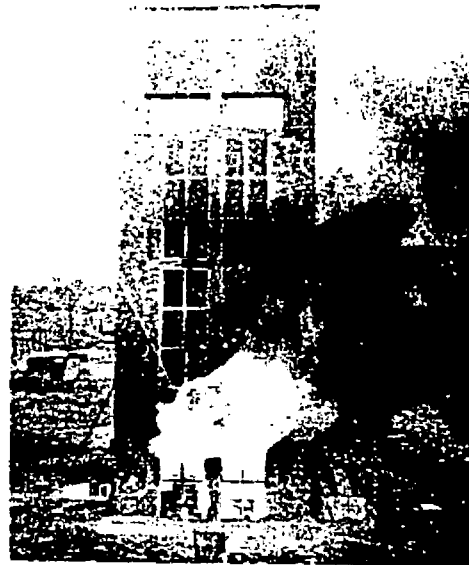
b. Effect of side wind on flames (5 min.)

TEST N<sup>o</sup>. 4. ROOM HEIGHT GLAZED WINDOWS

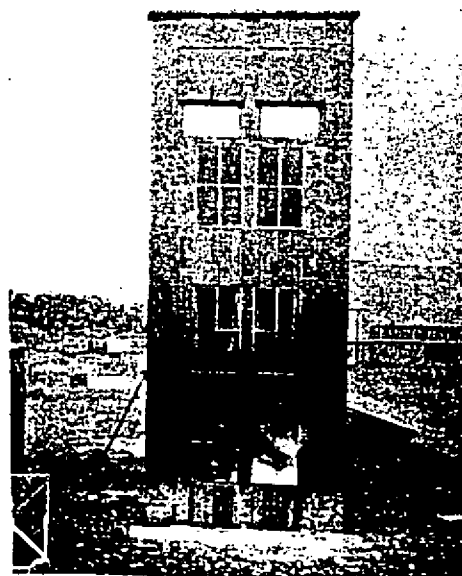
d. Fire penetrated ground floor panels (17 min.)

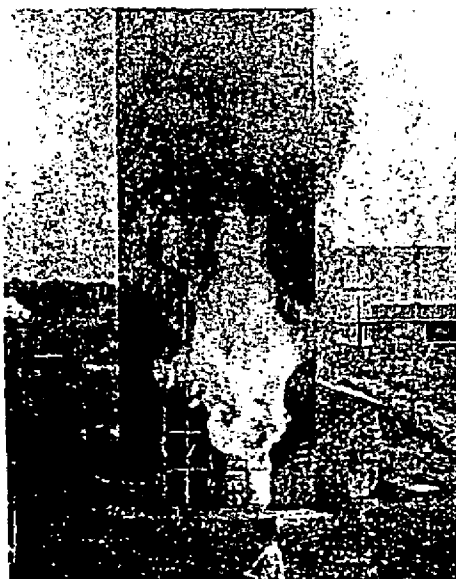
b. Flames reach the 2nd floor level (4 min.)

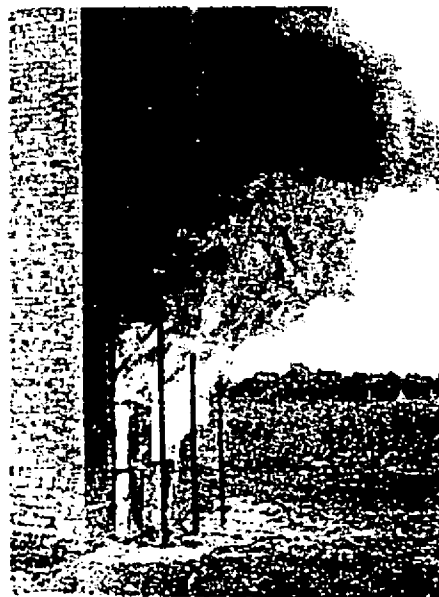
c. Side view showing curling  
of flames over balcony

Flames issued from the windows of the fire chamber at 6 min. The flames were observed to be deflected outwards by the balcony and once clear of it to curve inwards towards the first floor windows. By  $7\frac{1}{2}$  min. some of the glazing on this floor had broken and the window frames and the curtains were ignited. Three of the curtains were burnt out by 11 min. and nearly three quarters of the glazing fallen down. By 15 min. the flaming diminished and the fire was burning inside the fire chamber only. The fire was almost out by 20 min.

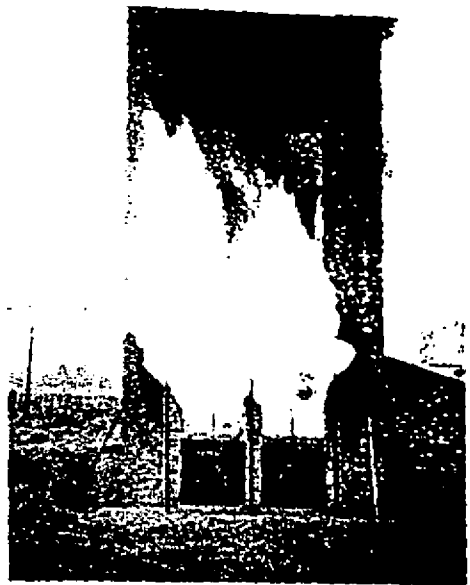
b. Flames covering first floor facade over the balcony (10 min.)

Flames issued from the ground floor windows after 8 min. There was vigorous flaming in front of the first floor window with the flames curling back over the balcony breaking the glazing and igniting the curtains. By 14 min. almost all the glazing on this floor had fallen down and the window frames were charred for their full height. The flame intensity started to decrease by 18 min. and the fire was burning inside the fire chamber with only slight flame emission.

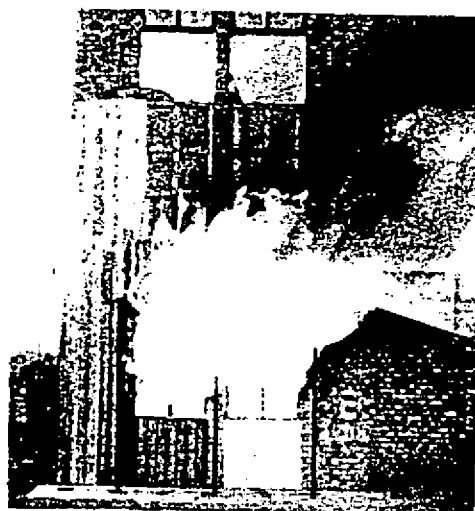
c. Impinging flames ignite cedar boarding (18 min.)

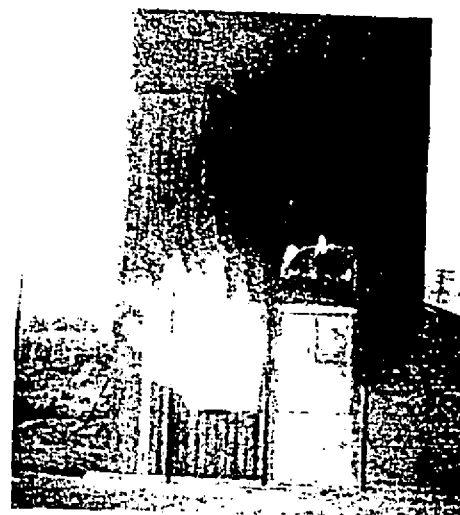
d. Aluminium facing on first floor melts (24 min.)

Certain non-combustible materials suffered the same kind of damage when attacked by external fire as is shown when they are exposed to internal fire; asbestos/cement sheets shattered and aluminium melted. The presence in these panels of an internal lining prevented the penetration of flames to the room through the panels.

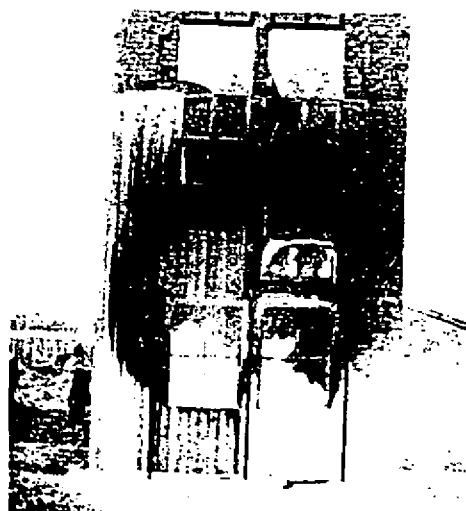
e. Penetration of fire on ground floor through aluminium face panel (29½ min.)

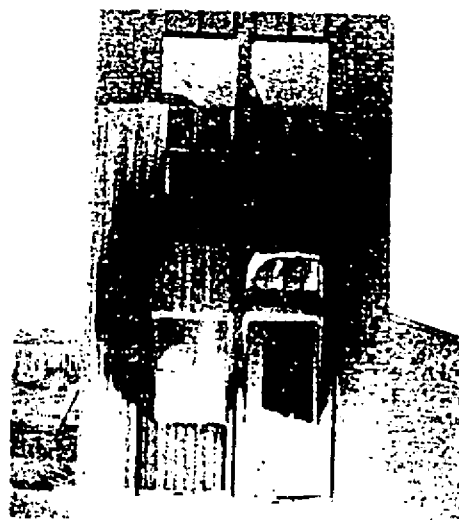
f. Penetration of fire on ground floor through timber clad panel
