F.R. Note No. 44

The Fire-Resistance of No-Fines Concrete Walls

*By L. A. Ashton, B.Sc.(Eng.)
and R. H. Bigmore, B.Sc.(Eng.)*

Reprinted from
CIVIL ENGINEERING AND PUBLIC WORKS REVIEW
8 Buckingham Street, Strand, London, W.C.2
June, July and August, 1954

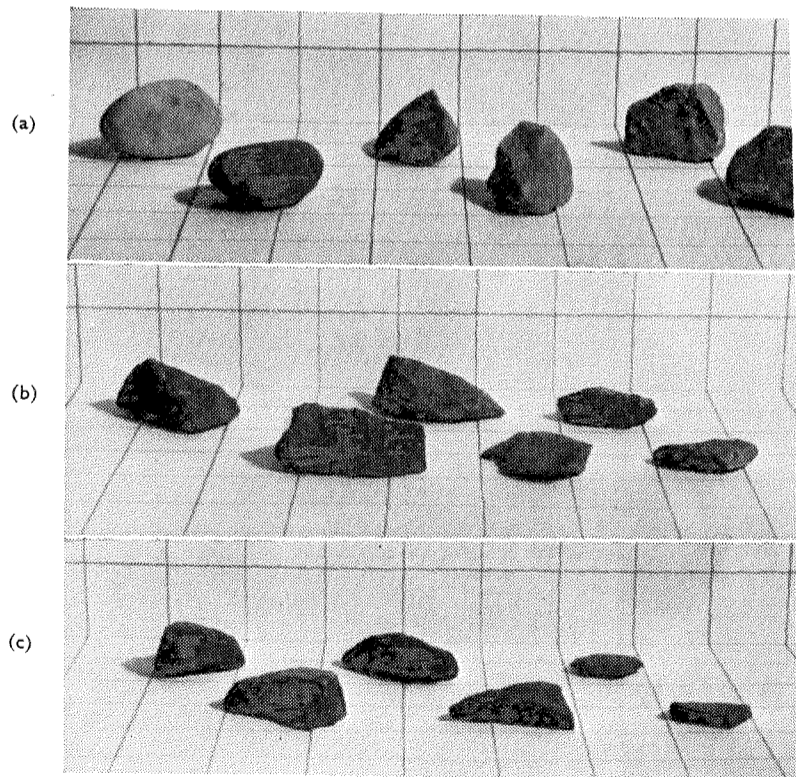
Fig. 1. Typical samples of aggregates shown on a $\frac{3}{4}$ in grid. The samples are: (a) crushed quartzite gravel; (b) crushed basalt, batch No. 1; (c) crushed basalt, batch No. 2.

After many enquiries, quarries were found which were able to supply aggregates approaching the requirements of the specification. The quartzite had an excellent shape, and the basalt, although it was considered suitable for the purpose. Two separate deliveries of each rock were obtained which, although from the same quarry and to the same nominal specification, varied slightly as shown by the analyses in Table I. Photographs of typical samples of aggregates are shown in Fig. 1.

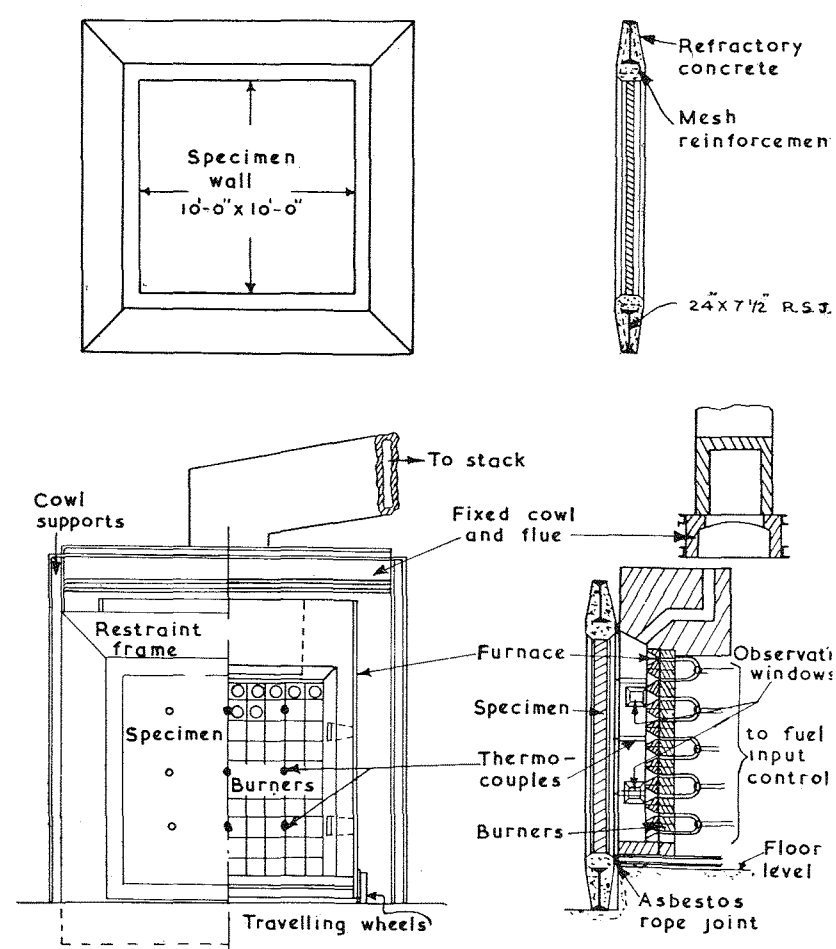
Fig. 2. Furnace testing equipment, showing details of end restraint (above), a half sectional elevation (lower left), and a part sectional side elevation of the furnace closed with the non-loadbearing wall in position ready for test.

The concrete was sampled at frequent intervals for making 6in cubes, 6in dia × 12in cylinders (having the tops capped with neat cement mortar) and 4in × 4in × 16in beams. These were tested in the standard manner after maturing under the same conditions as the corresponding walls; results are given in Table I. The walls were constructed in the 10ft square opening of the heavily reinforced refractory concrete frame shown in Fig. 2, which gave a high degree of restraint at the edges.

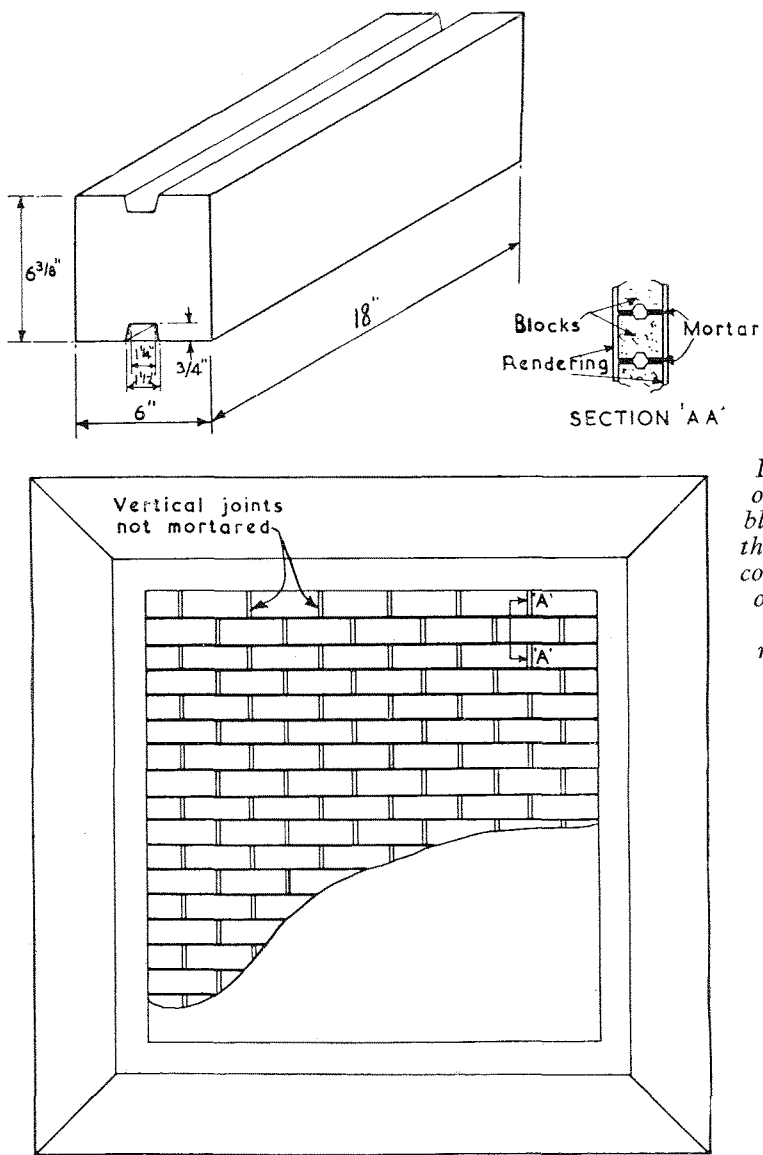
Fig. 3.
Detail of one of the blocks, and the form of construction of a wall, partly rendered.

The blocks, which had the shape and dimensions shown in Fig. 3, were cast in multiple moulds and were covered with wet sacks until demoulding after three days. In laying the blocks a 1:1:6 cement:lime:sand mortar was used in the horizontal joints only and the mortar bed was interrupted by the recess in the block. No mortar was placed in the vertical joints formed by the gaps between the ends of the blocks. This method of construction is designed to prevent moisture penetration by capillary action. One half-block was included in each course to break the vertical joints.

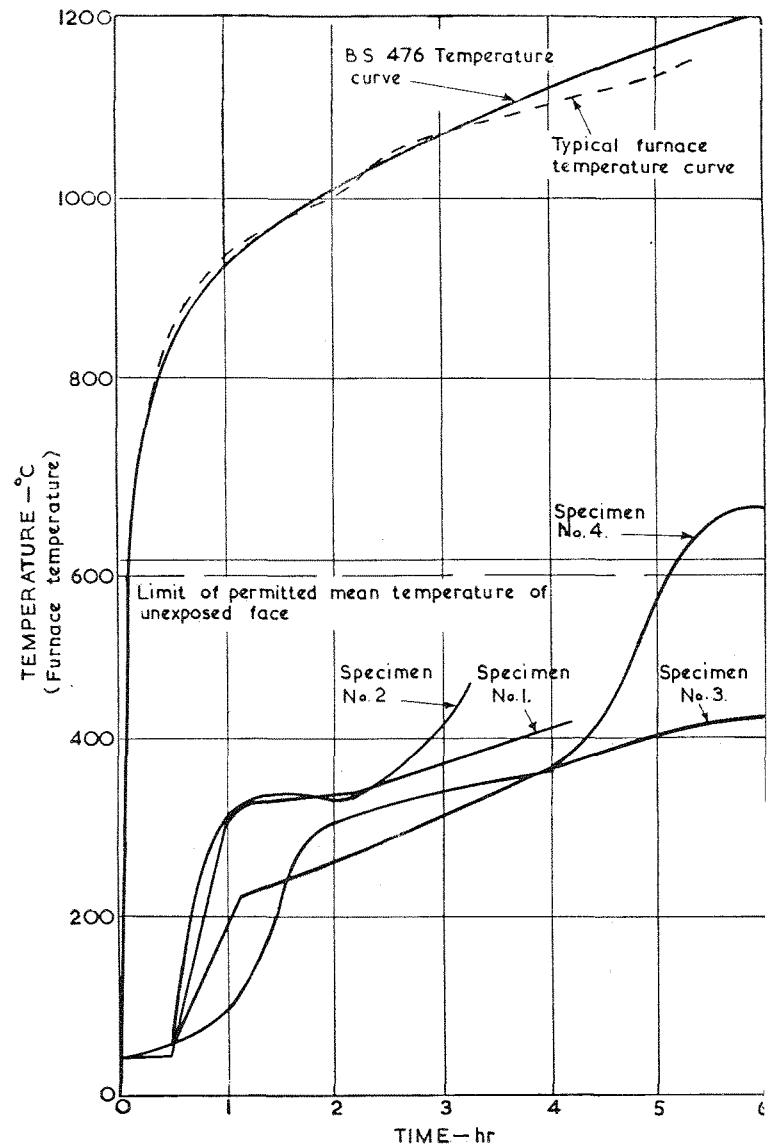
Fig. 5. Temperature curves.

A typical curve of mean furnace temperature is shown in Fig. 5 in comparison with the Standard time-temperature curve of British Standard 476. Curves of mean unexposed face temperature for the individual specimens have been plotted in the same figure. A summary of the results appears in Table II.

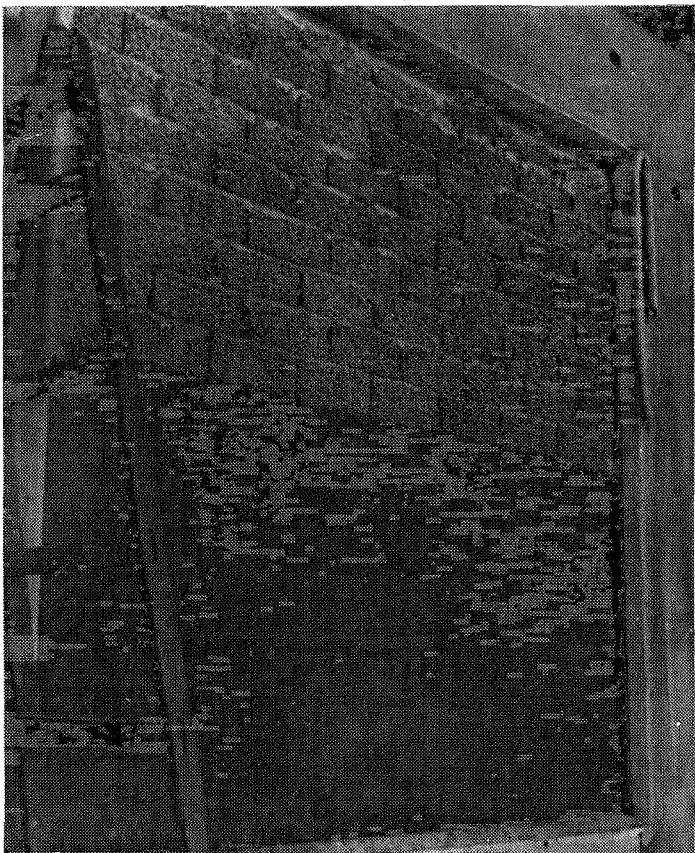
Fig. 4.
Partly rendered block wall.

A ½in thick rendering of 1:1:6 cement:lime:sand was applied to each face of both monolithic and block walls by a skilled tradesman. The rendering was in two coats, the first being a blinding coat. Fig. 4 shows the rendering in progress on a block wall.

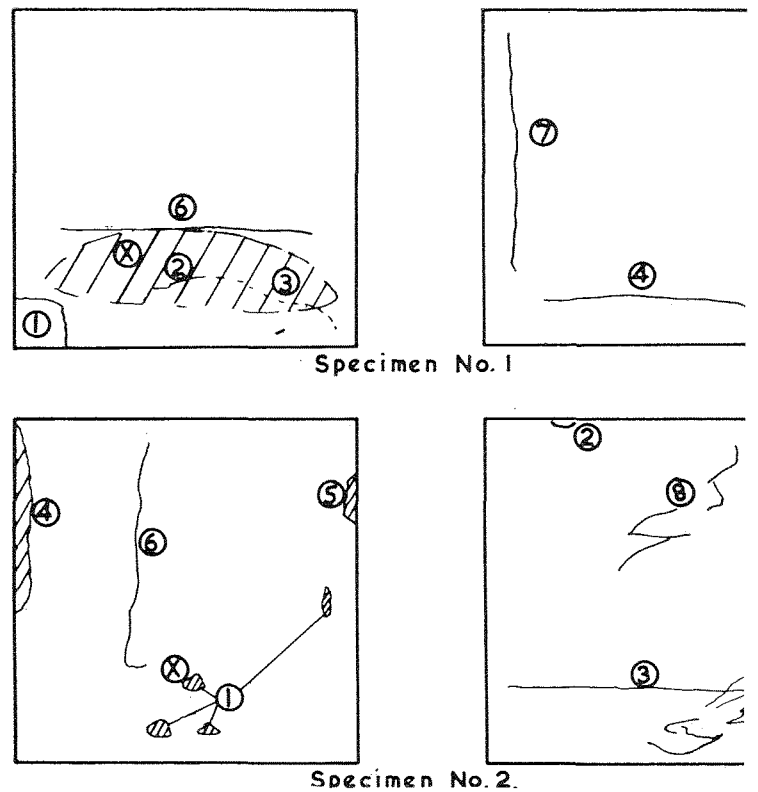
Above: Fig. 6. Observations during test; crushed quartzite specimens. Left: exposed faces. Right: unexposed faces.

Fig. 7 shows the appearance of the wall before and after test. The maximum recorded deflection was $\frac{7}{16}$ in towards the furnace. *Observations during test.* The first crack in the rendering was observed after 1 hr on the exposed face (1 in Fig. 6). On the unexposed face the first crack (4 in Fig. 6) was noticed at 2 hr. Further cracking occurred until 3 hr 5 min when cracks 6 and 7

appeared. At 3 hr 44 min the rendering bulged in the region cracks 4, 2 and 6 and break-up of the concrete in the lower part of the wall commenced with considerable noise. The rendering and concrete to a depth of 2 to 3 in fell away from the area X the exposed face 6 min later. At 4 hr 8 min rendering fell from the unexposed face on an area corresponding to X and at 4 hr 14 min a crack formed in the wall through which flame could pass. Heating was then terminated. The impact test was reapplied with little apparent effect followed by the 4 min water test, which removed all the rendering and some of the concrete from the exposed face.

Observations during test. Cracks appeared early on the exposed face and the finish coat rendering fell from small areas (1 in Fig. 6). By 1 hr the finish coat rendering had fallen from a large area in the vicinity of patches 1 and from vertical edges. The undercoat rendering had bulged and split at X. During the next 30 min crack 3 appeared on the unexposed face and opened to about $\frac{1}{16}$ in. On the exposed face a general break-up of the rendering began along the horizontal line through X. At 1 hr 50 min pieces of block fell from area X and during the next hour the damage to blocks extended in depth and area. The rendering fell from an area of the unexposed face (7 in Fig. 6) at 2 hr 59 min, followed 16 min later by further falls of rendering with some concrete. A passage for flame through the wall was then formed by a vertical construction joint (Fig. 8b) and the test finished. Fig. 8a shows the unexposed face during the test at 3 hr and the exposed face after the test. The maximum recorded deflection was away from the furnace.

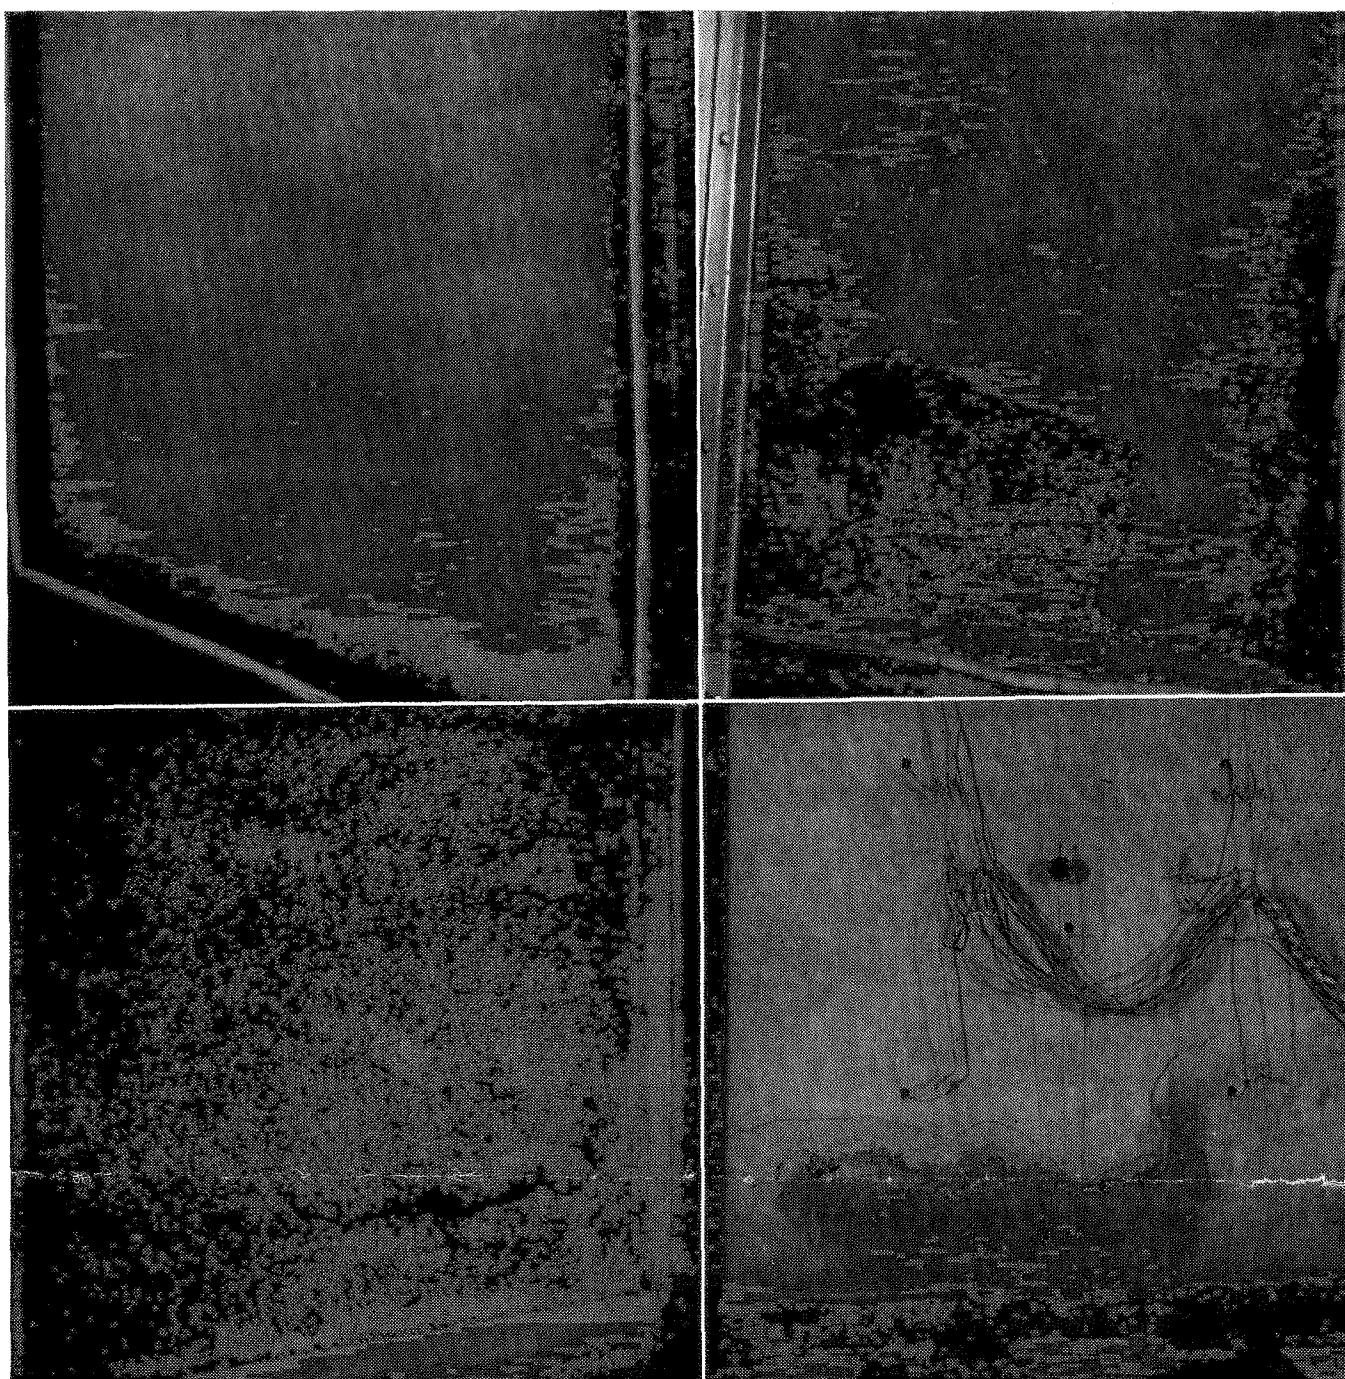
Fig. 7. Specimen No. 1.

(Upper left) Exposed face before test.

(Upper right) Exposed face immediately after end of heating.

(Lower left) Exposed face after water test.

(Lower right) Unexposed face after water test.

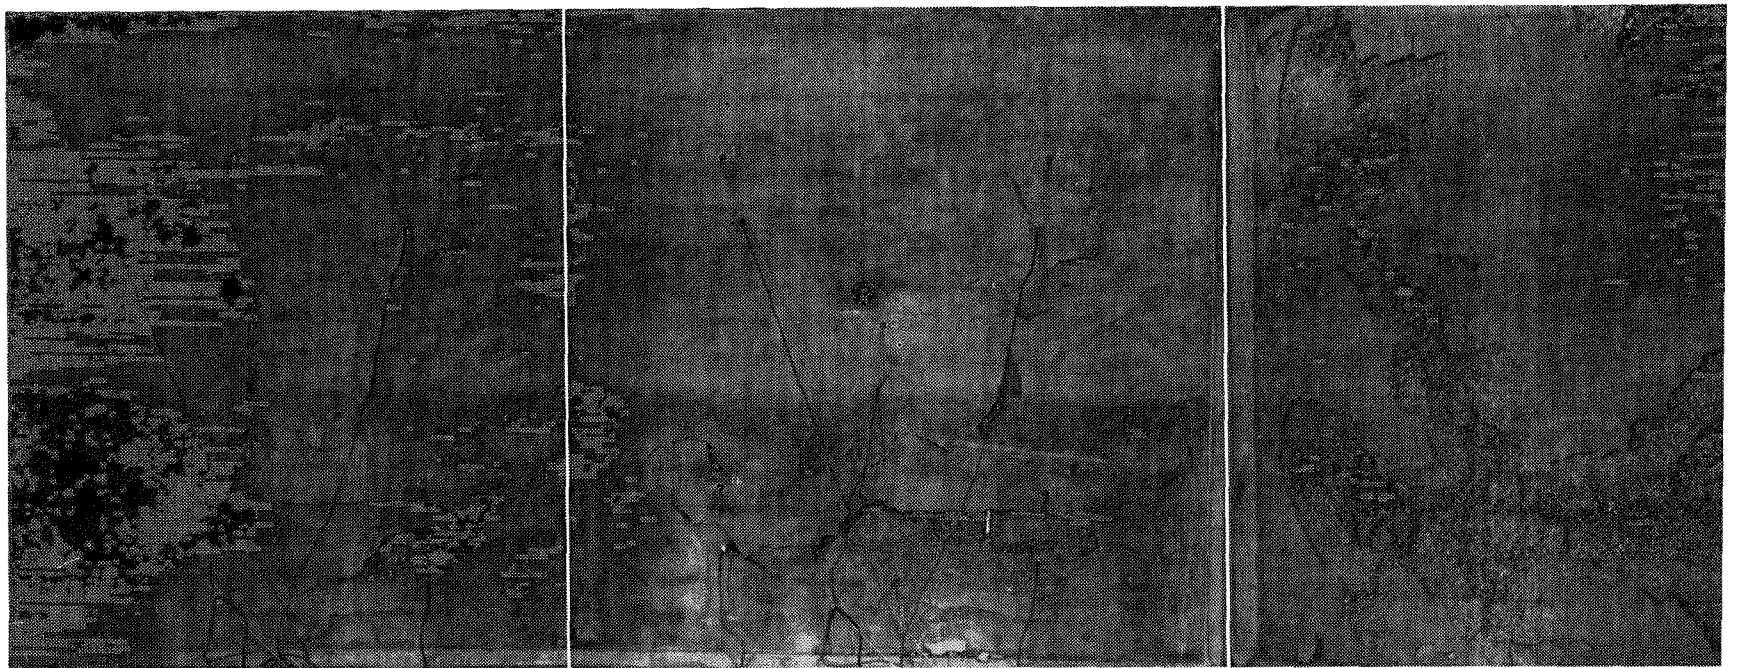
Fig. 8. Specimen No. 2. (Left) Unexposed face after 3 hr. heating. (Centre) Unexposed face after end of heating. (Right) Exposed face of heating.

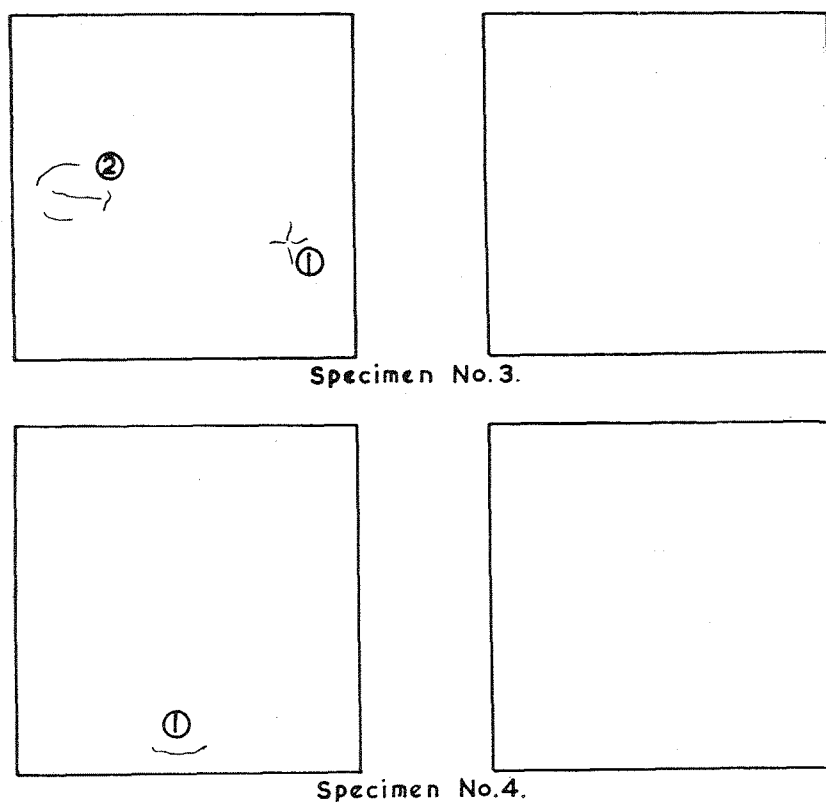
Fig. 9. Observations during test; crushed basalt aggregate specimens.
Left: exposed faces. Right: unexposed faces.

Monolithic wall in crushed basalt aggregate. Age at test—112 days. *Observations during test.* During the first 30 min cracks developed on the exposed face with some bulging in region of position 2 in Fig. 9 (above left), and a fall of the finish coat 3 min later. Except for a small fall of finish coat from area 1 on the exposed face no noticeable deterioration was observed in the condition of the wall when heating finished at 6 hr 3 min. The impact test was re-applied with little effect. Application of the water jet for 6 min removed all the rendering and some of the concrete from the exposed face. Fig. 10 shows the appearance of both faces at the end of heating and after the water test. The maximum deflection recorded was $\frac{7}{32}$ in away from the furnace.

Block wall in crushed basalt aggregate. Age at rendering (newest blocks)—41 days. Age at test (newest blocks)—79 days. *Observations during test.* During the first hour of test the only damage observed was crack 1 (Fig. 9 below left) on the exposed face with a slight bulging of the rendering. No further deterioration was visible when failure occurred by local temperature rise on the unexposed face after 5 hr 2 min. Heating was terminated at

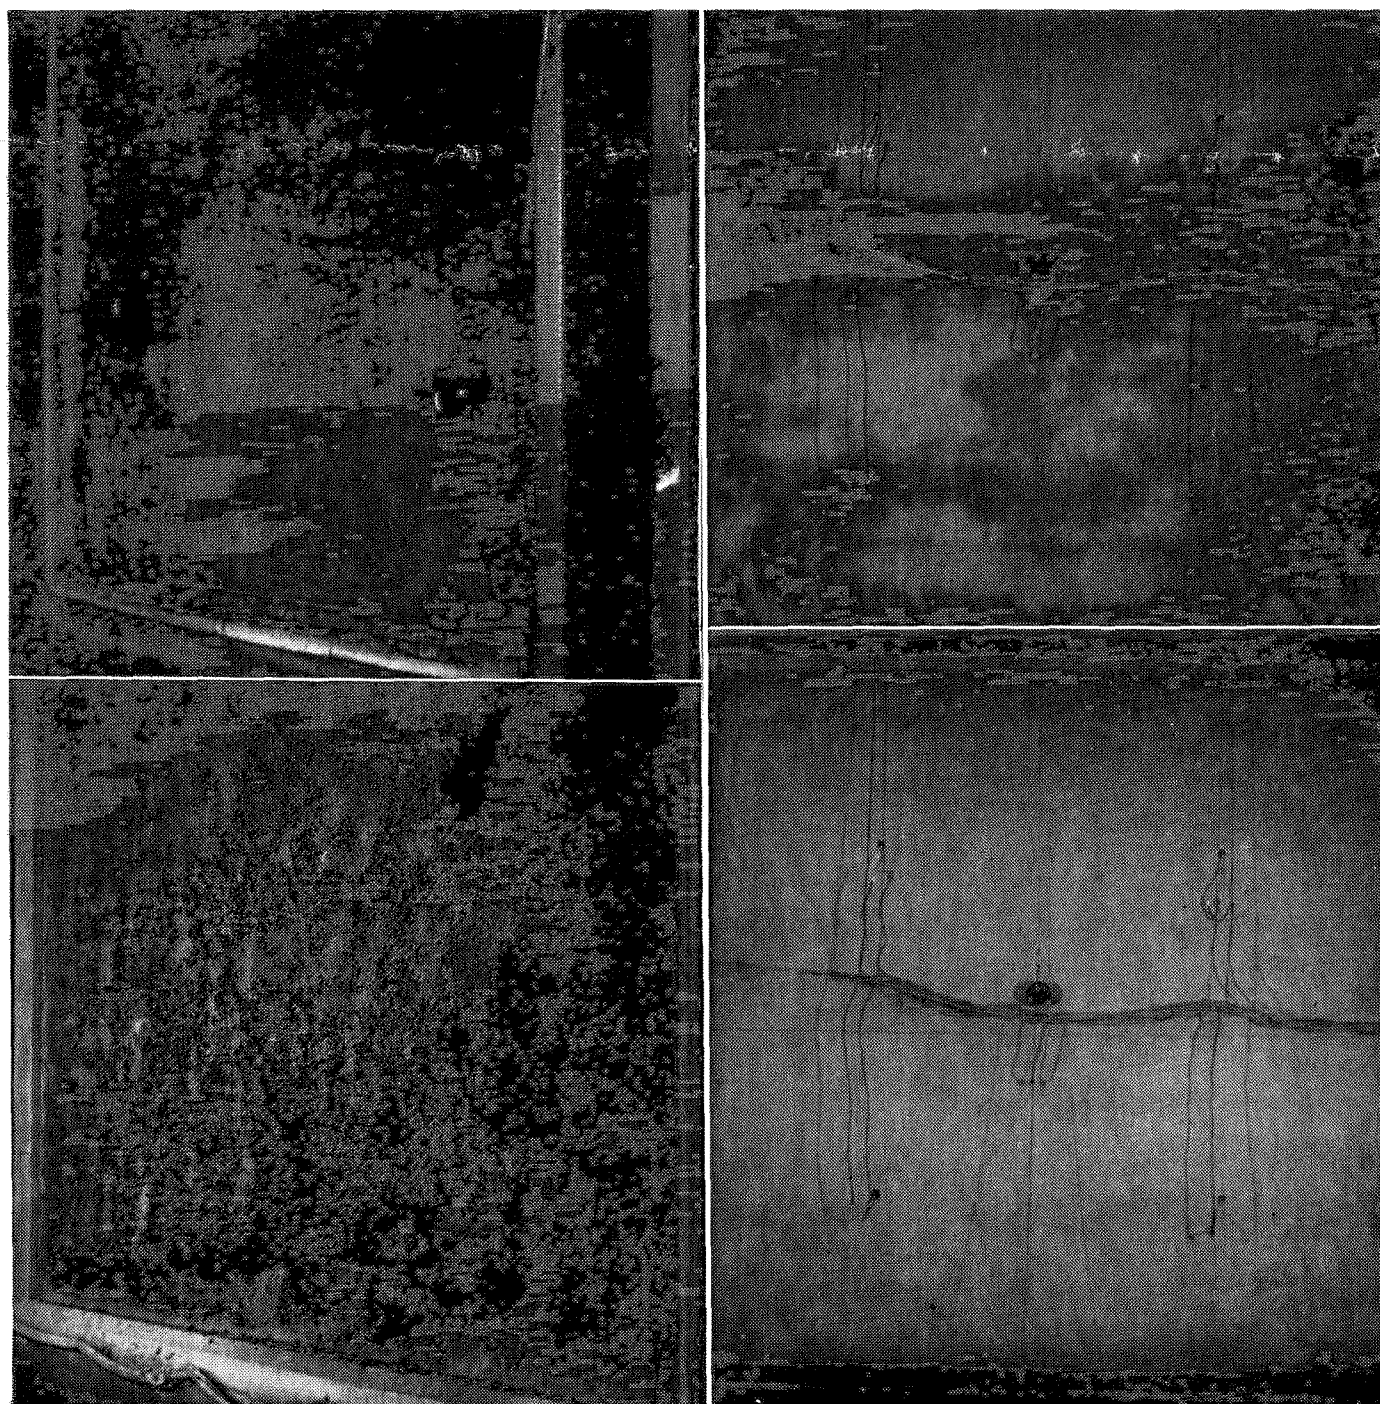
Fig. 10. Specimen No. 3.

(Upper left) Exposed face at end of heating.

(Upper right) Unexposed face at end of heating.

(Lower left) Exposed face after water test.

(Lower right) Unexposed face after water test.

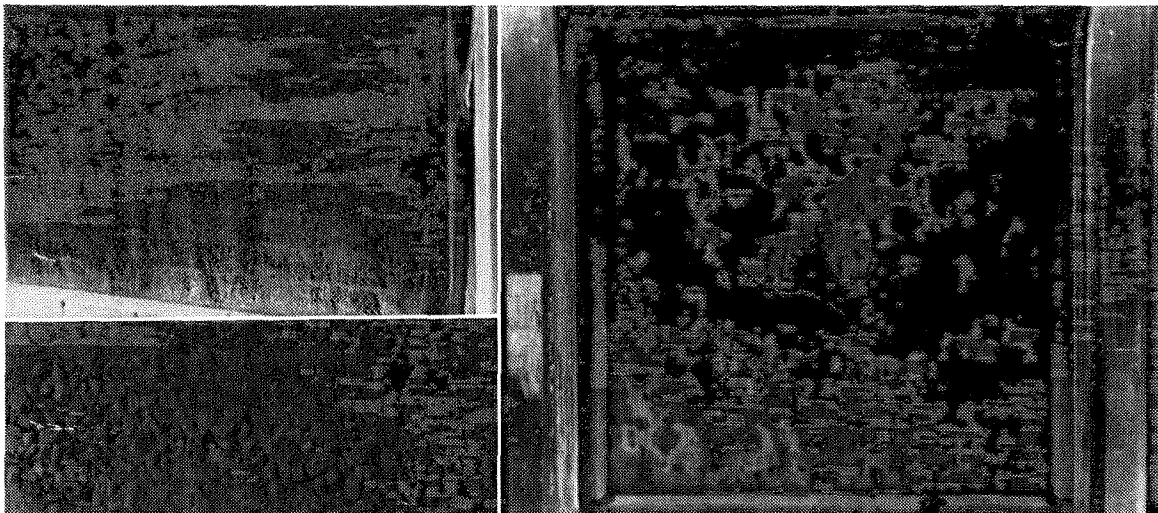
Fig. 11. Specimen No. 4. (Upper left) Exposed face after water test, with (lower left) close-up of face. (Right) Unexposed face immediately after water test.

5 hr 20 min, after which the impact test was re-applied. At the end of the $5\frac{1}{2}$ min water test removed all the rendering from the face but caused little damage to the blocks. Fig. 11 shows the appearance of the two faces of the wall after the water test. Comparative temperatures measured at different points in approximately at the centre of a block and in adjacent vertical and horizontal joints, are shown in Fig. 12. The maximum temperature recorded was $\frac{1}{4}$ in towards the furnace.

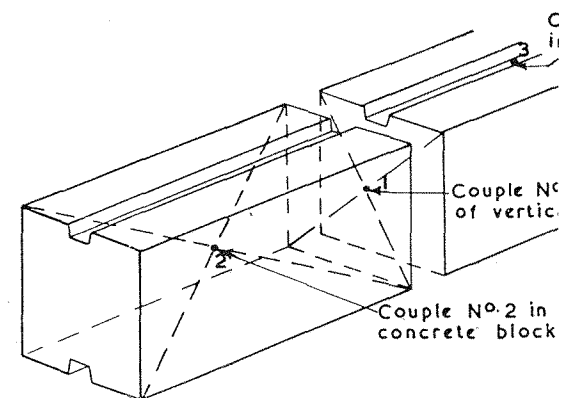
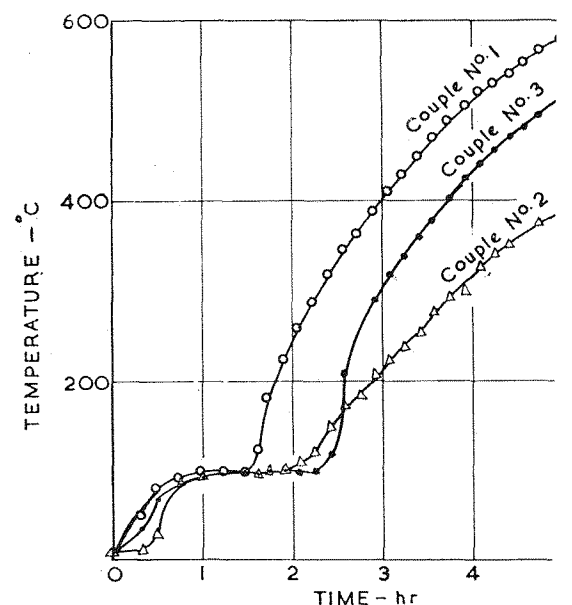
Fig. 12. Specimen No. 4 (Above) Posi thermocouples in blocks. (Below) Con temperatures within block wall.

In the basalt walls, the critical factor was heat transmission. Temperature measurements were made by means of thermocouples at the points in the blocks and joints shown in Fig. 12. High temperatures were obtained at any given time in the joints than in the concrete, indicating that heat transfer through a monolithic wall would be lower than through a block wall.
