NoF. R. Note No. 463

FIRE RESISTANCE OF PERFORATED BRICK WALLS

Summary

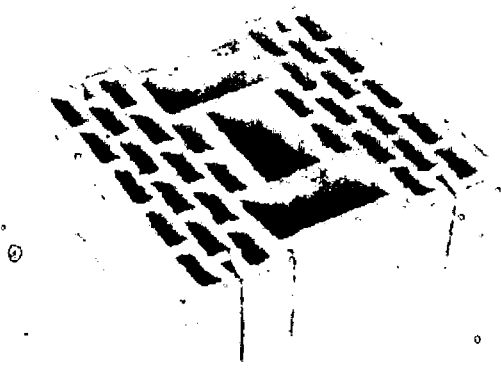
V5

TYPES OF PERFORATED BRICKS TESTED

The bricks used in this investigation consisted of extruded clay sections with through perforations or cells in the vertical direction arranged in two groups connected by four webs⁽¹⁾. Three types of brick, designated V5, V6 and V62 and shown in Plate 1, were used. The various types of brick had similar overall dimensions but varied in the size and shape of the perforations, giving voids in the range 50 to 60 per cent and weights from 6 to 8 lb. The materials used for the bricks and certain of their properties are given in Table 1.

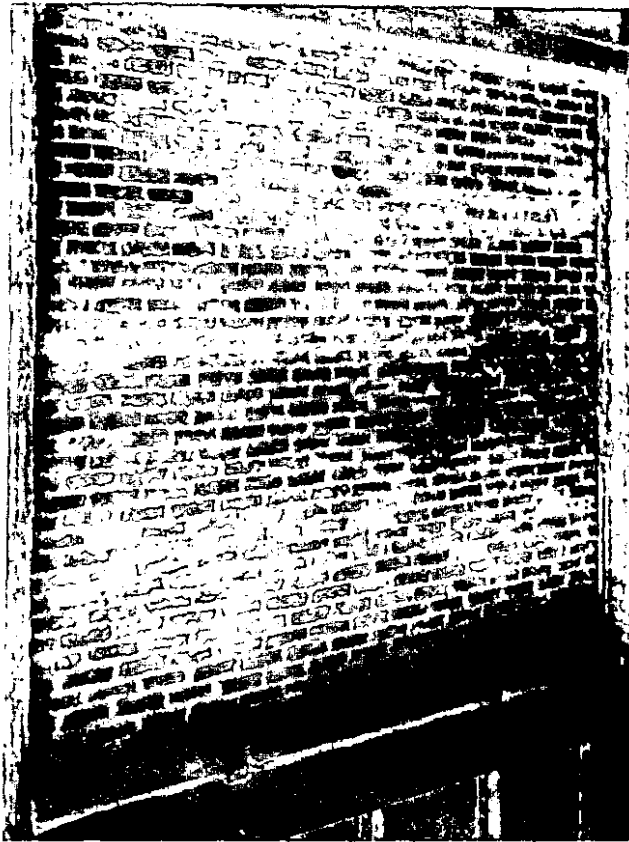
EXPOSED FACE BEFORE TEST

EXPOSED FACE AFTER FIRE TEST (1 HOUR
TEST No. 3. V5 BRICK WALL WITHOUT
PLASTER FINISH

Test No. 3. V6 brick wall; no plaster finish

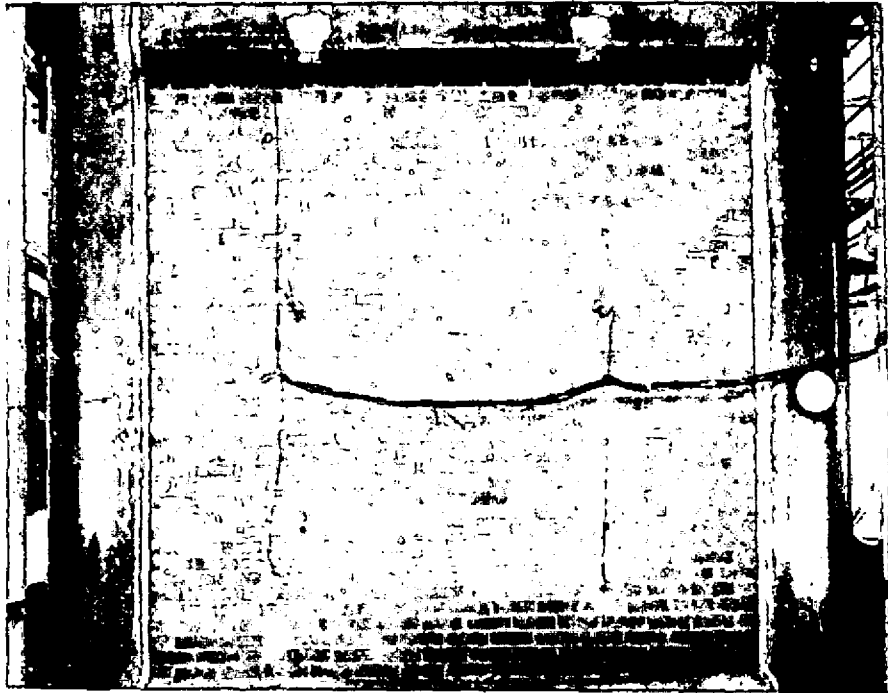
UNEXPOSED FACE BEFORE TEST

TEST No. 6. V62 BRICK WALL WITH VERMICULITE/
GYPSUM PLASTER FINISH

Test No. 6. V62 Brick wall; Vermiculite/gypsum plaster on exposed face

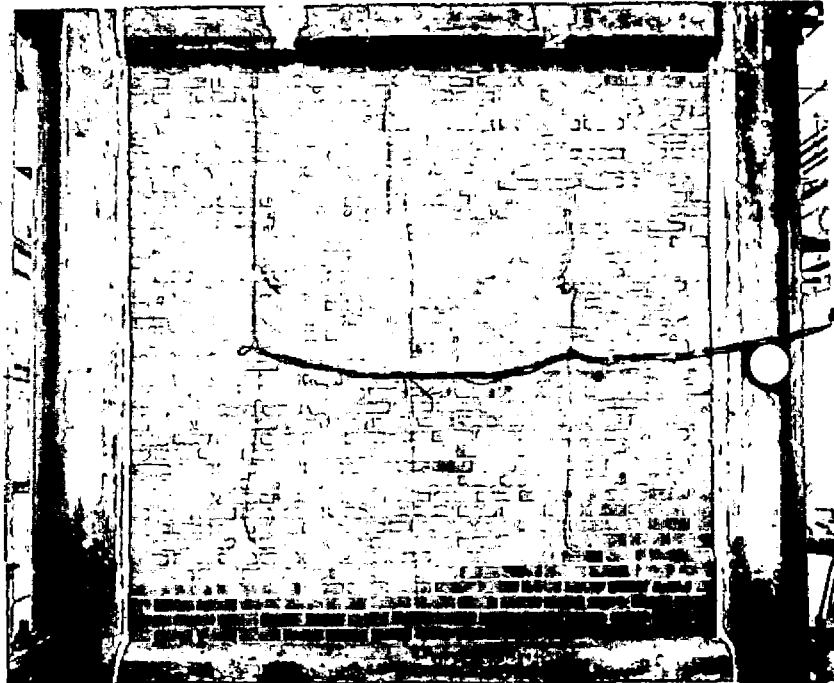
UNEXPOSED FACE AT 4 HOURS

TEST No. 6. V62 BRICK WALL WITH VERMICULITE/
GYPSUM PLASTER FINISH

Time hr. min.	Observation
0 00	Test commenced.
0 24	Appearance of a vertical crack on unexposed face.
0 30	No cracks on the plaster finish visible on exposed face.
1 10	The vertical crack $\frac{1}{16}$ in wide.
2 00	The vertical crack now $\frac{1}{8}$ in wide; no other change.
2 20	Appearance of two diagonal cracks.
4 07	Plaster coating on exposed face intact; no other change. Test terminated.
