Fire Research Note

No. 827

FIRE HAZARD OF EXPANDED POLYSTYRENE LININGS

May 1970

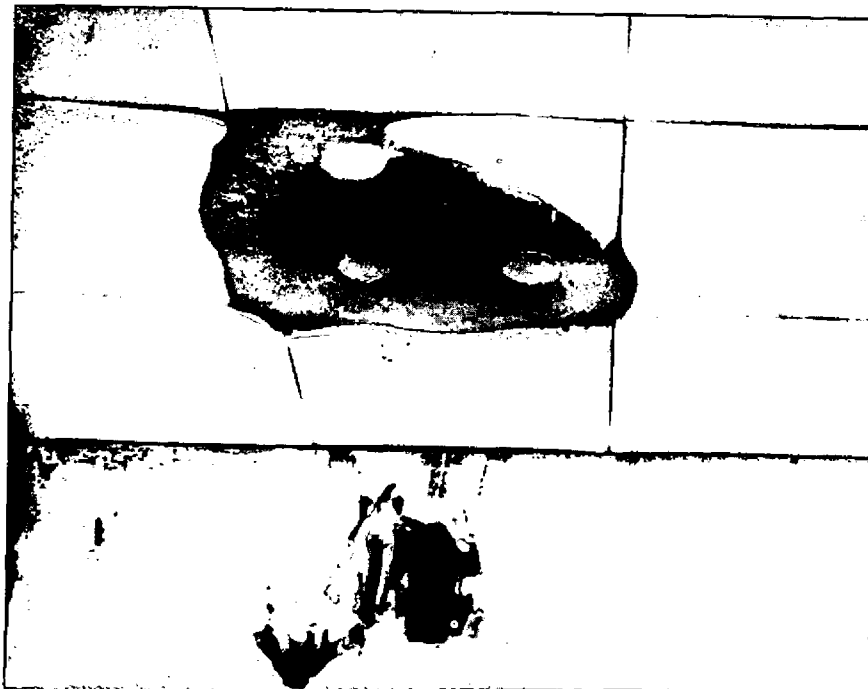
PLATE 3 STANDARD GRADE EXPOSED TO ALCOHOL FLAME

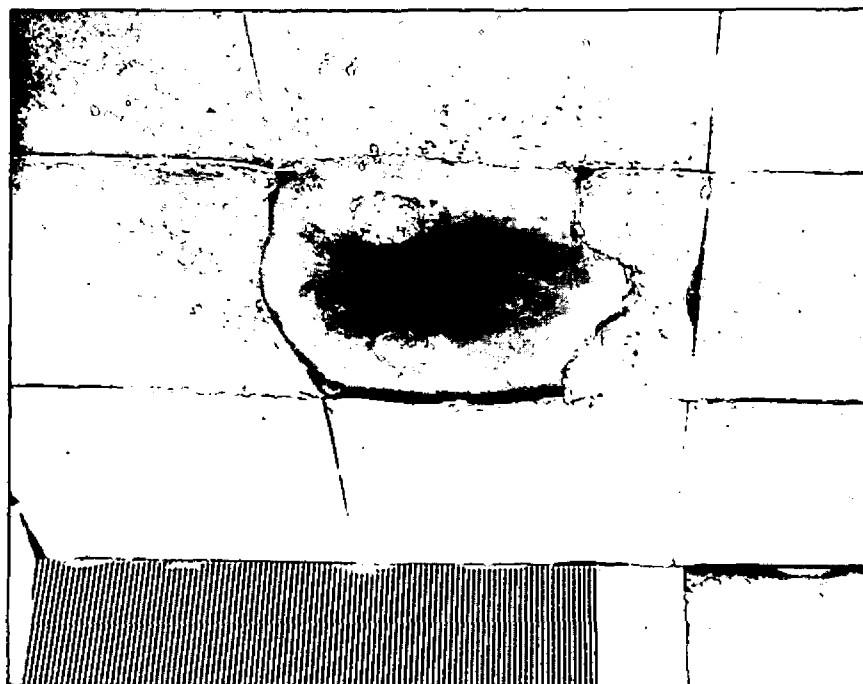
PLATE 4 EFFECT OF TREATING WITH EMULSION PAINT

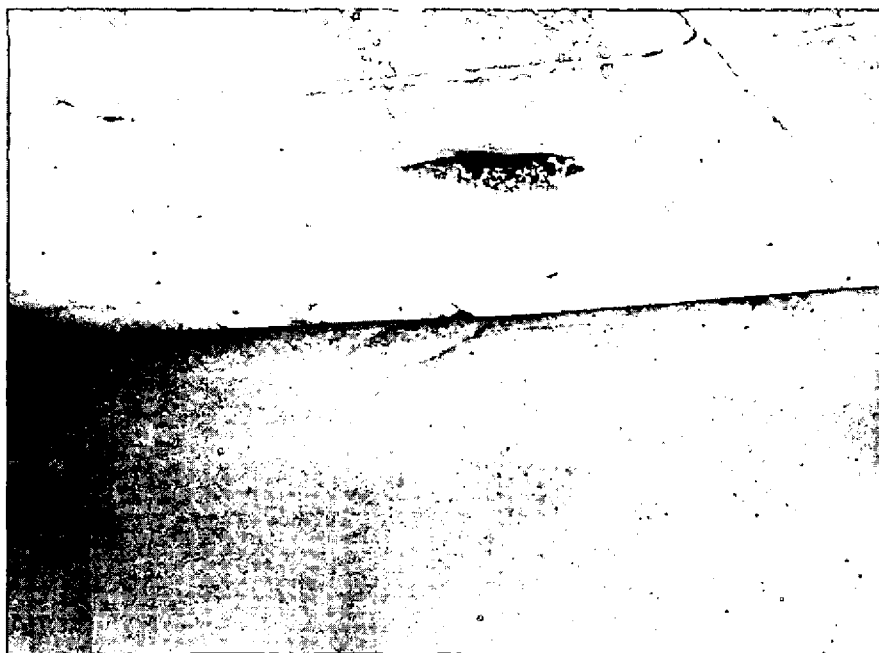
**PLATE 5 SELF EXTINGUISHING GRADE EXPOSED
TO GAS FLAME**

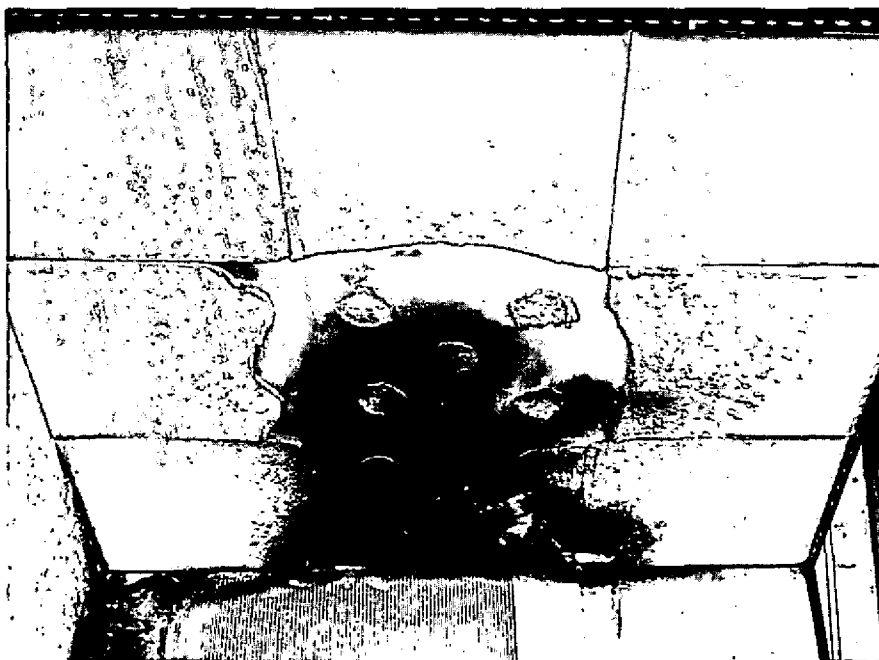
PLATE 6 EFFECT OF TREATING WITH EMULSION PAINT

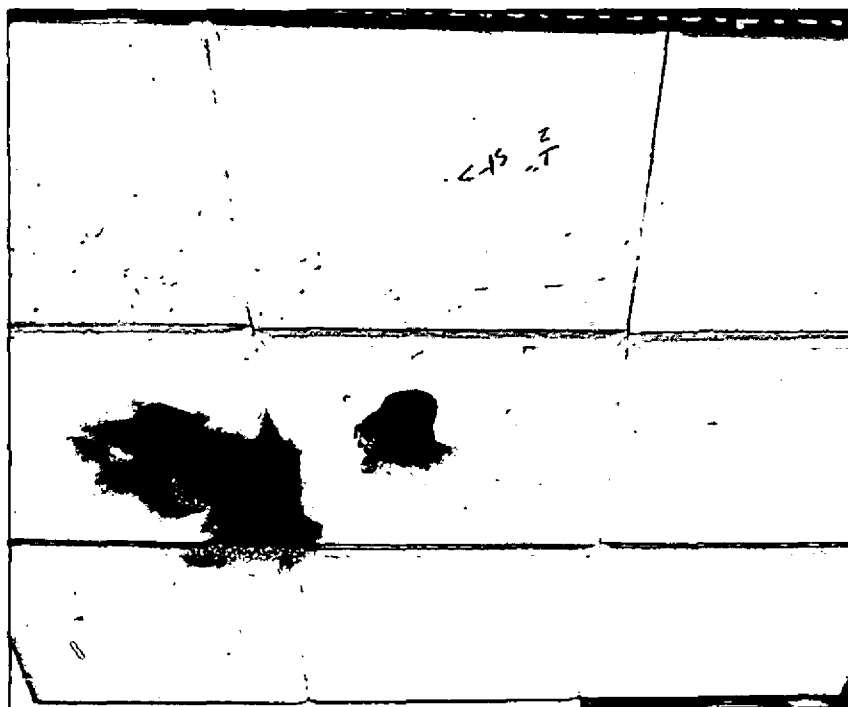
PLATE 11 13 mm STANDARD GRADE, ASBESTOS SUBSTRATE,
EXPOSED TO GAS FLAME

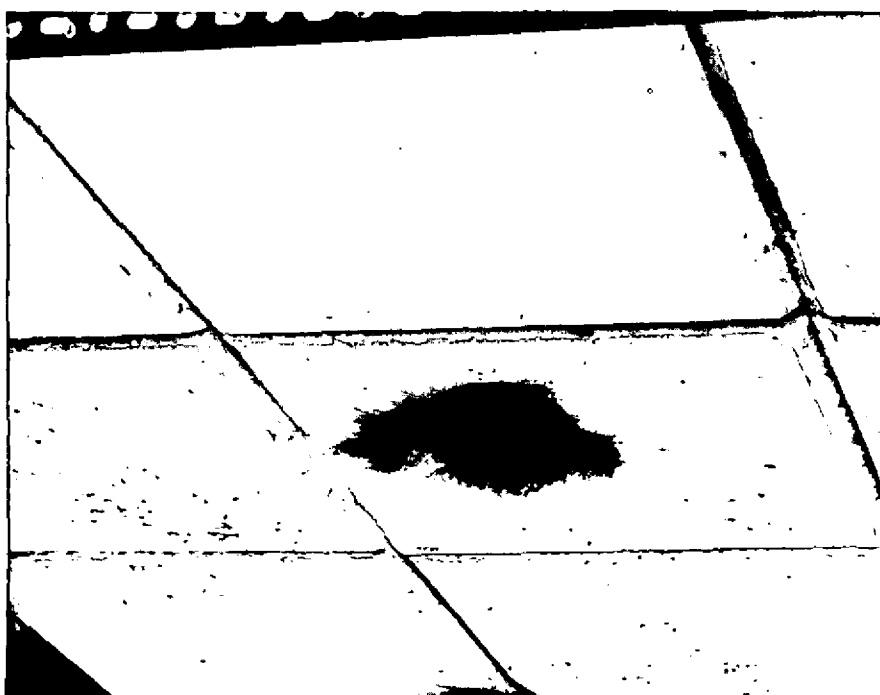
PLATE 12 EFFECT WITH PLASTERBOARD SUBSTRATE

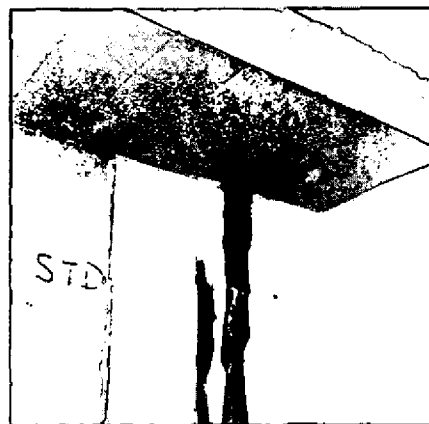
PLATE 30 TEST 11 STANDARD GRADE. CEILING WITH
EMULSION PAINT, WALLS WITH MEDIUM
WEIGHT PAPER.

Wall - Shrinkage of polystyrene leads to ignition of loosened
wall paper, flames spread vertically in a narrow band
up to ceiling, no lateral spread.
Ceiling - Local ignition of ceiling tiles, flaming drops, no
general spread, flaming out 6 min 20 seconds.
(Plate 30).

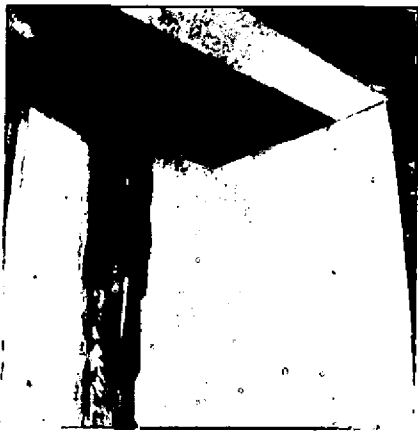
PLATE 31 TEST 12 SELF EXTINGUISHING GRADE. CEILING
WITH EMULSION PAINT, WALLS WITH MEDIUM
WEIGHT PAPER.

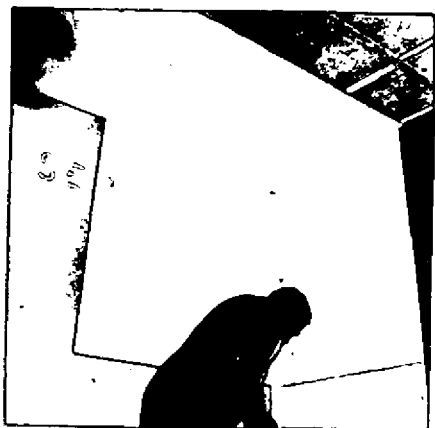
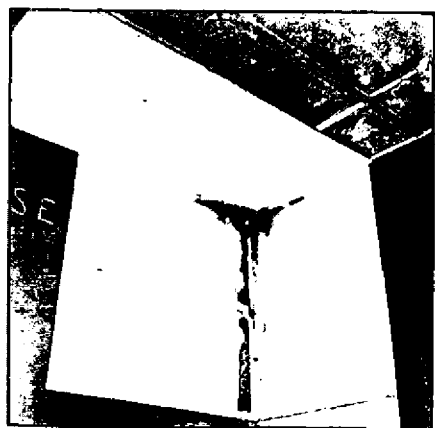
PLATE 34 SELF EXTINGUISHING GRADE DAB
ADHESIVE ON 9 mm BATTENS

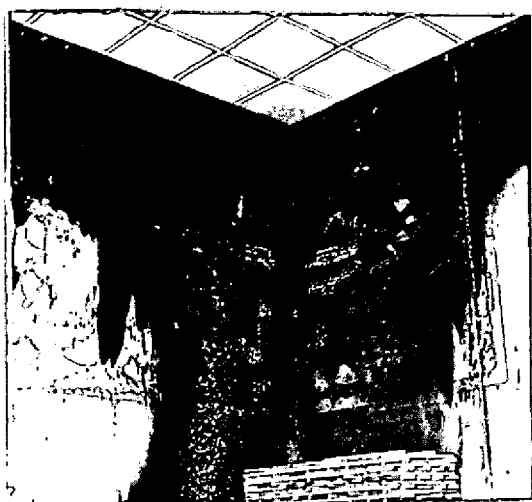
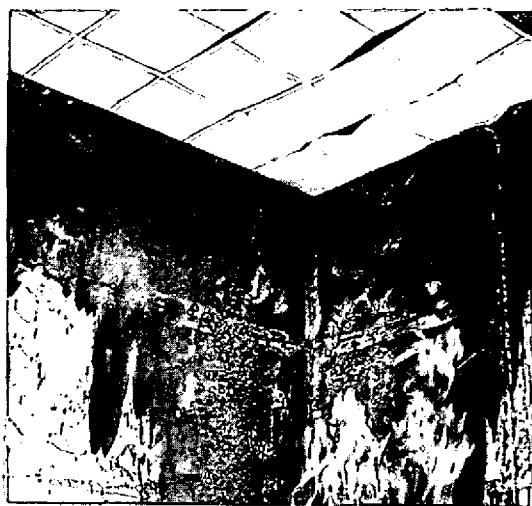
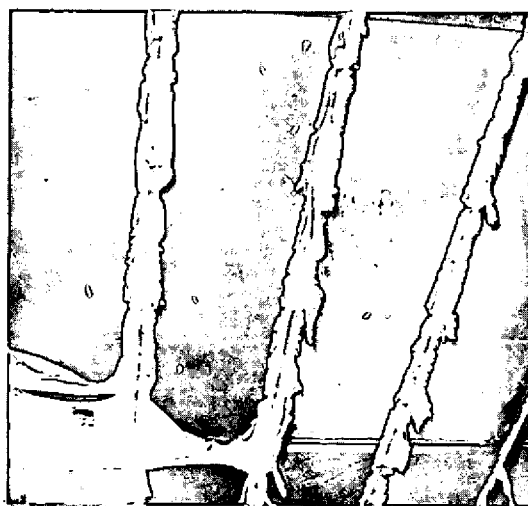
PLATE 35. STANDARD GRADE ATTACHED TO 9 mm BATTENS.
TIMBER CRIB IGNITING SOURCE

- Performance:- - Tiles receded from the heat as flames reached ceiling height. By 2 min, all but the farthest tiles had receded or fallen. No flaming drops were observed. (Plate 35).
