THE FIRE PROPAGATION TEST AS A MEASURE OF FIRE SPREAD.
CORRELATION WITH FULL SCALE FIRES IN CORRIDORS

H. L. Malhotra, W. A. Morris and J. S. Hopkinson

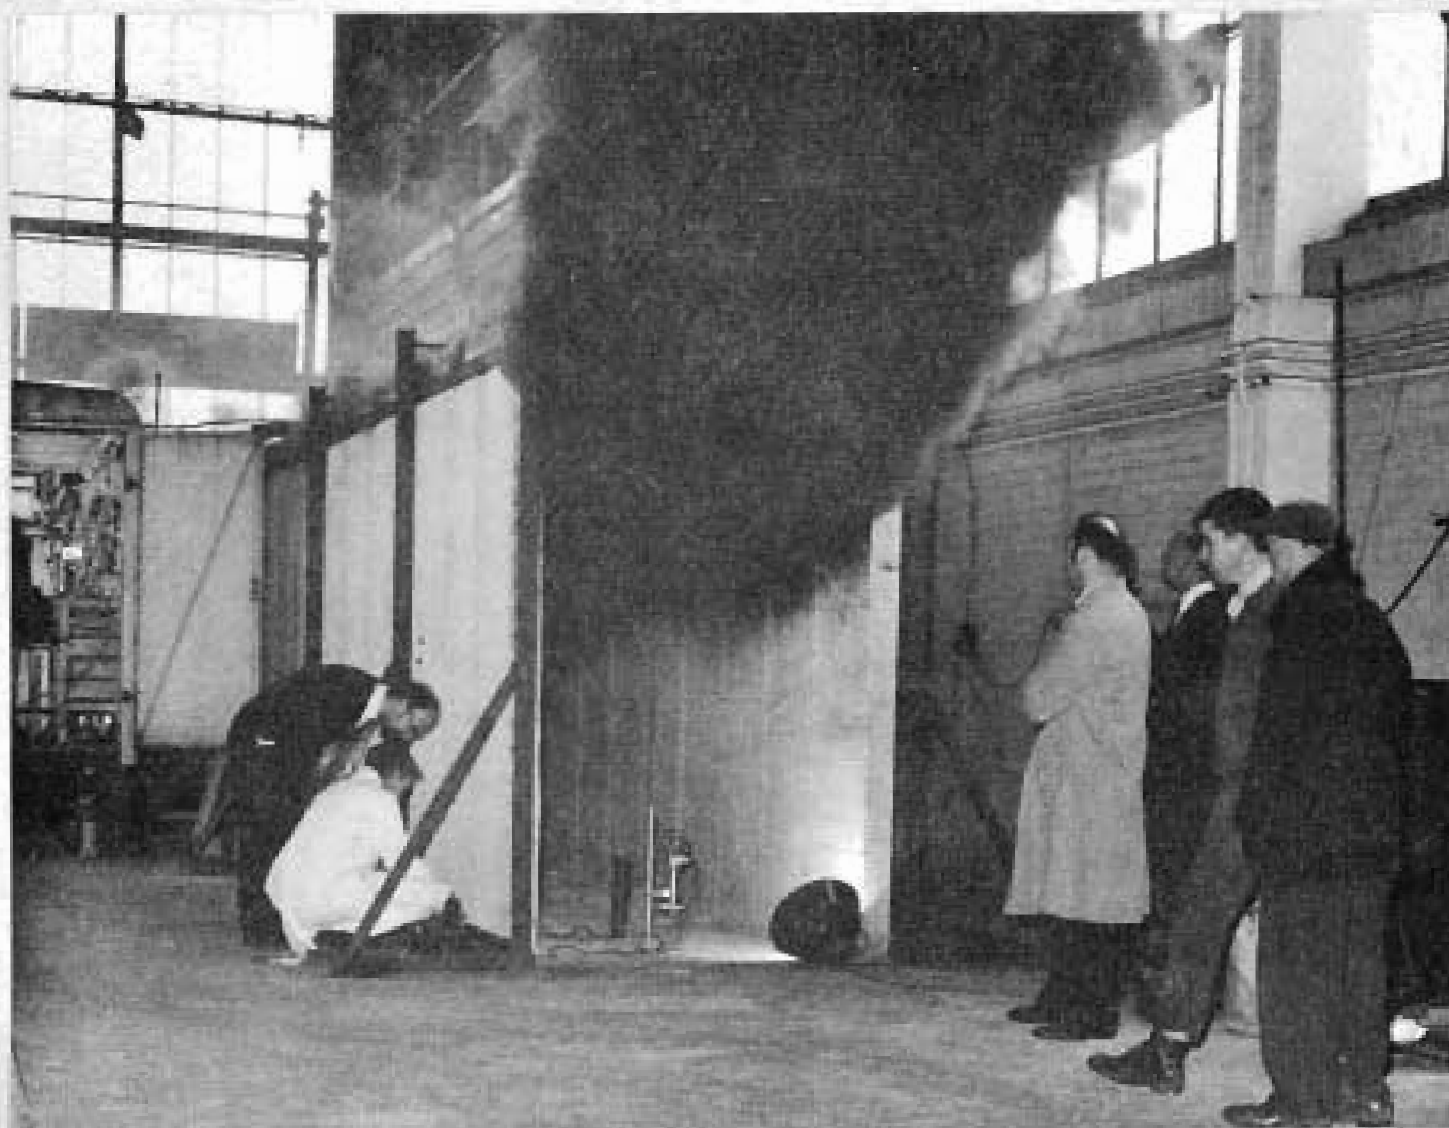
GENERAL VIEW OF TEST CORRIDOR
PLATE 1

A series of tests was therefore carried out in a structure consisting of a room with an attached corridor constructed from aerated concrete slabs, the walls and ceilings of which were lined with selected materials whose performance on the Fire Propagation Test had been determined.

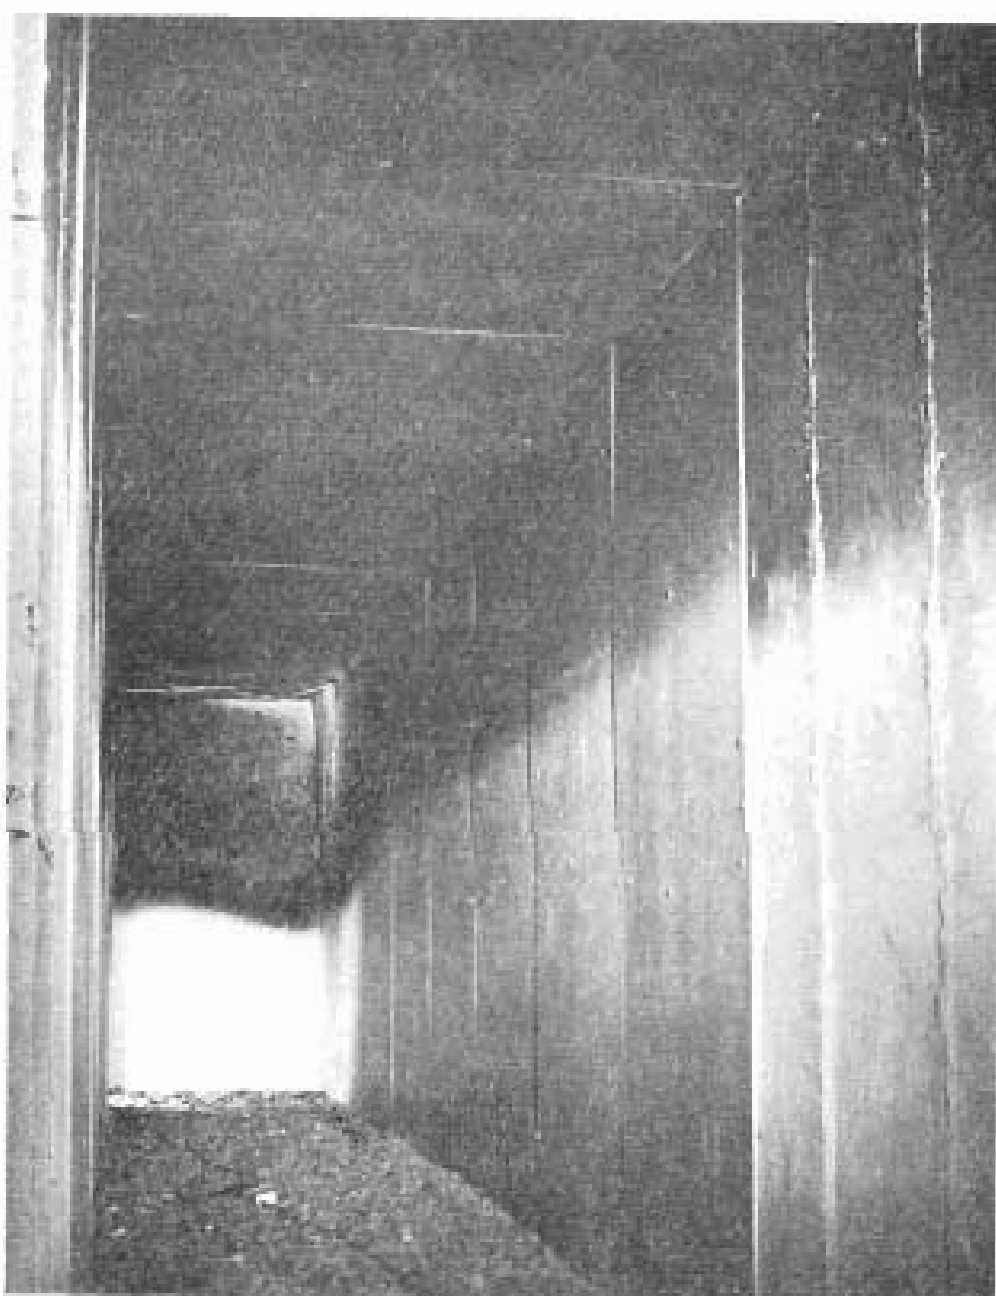
a) 3 min

b) 12 min

c) at end of test

PLASTER BOARD LINING (SYSTEM 1)
PLATE 3

The plasterboard lining (system 1) and the expanded polystyrene lining attached to asbestos/cement wall board (system 2) ignited only locally near the door opening after the emission of flames, and the flaming did not spread either along the ceiling or the walls. In the case of the expanded polystyrene tiles attached to asbestos/cellulose board (system 3), after the emission of flames, wall surfaces adjacent to the opening and facing it were ignited, flame spread occurring along the top portion of the walls. The spread of flame was slow (approximately 1 m/min) and the ignited tiles were soon consumed, resulting in a narrow flame front travelling towards the open corridor end, rather than the whole wall surface flaming at the same time. At the end of this test it was observed that the lower parts of the wall were relatively undamaged, melted and burnt material forming a triangular wedge having its maximum depth adjacent to the doorway.

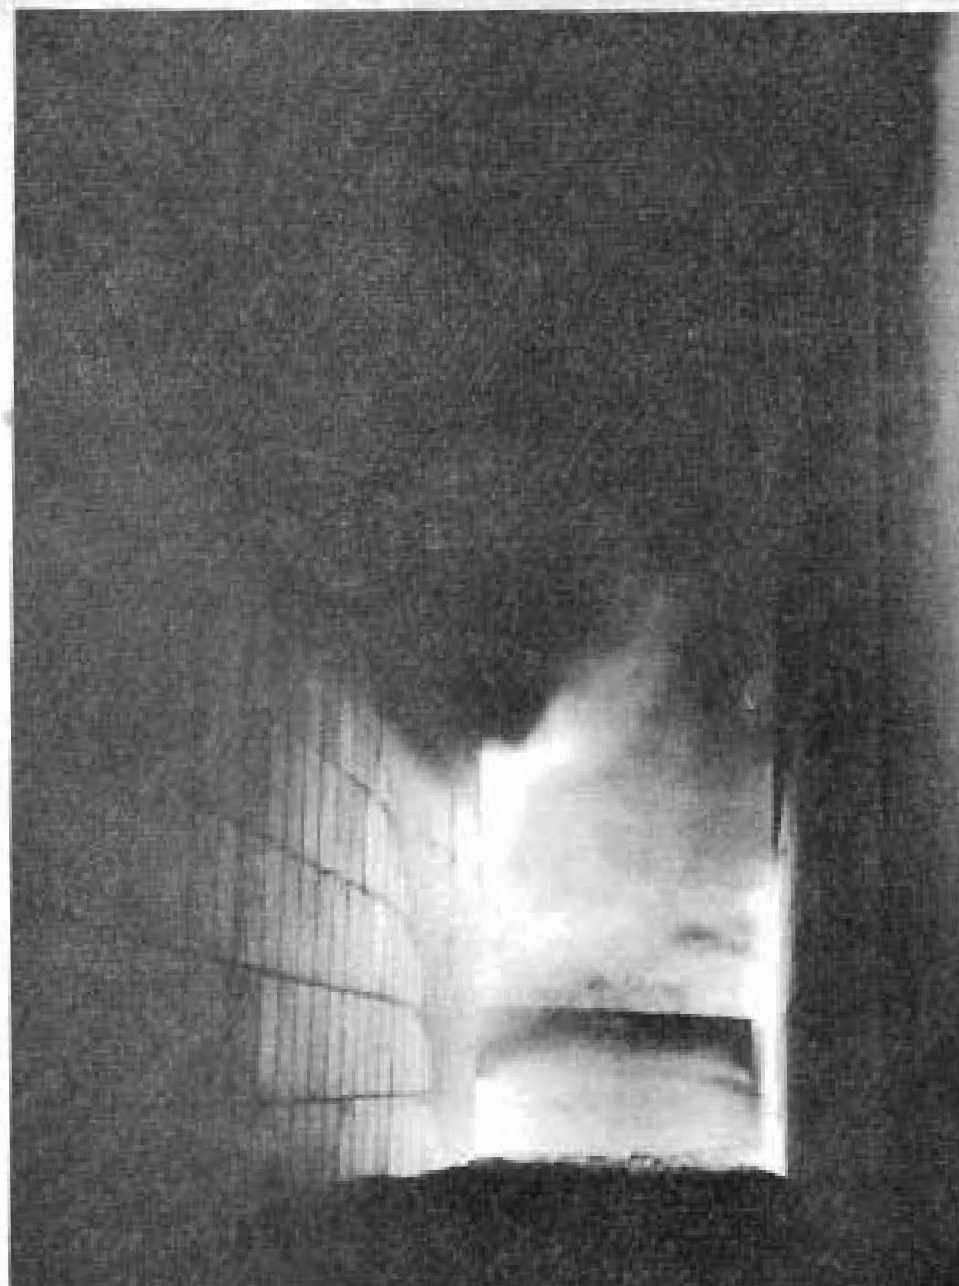
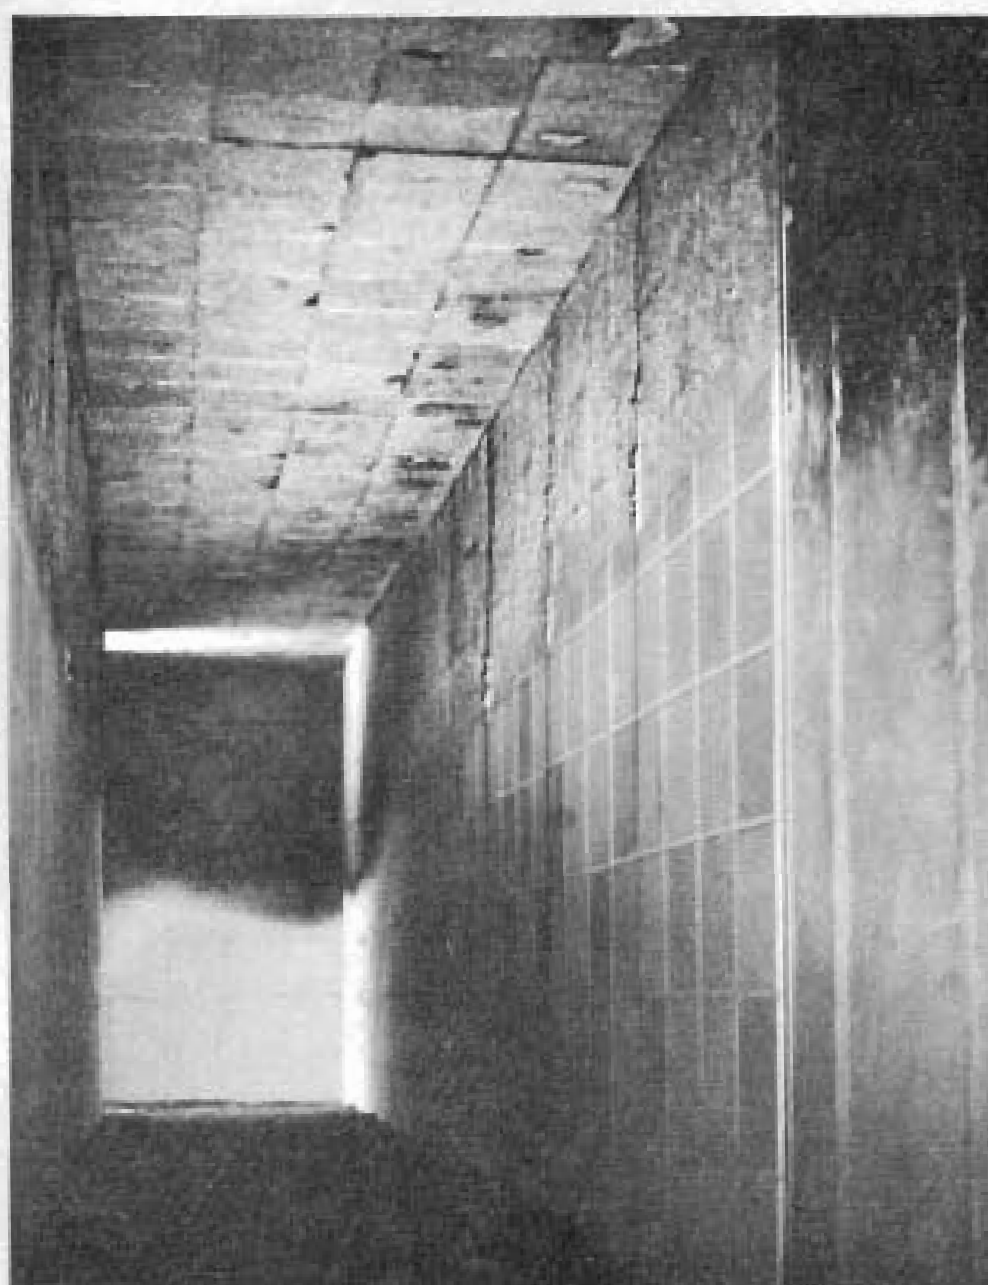
a) 3 min

b) 12 min

c) at end of test

EXPANDED POLYSTYRENE LINING (SYSTEM 2)
PLATE 4

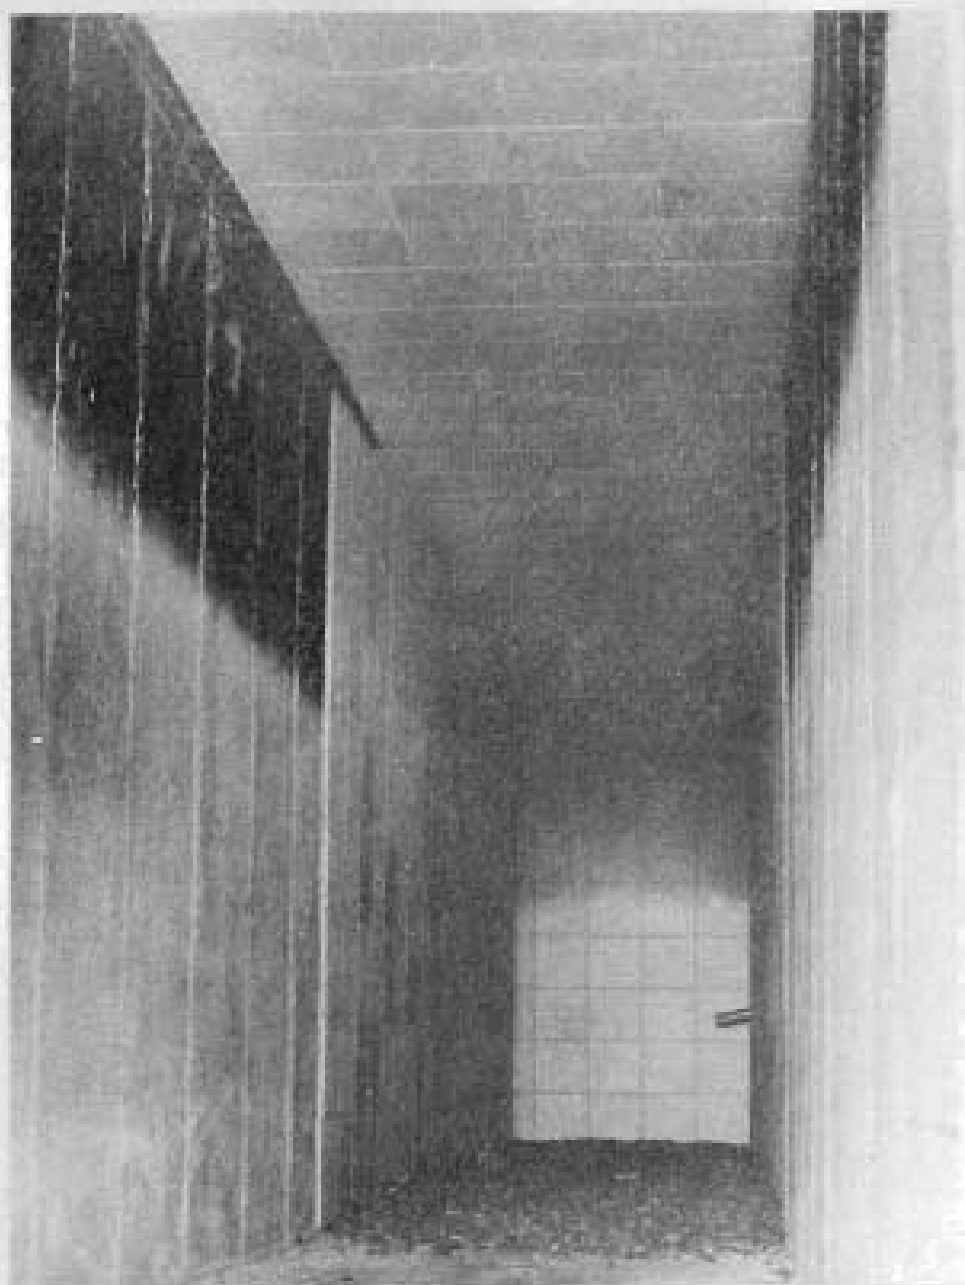
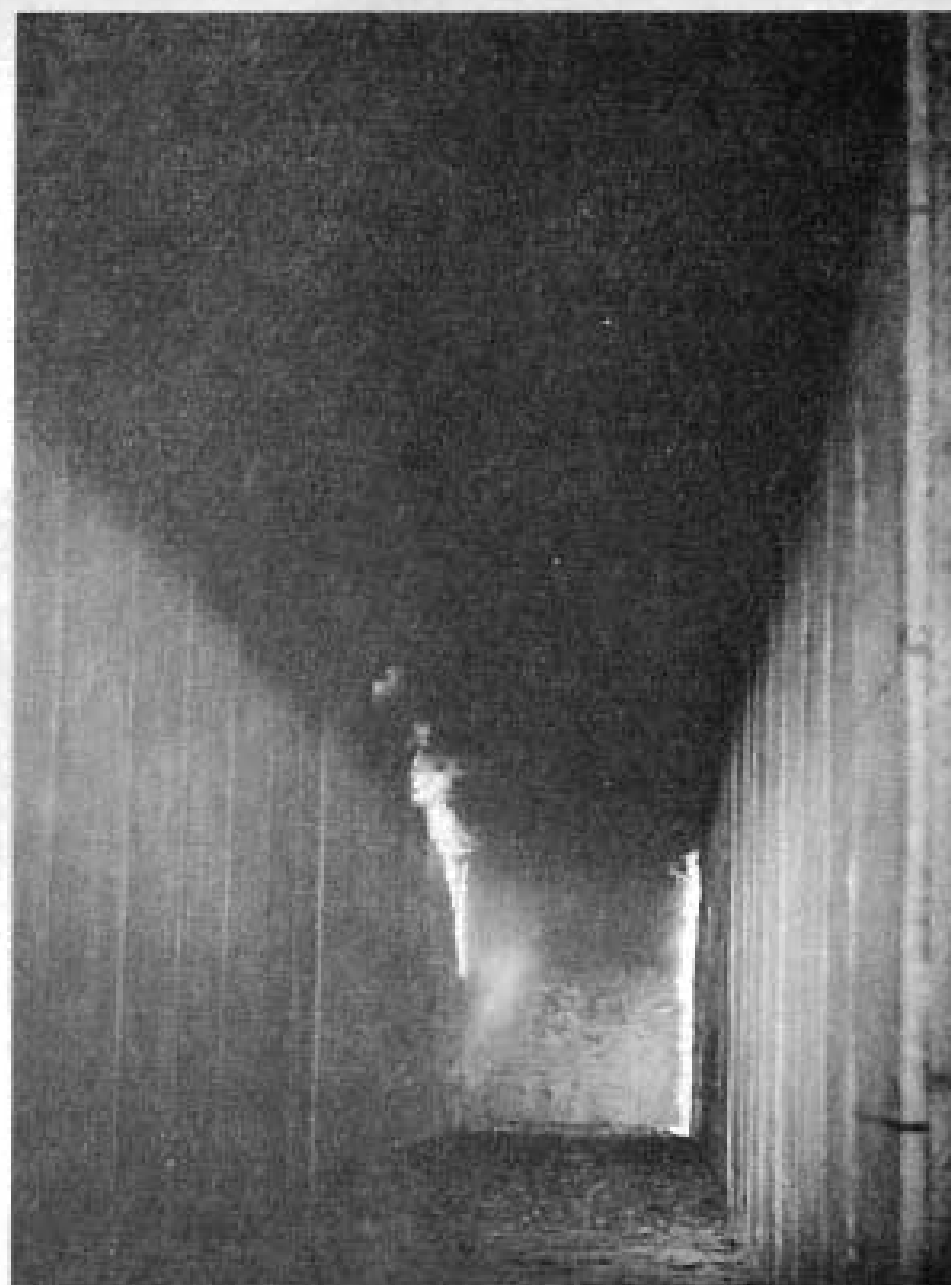
PLATE 5

a) 3 min

b) 12 min

c) at end of test

EXPANDED POLYSTYRENE LINING (SYSTEM 3)

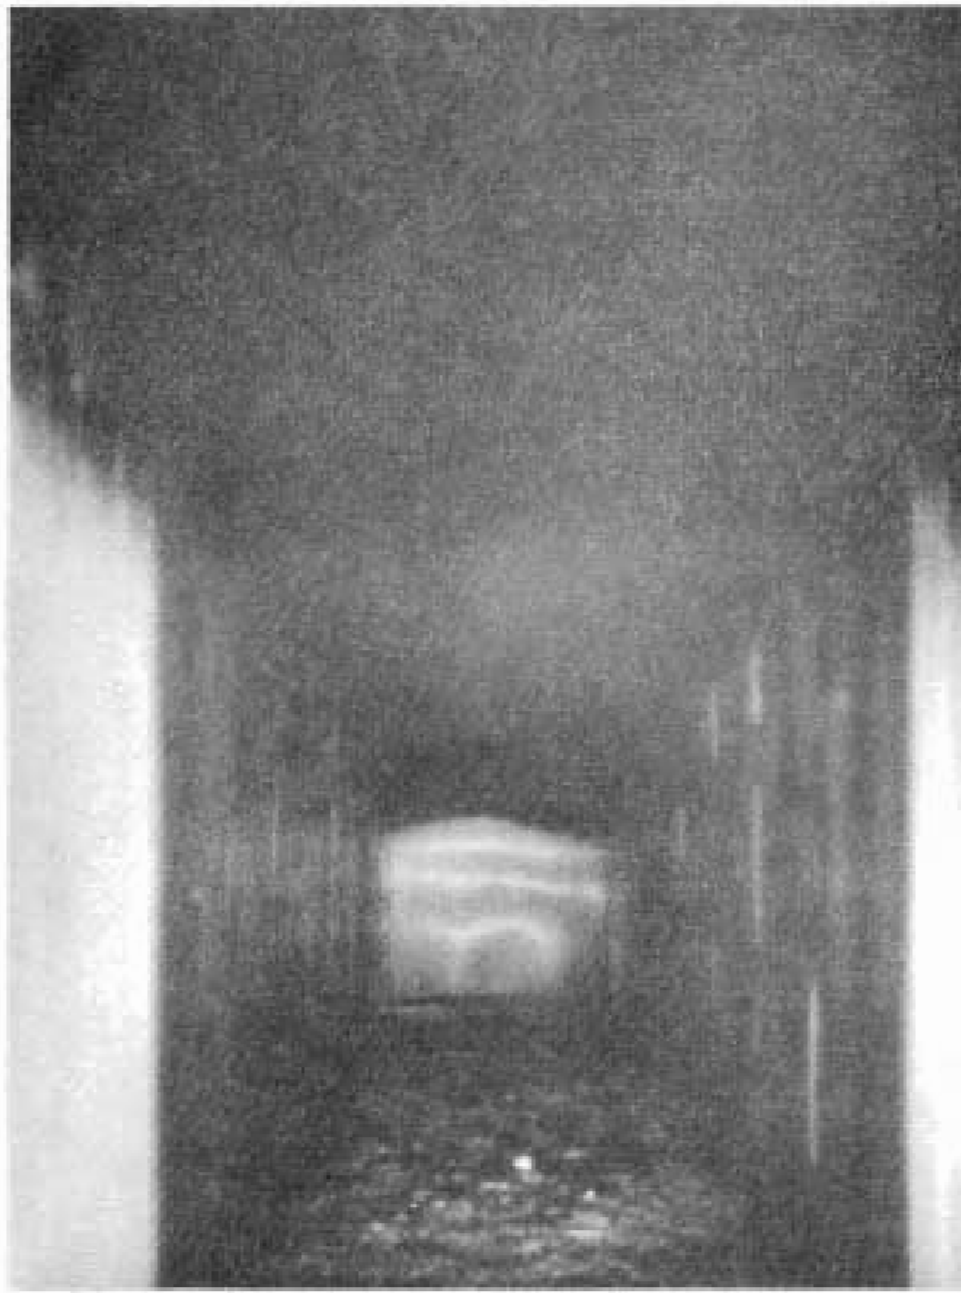
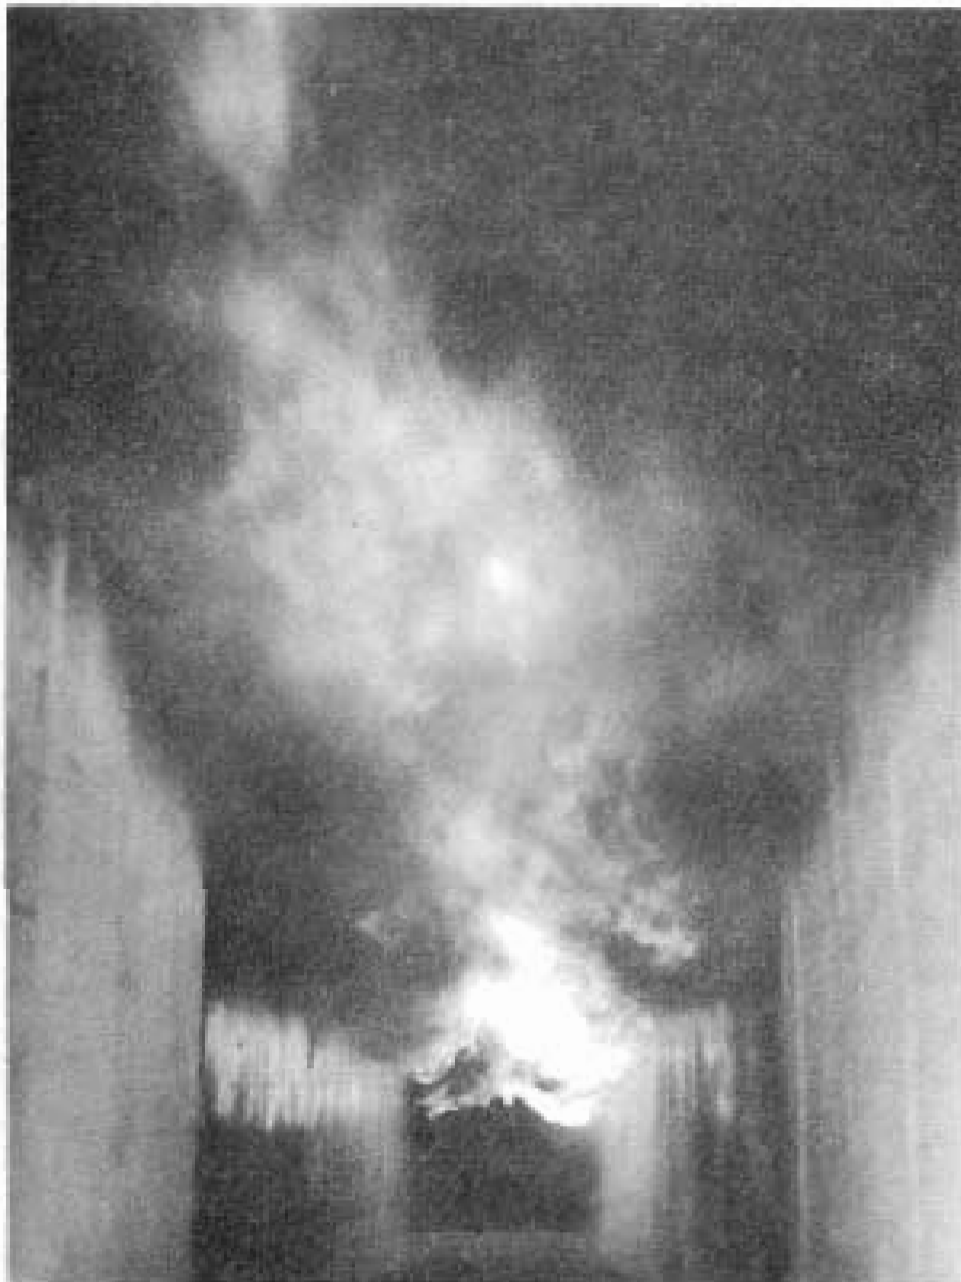
PLATE 6

a) 5 min

b) 7 min

c) 7 min 30 sec

b) 8 min

HARDBOARD LINING

The untreated hardboard lining ignited soon after 8 min 10 sec in the first test when the flames were emitted from the room, flaming spread very quickly (in about 45 sec) to the end of the corridor involving the whole of the exposed surface. In the second test similar behaviour was observed, the rapid flame spread occurring a little later. The intensity of flaming was high and the ignited lining was quenched with a water hose to prevent damage to the corridor.
