# Fire Research Note

## No 955

### FIRE TESTS ON AN AIR-SUPPORTED STRUCTURE

December 1972

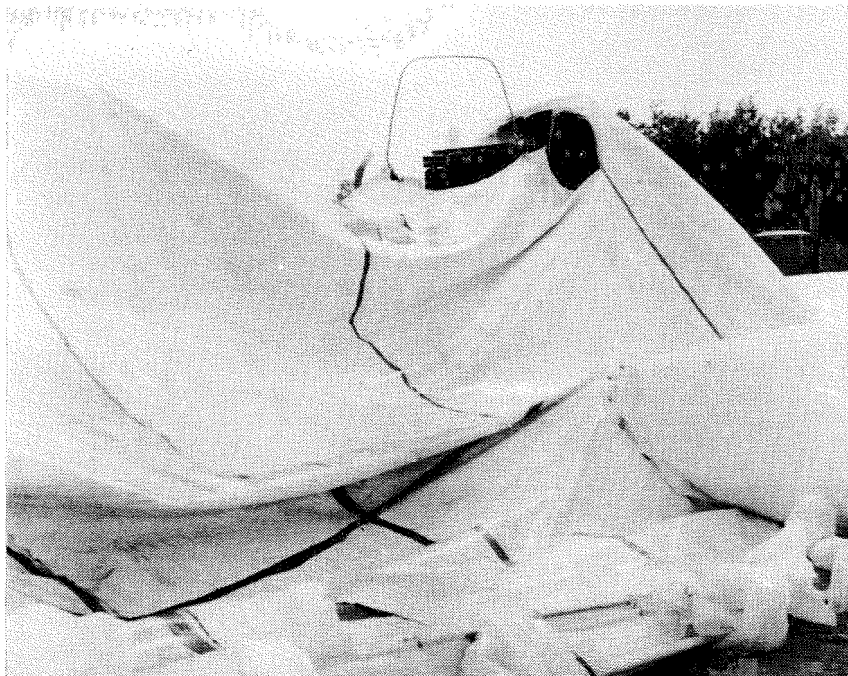
PLATE 6. STRUCTURE COLLAPSED AROUND CRIB  
- TEST F2

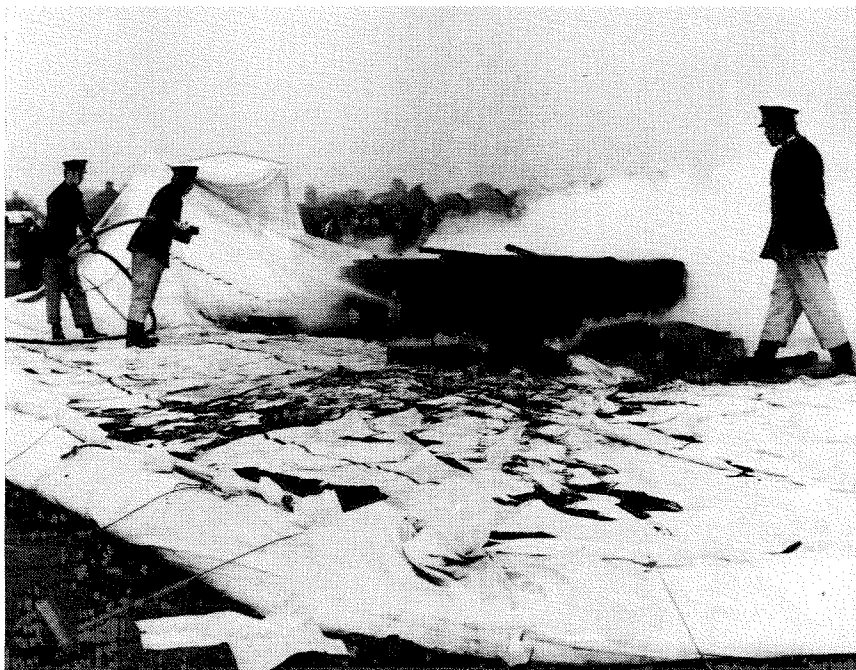
PLATE 8. EXTINGUISHING OF FLAME AT  
END OF TEST F2

In tests where deflation took several minutes, any further venting would have reduced the collapse time introducing problems for the fire fighters. For this reason the events in test  $F_3$  are significant because fire fighting took place from the outside after deflation was complete. Under these conditions, there was no difficulty in reaching the burning timber and tyres by walking over the collapsed fabric and the fire was extinguished by approaching from the windward side (Plate 8).

05.25	Fabric on south side burnt right to the edge of structure
08.30-11.00	Fire brigade putting out fire (Plate 8)
