Real Fire Test on Concrete Columns and Post-tensioned Slabs

IAN BENNETTS and WARREN SOUTH*

Centre for Sustainable Infrastructure

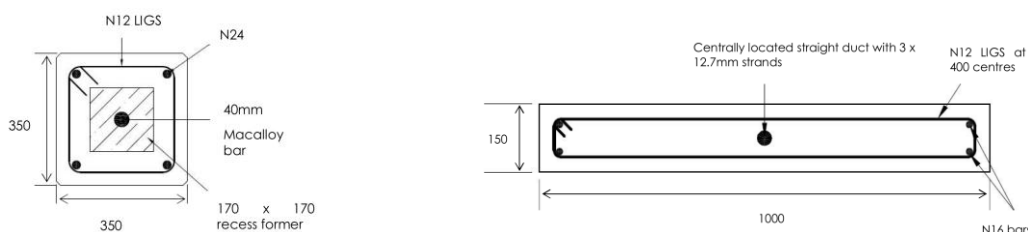
Figure 1 Cross-section of Typical Column and Slab

The post-tensioned slabs were constructed from normal strength concrete whilst all columns were constructed from high strength concrete. The concrete strengths are summarised in Table 1. Details of the members tested are given in Table 2 with the cross-sectional reinforcing details and dimensions shown in Figure 1. All of the 12 columns had the same cross-sectional dimensions and longitudinal reinforcement and all were 3m in length. Each column incorporated a high strength Macalloy bar which was stressed to induce a minimum level of compression into the column. This was done since it was not possible to otherwise load the columns and the presence of a level of compression was considered likely to enhance the likelihood of spalling.

Three post-tensioned slabs were constructed – two from normal strength concrete containing basalt and one with concrete incorporating Nepean River gravel. All slabs were 6m long and incorporated some nominal reinforcement to enable handling after casting and a centrally placed flat duct containing 3 x 12.7mm strands. As with the Macalloy bars for the columns, the strands were also tensioned approximately one month after casting.

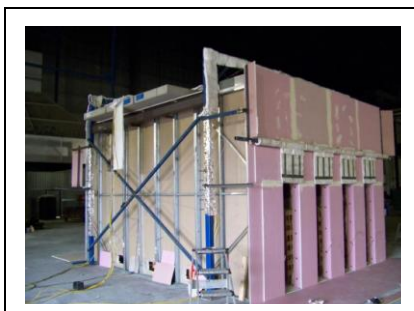
Figure 2 View of Test Enclosure with Slabs supported over Top

to the supporting frame after all of the walls had been erected. In addition to the slabs (each 1m wide), ceiling sections consisting of 25mm of ceramic fibre (on innermost face) and two layers of 16mm fire resistant plasterboard were designed to span between the side walls of the test enclosure and placed at each end of the test enclosure so as to complete the roof. The inside dimensions of the enclosure measured 4250mm x 5400mm when measured between the insulated walls. The height to the soffit of the slabs from the floor was 3300mm.

The ventilation openings into the enclosure consisted of four 1800mm x 465mm openings at each end and three low level openings on the other sides to allow more air into the enclosure should it be considered that the fire did not have sufficient severity. An adjusting facility was also provided to limit the height of the openings at each end so as to reduce the fire severity should this be considered necessary. The adjuster can be seen in Figure 2.

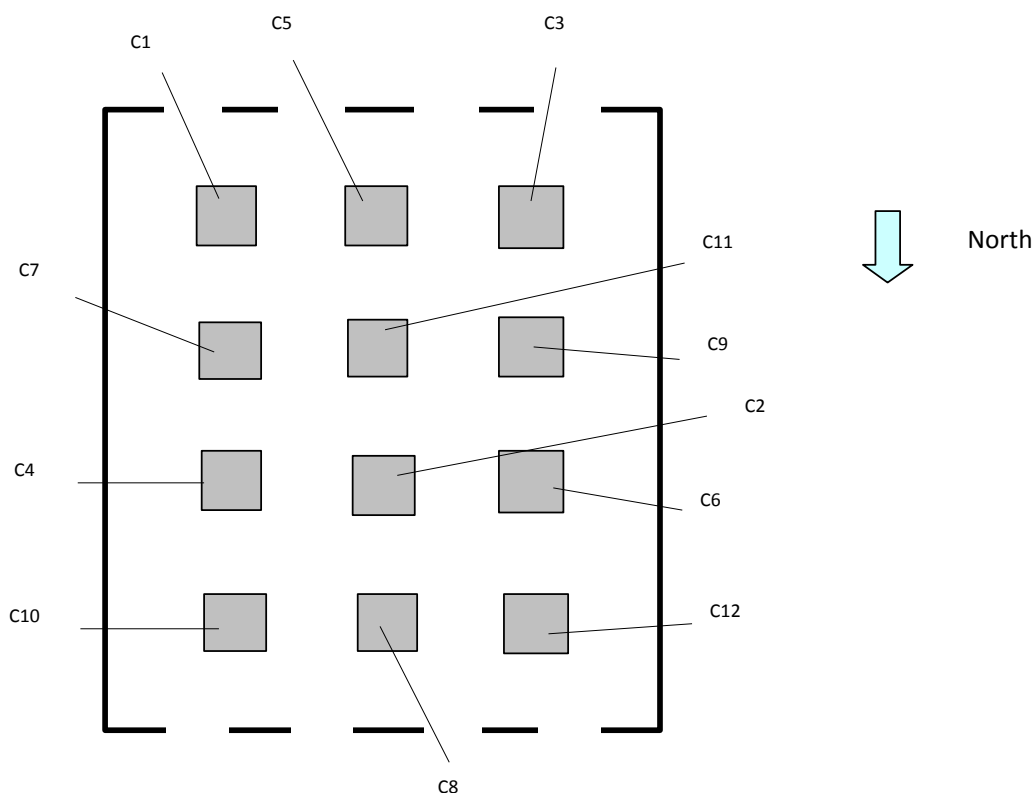
Figure 3 Plan view showing position and orientation of columns within enclosure

The faces of the columns were 800mm apart. Similarly, the distance between the outer face of a column and the inside face of the enclosure wall was 800mm and were positioned within the enclosure as shown in Figure 3 whilst the position of the slabs placed over the top of the enclosure and forming part of its ceiling is shown in Figure 4. The end ceiling panels that completed the roof of the enclosure are also shown. The clear span between the supports for the slabs was 5100mm.

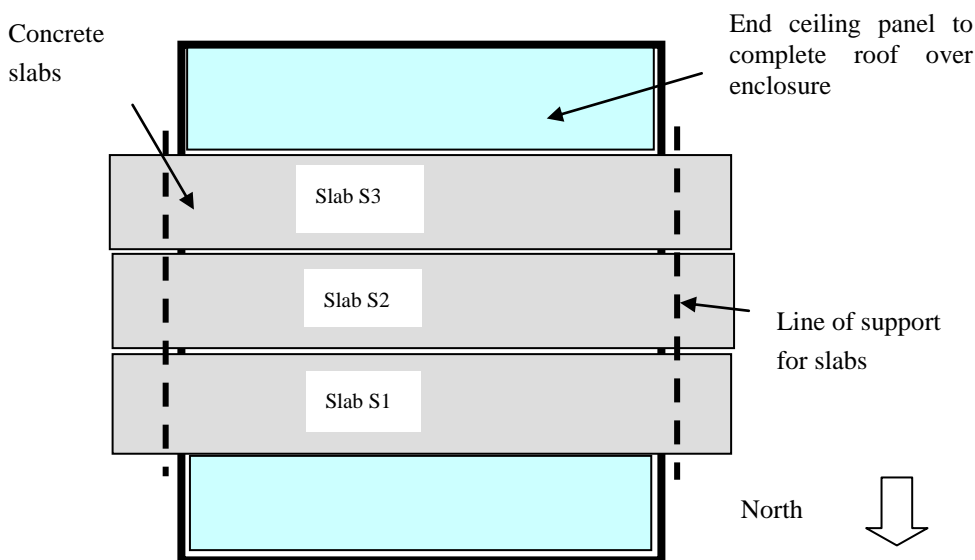
Figure 4 Positioning of Slabs over the top of Enclosure

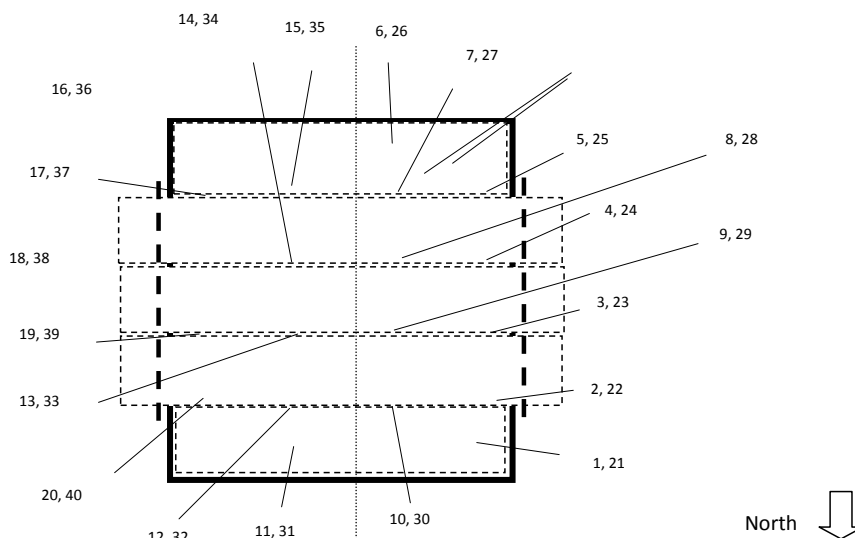
Figure 5 Locations of Thermocouples in Plan

Two layers of thermocouples were provided within the test enclosure. The uppermost layer, numbered 1 – 20 were located 400mm down from the soffit. The second layer, numbered 21 – 40 was positioned approximately 1500mm below the soffit but in the same locations when viewed from above. The positions for the uppermost layer are shown in Figure 5.

When viewed in plan, the thermocouples were located in the east-west direction midway between the faces of the columns or midway between faces of the columns and the internal walls of the enclosure in the case of the columns closest to the walls. The thermocouples were mineral insulated 3 mm diameter Type K. They were located down from the top of the enclosure by placing them between and through the mineral fibres insulation located between the slabs or between the slabs and the end roof panels. Eight thermocouples were located through the end roof panels via holes through the plasterboard linings.

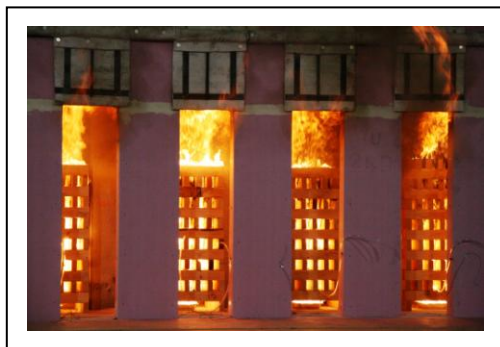
Figure 6 Burning Cribs

The fire was initiated by igniting the methylated spirits in each of the aluminium trays at the bottom of the cribs. This was achieved by remote electrical ignition. A view of the burning cribs shortly after ignition is shown in Figure 6.

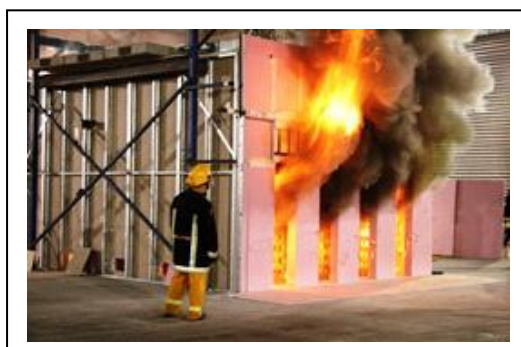
Figure 7 Flames emitted from openings

After ignition of the cribs, significant external burning and flaming was noted at both ends of the enclosure – but particularly at the south end (Figure 7). The temperatures within the enclosure were being constantly monitored and it was considered necessary to reduce the south end ventilation so as to increase the quantity of heat energy being released within the enclosure. This was done using the ventilation closing mechanism. The openings at the south end were maintained at the original height. The low level openings were blocked and subsequently opened depending on the temperatures achieved in the enclosure. During the test, spalling occurred and generated various types of sound which were recorded by the external video recorders.

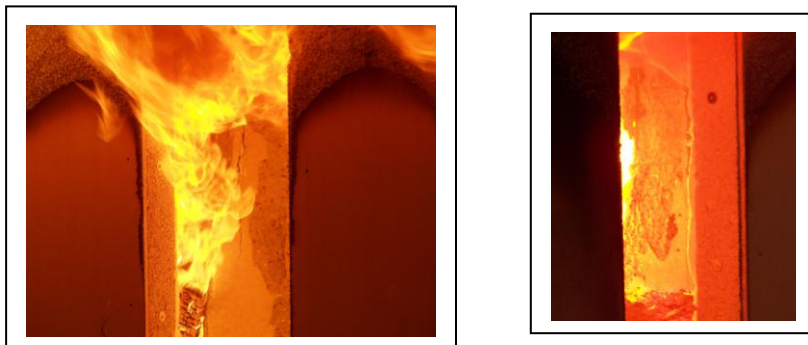
Figure 8 Photos showing spalled columns through flames

Views of the spalled concrete columns at the 30 minute mark are given in Figure 8. In some cases, the “explosive” spalling resulted in pieces of concrete being ejected through the openings of the enclosure on to the floor of the test building.

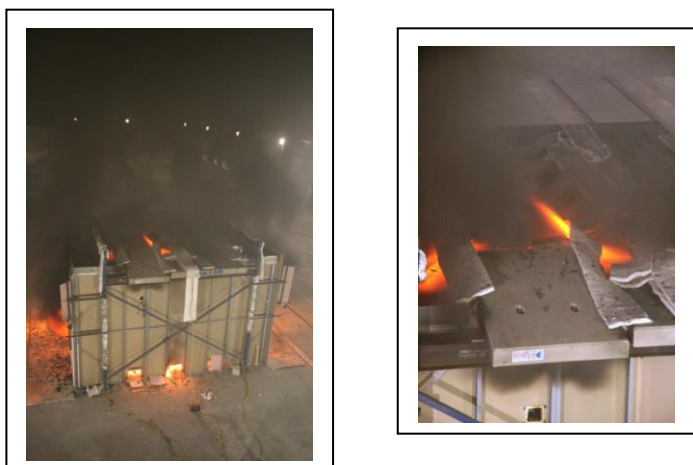
Figure 9 Fracture and failure of Slab S3 at 61 minutes

At 61 minutes, a major crack developed in slab S3 causing the slab to move upwards at the crack and allow flames to pass out of the gap formed at the edge of the slab. This is shown in Figure 9. The test was stopped at 68 minutes due to concern about the broken slab. This was done by reducing the north ventilation and then carefully placing water on the burning fuel so as not to wet the columns. Once the fuel bed had been sufficiently cooled, the north wall of the enclosure was removed and photographs were taken. These are shown in Figure 10.

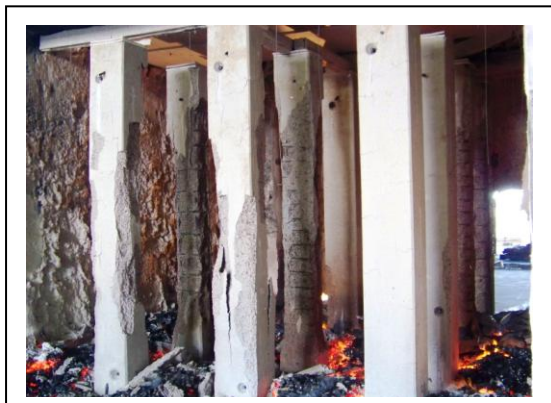
Figure 10 View of columns just after fire with north wall removed

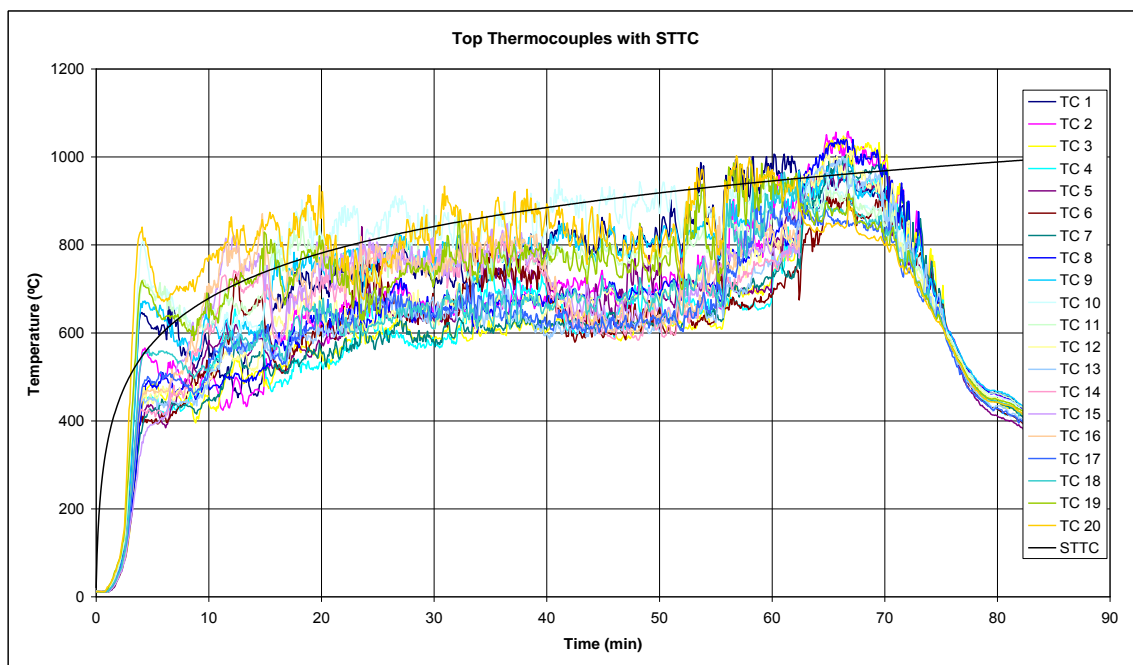
Figure 11 Temperatures as recorded by top level

The gas temperatures within the enclosure for the uppermost layer of thermocouples (i.e. the layer located 400mm below the soffit) are plotted in Figure 11. Also shown in this figure is the standard time temperature curve (STTC) used for heating of elements of construction during standard fire tests according to ISO 834.

It was noted that the bottom layer of temperatures were marginally higher than the top layer at various locations but for both sets of thermocouples, the localised maximum temperatures exceeded the STTC by

up to 200°C at the early stages and 100°C at later stages. However, the average enclosure temperatures at any time were lower than the STTC. At around 60 minutes, the temperatures become more uniform and began to increase significantly. This is thought to be due to the fact that the fuel had essentially turned into a charcoal fuel bed with heat being released more efficiently and with the enclosure surfaces radiating more effectively back into the enclosure.

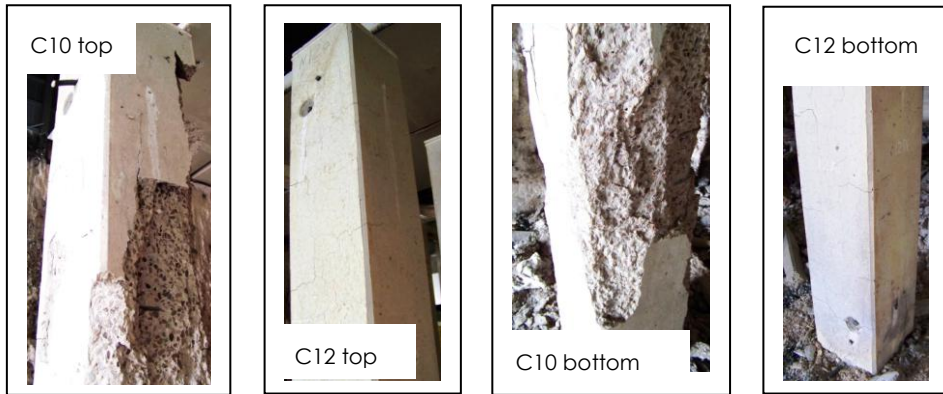
Figure 12 Comparisons of Columns C10 and C12

All of the columns except for those with polypropylene fibres suffered significant spalling. The comparison in behaviour is illustrated in Figure 12 which shows column C10 (no fibre) and column C12 (fibre). Extensive photographs of the columns were taken and diagrammatic records made of the depth of spalling at the most severely affected cross-section. Generally the maximum depth of spalling at locations was to the rear of the ties but in the case of columns C1, C2, C3 and C4 (all basalt aggregates) the depth of spalling extended past the inside of the ties (Figure 13).

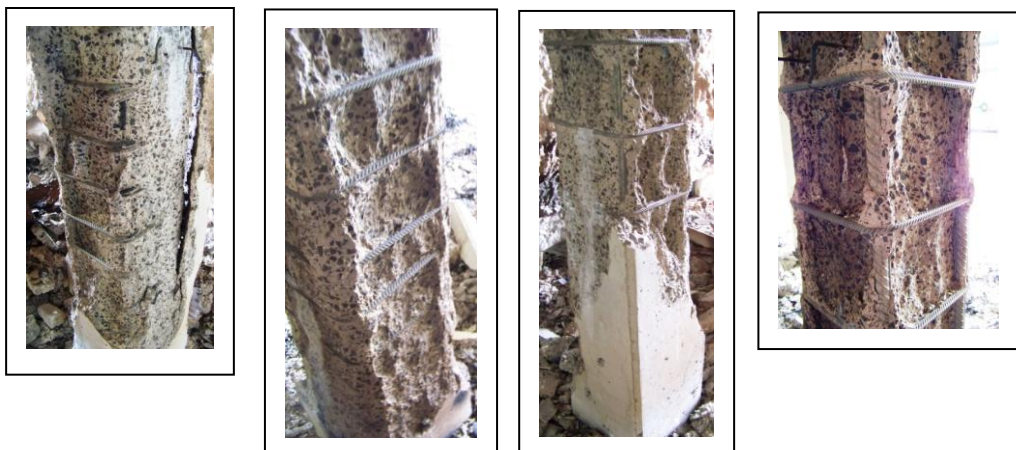
Figure 13 Spalling associated with Columns C1 –C4

The behaviour of columns without polypropylene fibres is now considered. All of these columns suffered serious spalling. The spalling experienced ranged from large pieces (1–2kg) being blown off to smaller pieces being removed on a more or less continuous (staccato) basis. It is noted that the depth of spalling appears to be greater for the columns with basalt aggregate concrete where spalling went well within the column ties at various locations (see Figure 13). The temperatures adjacent to the columns have been considered and it is found that these temperatures were slightly higher for the columns containing Nepean River Gravel. Thus the difference in fire temperature cannot be used to explain the apparent difference in spalling depth.

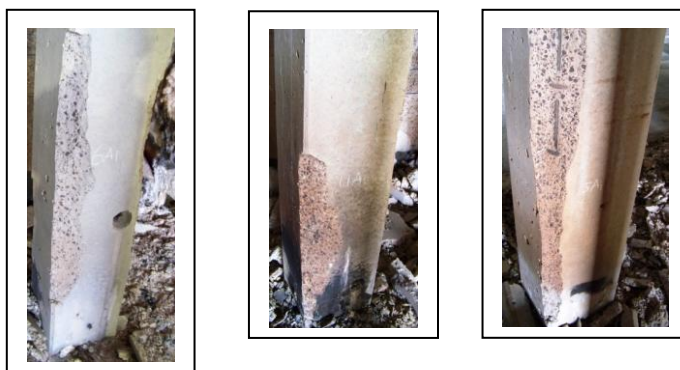
Figure 14 Corner spalling of columns with fibre

In the case of the columns made from concrete with fibre, the column that behaved best was C12 with no loss of concrete whilst the other columns (C5, C6, C11) lost concrete at particular locations from one corner (C5, C11) or two corners (C6) (Figure 14).

It is noted that the locations of corner spalling for columns containing fibres were all associated with the column face containing the lifting lugs – i.e. the uppermost face during casting. Following casting of the columns without fibre, the fibre was added to the mix but by this time the workability of the mix had reduced and placement of concrete within the formwork required considerable compaction. The significance of this requires further consideration and it would be helpful to undertake research to study the effect of compaction of pp fibre distribution in a concrete member given that the addition of such fibres appears to limit the workability of the concrete mix.

It is interesting to note that in the large-scale natural test described by Bailey [14] the supporting columns which were constructed from limestone aggregates (known to perform better in fire) and with pp fibres added at a rate of 2.7kg/m³ showed little but not a complete absence of spalling showing similar behaviour to that shown in Figure 14.

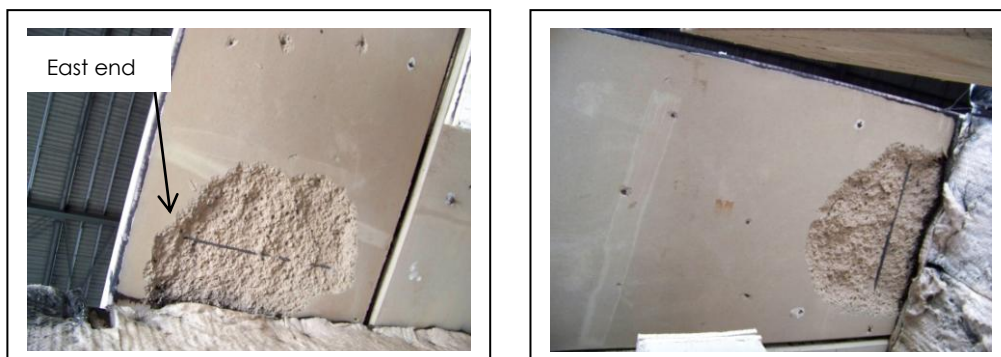
Figure 15 Localised Spalling at the ends of Slab S1

As far as the slabs were concerned, Slab S2 exhibited no spalling at all whereas Slab S1 exhibited spalling at the ends of the slab below the anchorages (Figure 15) but not elsewhere. The spalling at the east end of the slab measured approximately 750mm x 600mm in area and was 30mm deep whilst that at the other end was slightly less in area but 40mm deep.

One of the slabs constructed from basalt aggregate exhibited no spalling whereas the other slab, of nominally identical construction, spalled at each end of the slab. No reason is offered for the difference in behaviour except that it could be due to normal fire test variability. Further testing is recommended. It is likely that the addition of polypropylene fibres to the concrete mix would have minimised the spalling at the ends of Slab S1.

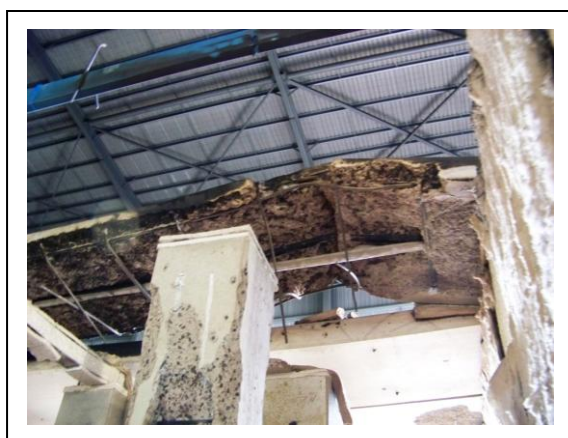
Figure 16 View of Slab S3 showing spalling

Figure 16 shows Slab S3 after the test and the associated extensive spalling. In this case the reinforcement and prestressing duct were completely exposed with the depth of spalling exceeding one half the depth of

the slab. It will be noted from Figure 16 that the slab appears to have displaced upwards. This, at first sight, is a surprising outcome. However, as spalling progressed the self-weight of the slab would have been significantly reduced and this would have resulted in the overhang with greater mass tending to displace

downwards especially with loss of flexural strength at the crack due to progressive spalling. The sudden upwards movement of the slab is probably explained by reduction of compressive resistance at one location due to spalling such that the residual force in the prestressing tendons caused the slab to move upwards resulting in failure of the concrete at this location resulting in formation of the observed crack across the width of the slab. The slab was able to remain in this position due to the tendon acting as a tie and the slab and associated top reinforcement forming an arch. The resultant self-weight was therefore supported by tied arch action and the mass associated with the overhangs. Subsequent examination of the tendon indicated that this was substantially intact and therefore had not failed during the test.

The exposed surface of the slab suggested that most of the exposed surface appeared to have experienced a “pitting” type of spalling and this would well have corresponded to the staccato spalling noise mentioned previously. This appears to have been associated with fracture of the aggregate.
