# Fire Performance of Timber Structures under Natural Fire Conditions

ANDREA FRANGI and MARIO FONTANA  
Institute of Structural Engineering IBK  
Group for Steel, Timber and Composite Structures  
Swiss Federal Institute of Technology ETH Zurich  
IBK, HIL D36.2  
CH-8093 Zurich, Switzerland

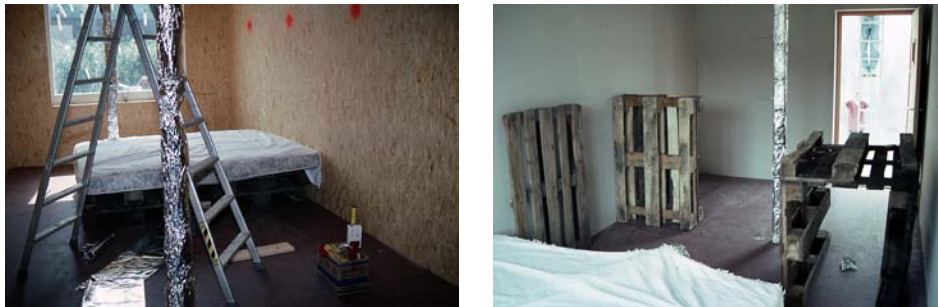
Fig. 2. Movable fire load consisting of a mattress (left) and wooden pallets (right).

In building fires, the contents (movable fire load) as well as combustible construction materials contribute to the total fire load. In a hotel room, the contents consist mostly of beds, tables, cabinets, electronic apparatus, etc. Each module was equipped with a typical mattress (1.6 x 2.0 m) made of foam material (see Fig. 2 left). As additional movable fire load, 11 wooden pallets were located in the module (see Fig. 2 right). The mattress was ignited with four dl n-heptane.

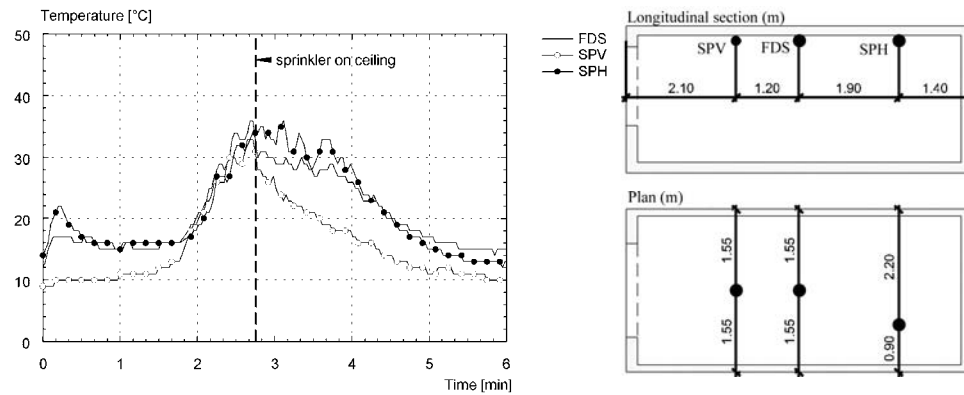
Fig. 3. Room temperatures measured on the ceiling for the first fire test (BE bb g).

Figure 3 shows the temperatures measured on the ceiling for the first fire test (BE bb g). In all experiments, at the time of the sprinkler activation the room temperatures measured at different locations varied between 50°C and 200°C. Because flashover occurs only at higher temperatures, the combustible room linings during the early stage of the fire development had no influence on the activation of the sprinkler systems.

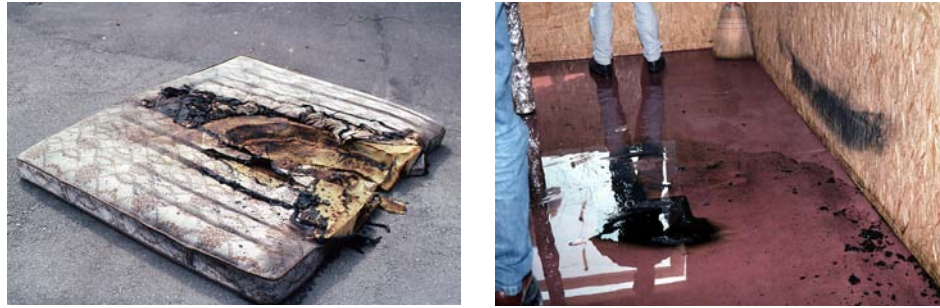
Fig. 4. Damages on the mattress (left) and on the wall and the floor (right).

In all experiments, the sprinkler system was able to extinguish the fire before the fire could spread on further goods or even on the combustible room surfaces. On the other hand, for the second series of tests with deactivated sprinkler systems, flashover occurred only a few minutes after the theoretical activation of the sprinkler systems. Figure 4 shows the damage on the mattress as well as on the wall and the floor. It can be seen, that because of the fast activation of the sprinkler system, the damages were very small. Even the mattress was not completely burned up. The tests have confirmed that with fast response sprinkler systems the influence of a combustible structure on the fire safety was compensated and the fire safety objectives can be fulfilled by any type of construction. Despite fast fire development, the structure was undamaged because the sprinkler system extinguished the fire in an early stage.

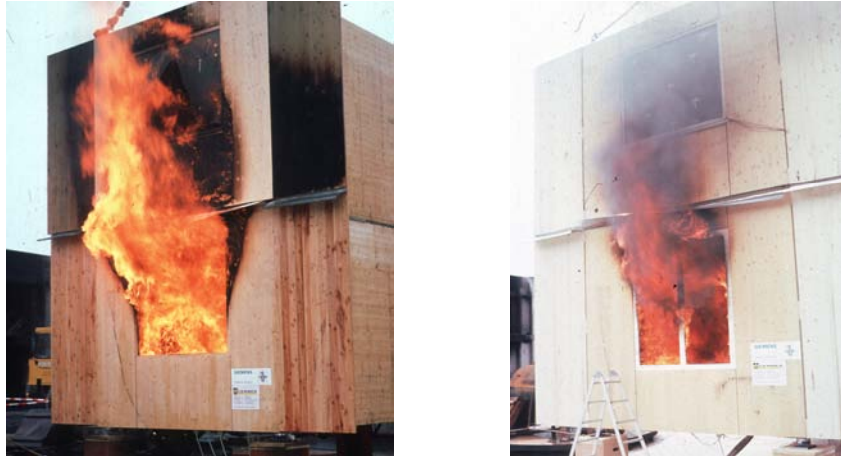
Fig. 5. Fire development 7 minutes after fire ignition; left: lower module with combustible linings (fire test BÜ bb), right: lower module with non combustible linings (fire test BÜ nbb).

The influence of combustible linings was clearly observed after flashover occurred. For the module with combustible wall and ceiling linings the external burning out the window was much more severe than for the modules with non combustible wall and ceiling linings (see Fig. 5). The temperatures measured with the infrared camera on the facade confirmed the visual observation (see Fig. 6).

The tests with non combustible linings also showed that the 250 mm protruding ledge made of 1 mm thick steel sheet and placed on the facade between the lower and the upper module (see Fig. 5) was able to delay the fire spread over the facade and to limit the damages at the facade. In these tests, the interior glass of the upper window failed only after about 40 and 42 minutes. In the case of the test with combustible linings the heat flux from the flames emerging from the window opening on the facade was much higher and therefore fire spread could not be significantly delayed by the ledge. In this test, the

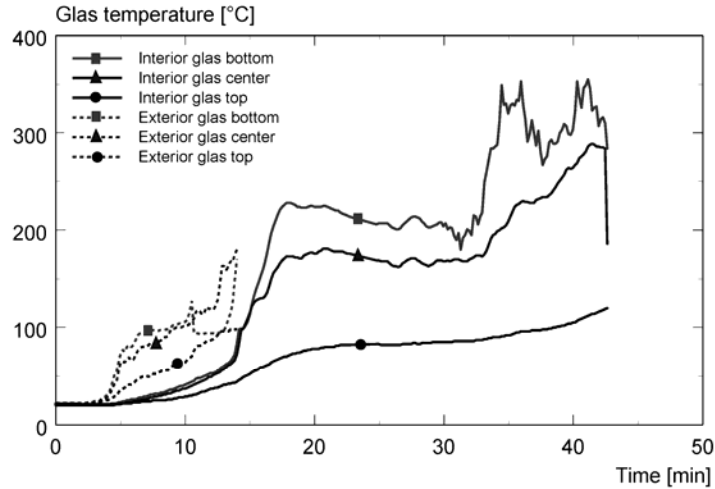
Fig. 7. Temperatures measured at different heights (bottom, center and top) on the interior as well as the exterior glass of the upper module for the fire test BÜ nbb.

Figure 7 shows the temperatures measured at different heights on the interior as well as the exterior glass of the upper module for the fire test BÜ nbb. When the exterior glass failed, the maximum and minimum glass temperatures were 200°C and 100°C, respectively. On the interior glass, a first crack was observed after 34 minutes. At that time, the maximum and minimum glass temperatures were 230°C and 70°C, respectively. Similar results were observed also in the other tests. In the test BÜ nbb demo, the exterior glass collapsed with maximum and minimum glass temperatures of 220°C and 80°C, respectively.

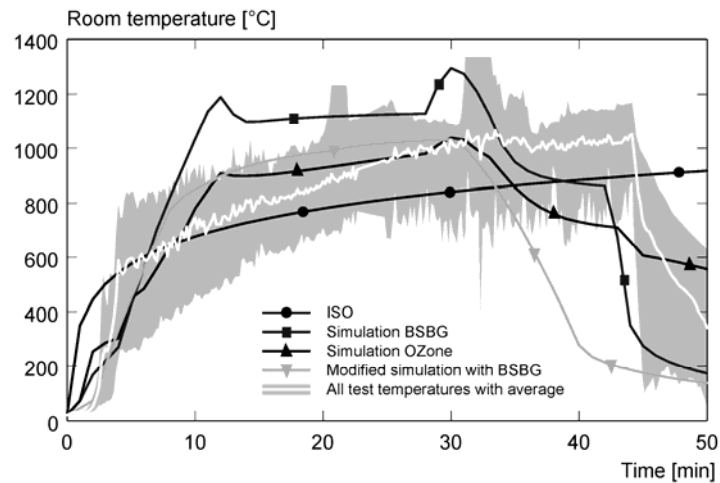
Fig. 9. Comparison between simulations and results of the test BÜ nbb.

The temperature development in the module was simulated using two different softwares (BSBG and OZone). Figure 9 shows the comparison between simulations and results of the test BÜ nbb. Figure 9 also reports the ISO standard fire curve. It can be seen, that the temperatures measured in the fire compartment were higher than in case of the ISO standard fire curve. Further, a good agreement between test results and simulations with Ozone and modified BSBG was observed during the first half hour of the fire test. After that time, the simulations predicted a reduction of the temperature in the module, which was not observed. A possible reason is that after about 30 minutes the lining made of one layer gypsum plasterboard begun falling down, so that the wood based fibreboards placed behind the gypsum plasterboard started burning and contributed to the fire load.
