F.R. Note No. 2967 אינידו

A VISIT TO THE SCENE OF A FIRE AT THE AMALGAMATED DENTAL ENGINEERING CO., HAMM MOOR LANE, CHERTSEY, SURREY.

H. L. Malhotra

February, 1957.

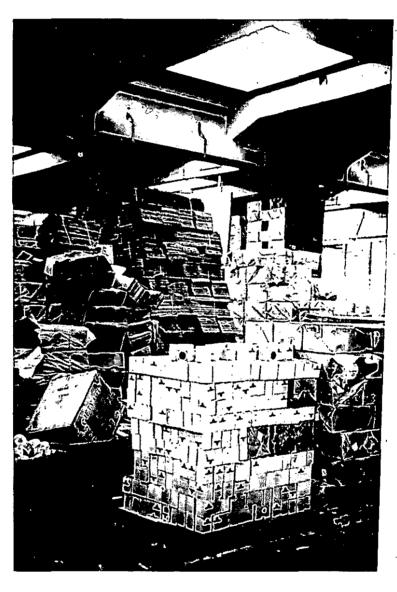
Figure 1 shows the layout of the bay which was affected by the fire, and Figure 2 shows from below the construction of the roof for an undamaged part of the building, clearly illustrating the prestressed concrete planks supported by secondary beams. The skylights which are visible in Figure 2 consisted of wired glass domes in aluminium alloy framing. The underside of the roof was painted with distemper.

FIG. 2. INTERIOR VIEW OF BUILDING SHOWING CONSTRUCTION
