F.R. Note No.444.

THERMAL CONDITIONS IN SHIPS' LIFEBOATS ENVELOPED IN FIRE

P. Nash and R. H. Bignore

September, 1960.

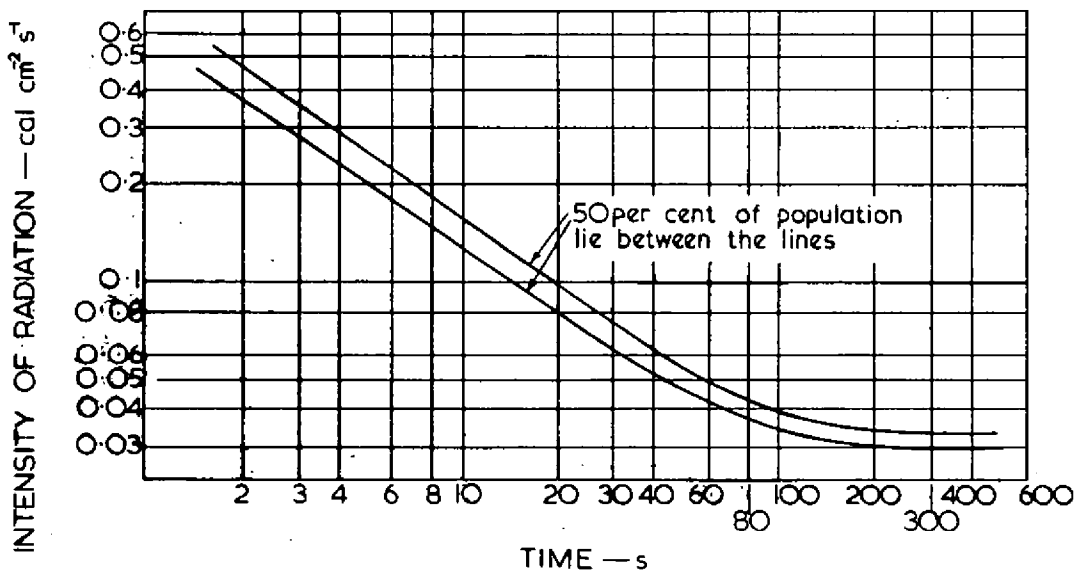
FIG. 8. TOLERANCE TIMES OF RESTING MEN

An examination by Buettner of the tolerance limits of men exposed to hot air and radiant heat suggests that for 5 minutes exposure, an air temperature of 120°C could be tolerated and a radiant intensity of 0.03 cal/cm²/s falling on the bare skin would not cause unbearable pain. (See Figs. 8 and 9).
