FIRE AND THE MOTOR CAR

**RESULTS OF TESTS ON THE PROPAGATION OF FIRE
IN PARKED CARS**

October 1967.

**FIRE
RESEARCH
STATION**

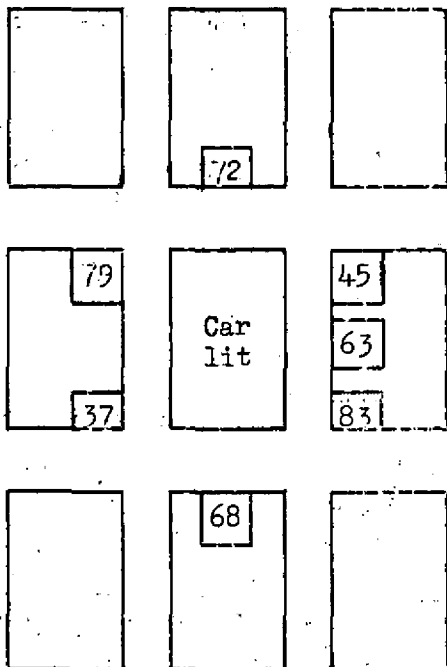
Test No.2.

Time of intense burning taken to be 20 min. (This time is less than that required by the block to attain temperature equilibrium and the estimates of intensity of radiation obtained from the surface temperature measurements will therefore be too low)

Block	Intensity from reflectivity change cal cm ⁻² s ⁻¹	Intensity from depth of charring cal cm ⁻² s ⁻¹	Intensity from surface temperature cal cm ⁻² s ⁻¹
72	0.23		
45	0.17		
63	0.32	0.31	
83	0.14		0.06 - 0.1
68	0.11		0.06 - 0.1
37	0.11		0.06 - 0.1
79	-	0.6

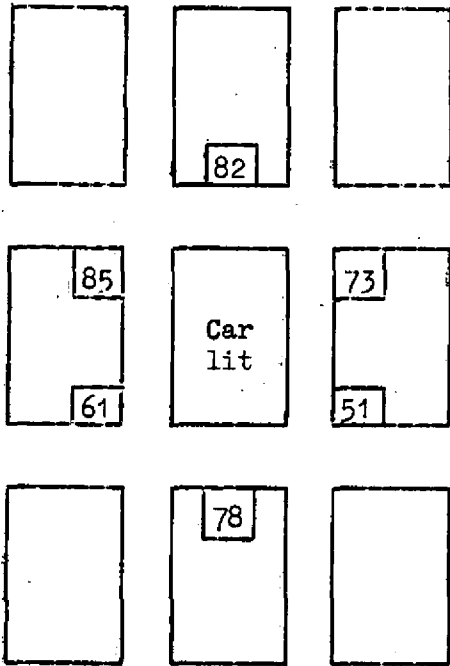
Test No. 3.

Time of exposure taken to be 20 min. (see note on Test No.2)

Block	Intensity from reflectivity change cal cm ⁻² s ⁻¹	Intensity from depth of charring cal cm ⁻² s ⁻¹	Intensity from surface temperature cal cm ⁻² s ⁻¹
82	0.1	No charring	0.06 - 0.1
73	0.12		0.06 - 0.1
51	0.11		0.06 - 0.1
78	0.12		0.06 - 0.1
61	0.15		0.06 - 0.1
85	0.11		0.06 - 0.1

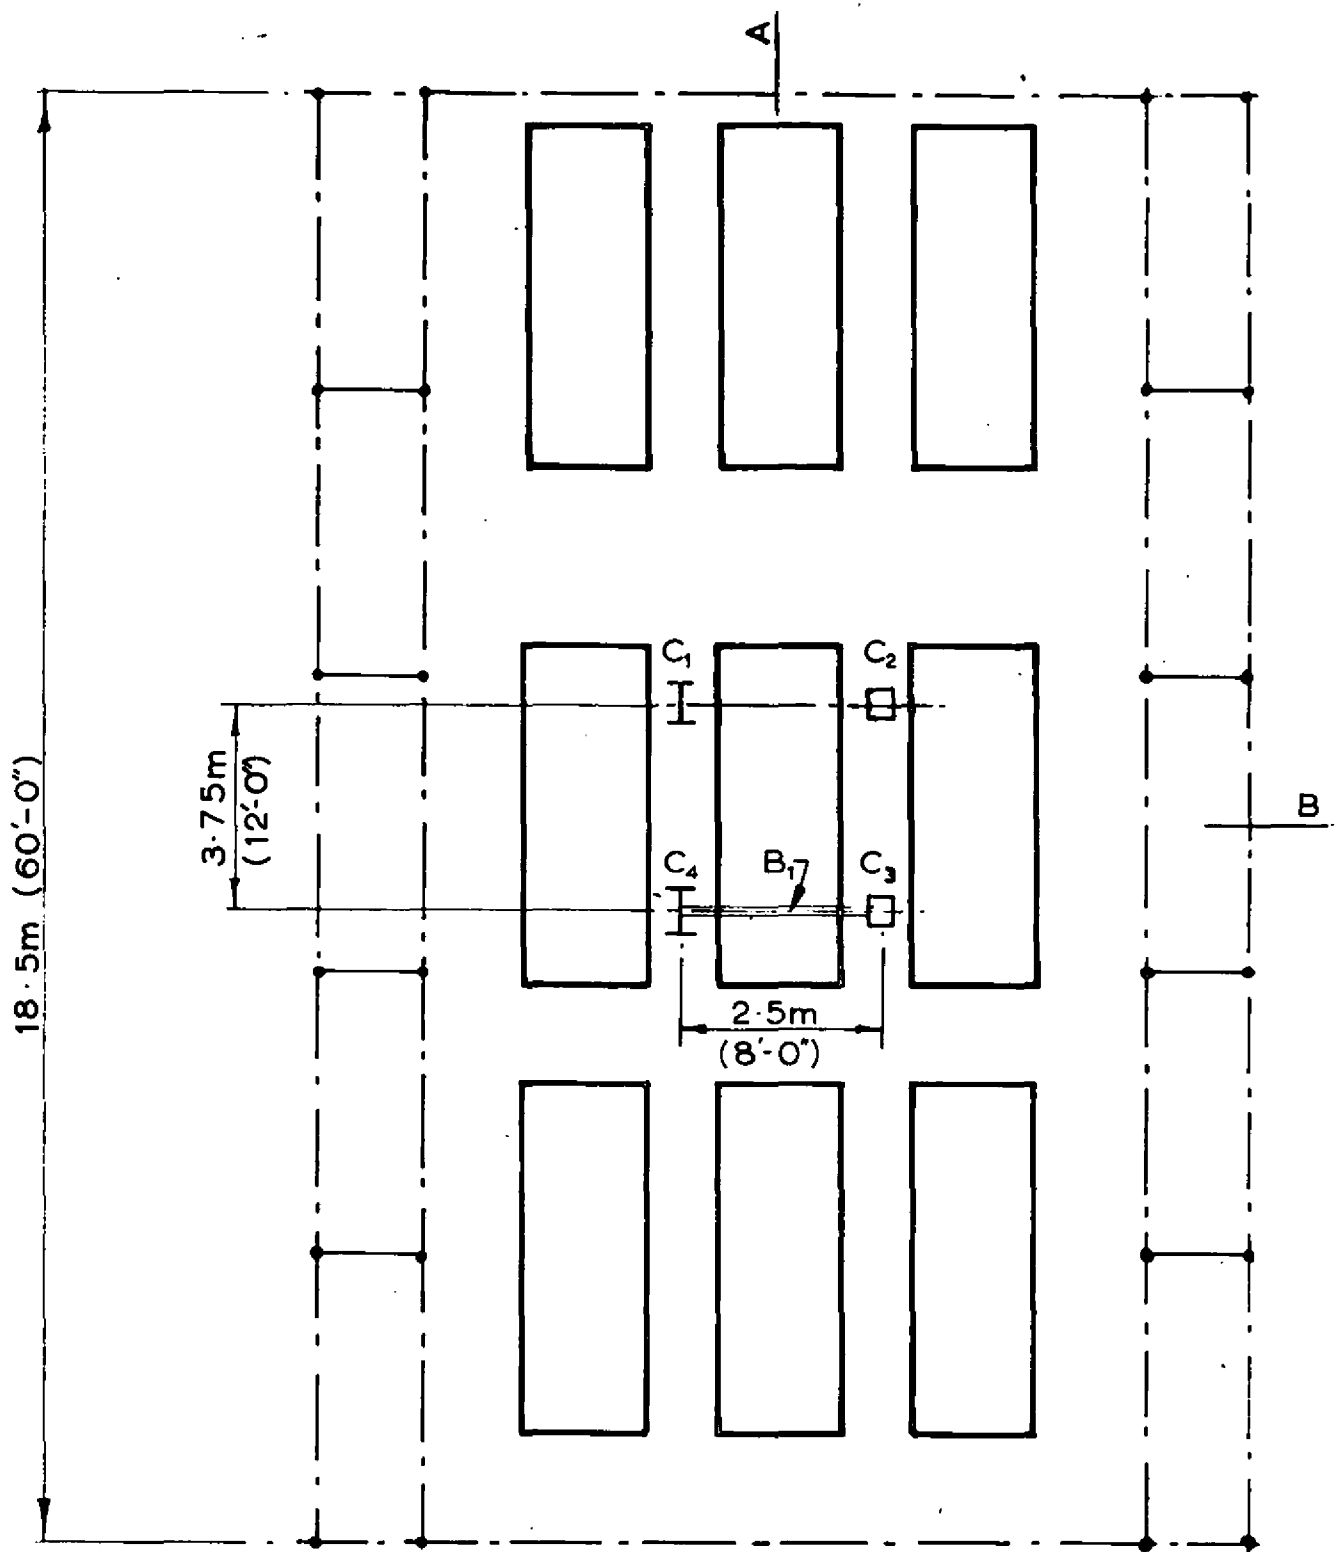
FIG.1a. PLAN SHOWING THE POSITION OF STEEL MEMBERS, CARS AND TEMPORARY SCAFFOLDING

- C_1 - 26.7cm x 25.8cm x 107 kg/m (10"x10"x72 lb/ft)
- C_2, C_3 - 10.3cm x 10.3cm x 9.7 kg/m (4"x4"x6½ lb/ft)
- C_4 - 20.6cm x 20.4cm x 5.2 kg/m (8"x8"x35 lb/ft)
- B_7 - 7.75cm x 3.8cm x 6.7 kg/m (3"x1½"x4½ lb/ft)

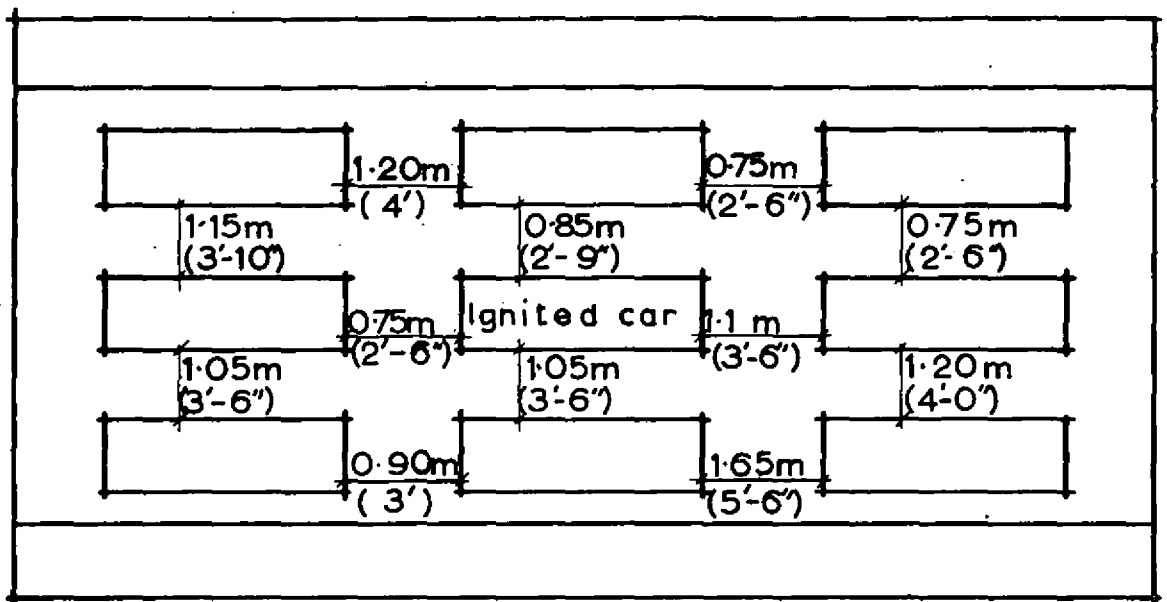
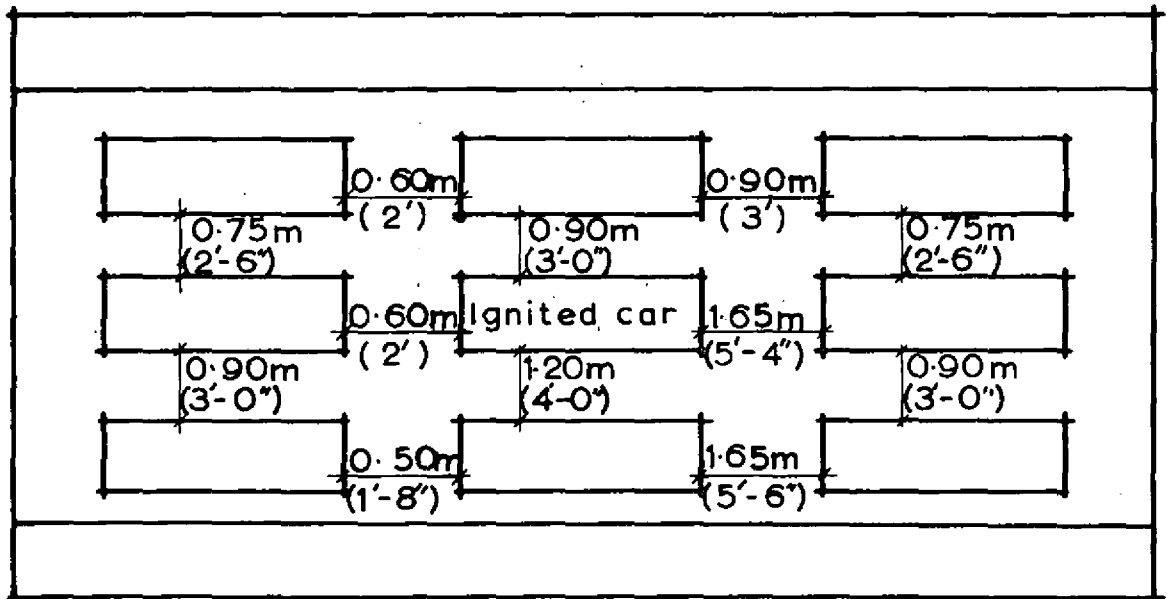
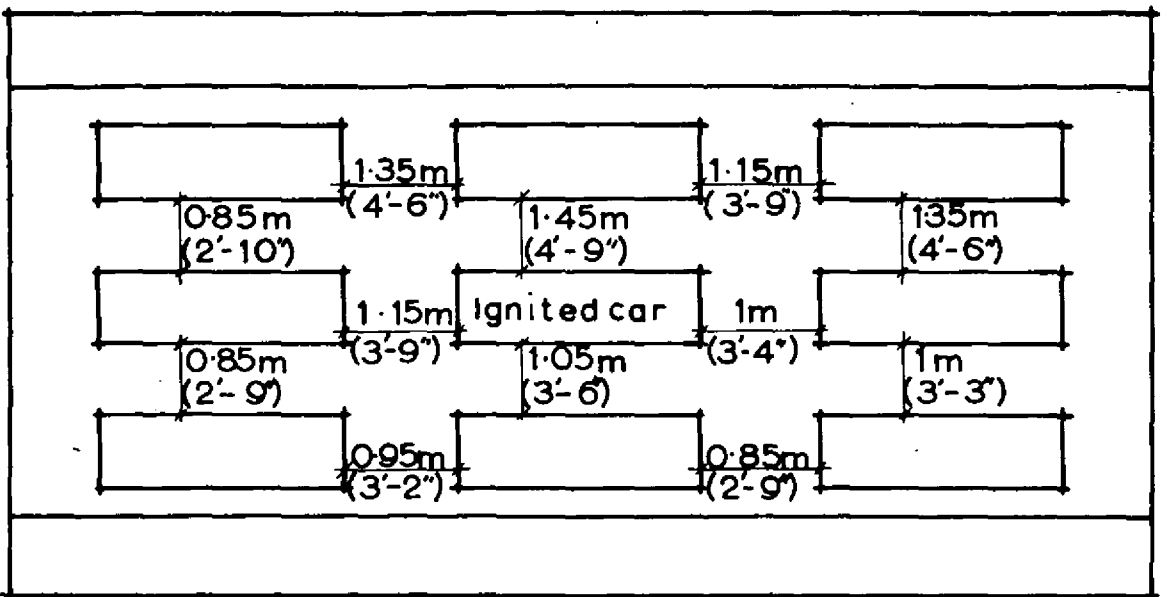
FIG.2. POSITION AND SPACING OF CARS FOR THREE TESTS

The minimum number of cars which was considered necessary to establish the most congested parking conditions was nine cars laid out in three parallel rows of three. The cars selected for the test were typical vehicles as complete as possible, i.e. having tyres, upholstery and a tank capable of holding petrol. All vehicles were fuelled with five gallons of petrol and combustible materials were placed inside the cars to represent items of personal luggage. As has already been stated, the spacing of vehicles can influence the fire load conditions. The spacing selected was considered to be the minimum which could be tolerated in the car park of the type under consideration, and the actual spacing between individual cars in the three tests is shown in Fig.2.

The centre car (see Fig.2) was ignited and the fire allowed to develop naturally and to continue to burn until it had either burnt itself out or the temperatures reached had fallen to an insignificant level, at which point the Fire Service, who were in attendance at all three tests, extinguished the remaining burning materials. As far as was practicable with the vehicles available the windows were closed on the assumption that security would expect such conditions to be found in the car park. However, for the ignited car the drivers window was left half open. At the completion of each test the burnt-out car was moved to the least vulnerable position and the assembly repositioned for another test with, as near as possible, identical test conditions. The weather conditions were similar for all three tests and could be said to be fairly typical. Wind speeds within the range of 6-12 m.p.h. and gusts of a maximum 18 m.p.h. were experienced. Conditions could therefore be said to be those which would be experienced in a multi-storey building.
