# Fire Research Note No. 835

FIRE TESTS IN TWO CARAVANS

E.G. BUTCHER and G.K. BEDFORD

September 1970

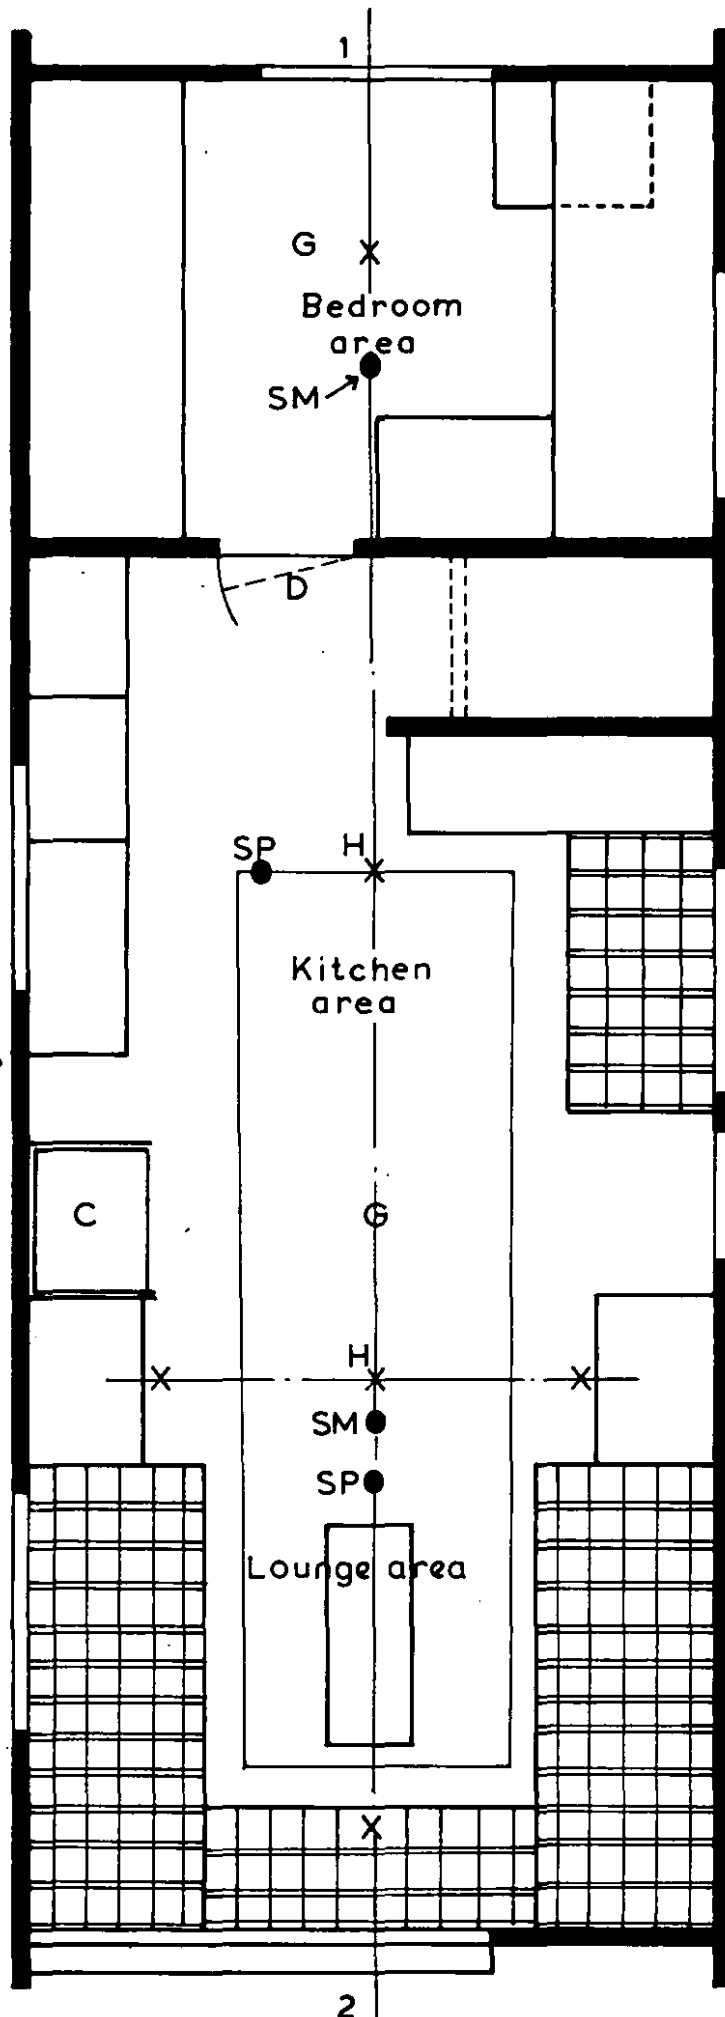
FIG. 1. PLAN OF CARAVAN

a) In one caravan a simple sprinkler system was installed. This consisted of two 9.4 mm bore (0.375 in) sprinkler heads (pendent type) each with its own pressurized water supply of 9 l at  $690 \times 10^3 \text{ N/m}^2$  (2 gallons at 100 p.s.i.) designed to operate at  $67.4^\circ \text{C}$  ( $155^\circ \text{F}$ ) and giving a discharge time of 25 seconds. Their position is denoted by the letters SP in Fig.1.

b) Smoke detectors of a type using an ionization chamber were fixed to the ceiling in both caravans, their position is denoted by the letters SM in Fig.1.

Accordingly a small electric fire element, representing the overheated flue pipe was placed at one end of a ventilated cupboard 0.61 m x 0.61 m x 0.31 m (2 ft x 2 ft x 1 ft) deep, positioned 0.92 m (3 ft) from floor level as shown by the letter C in Fig.1.

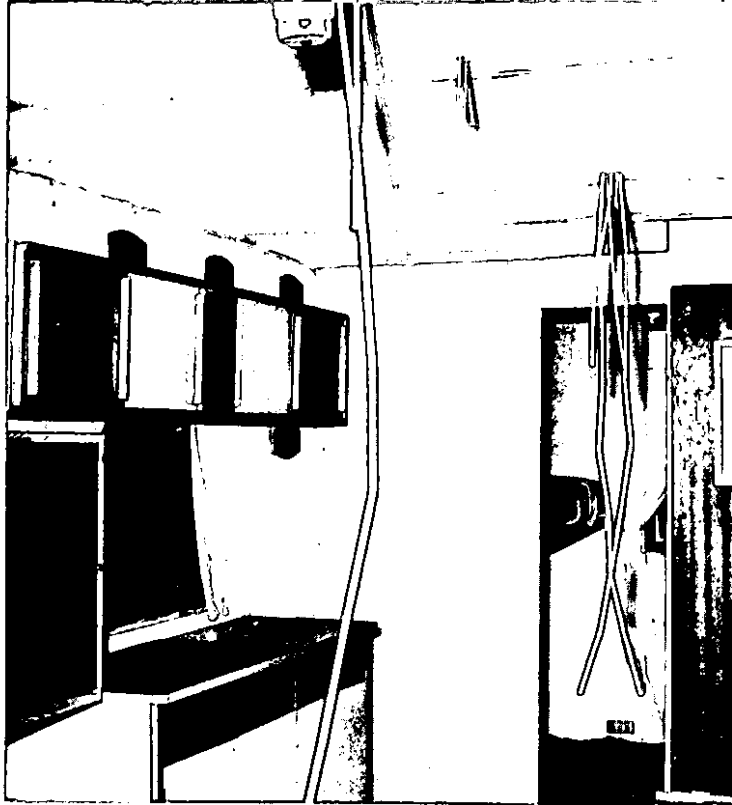
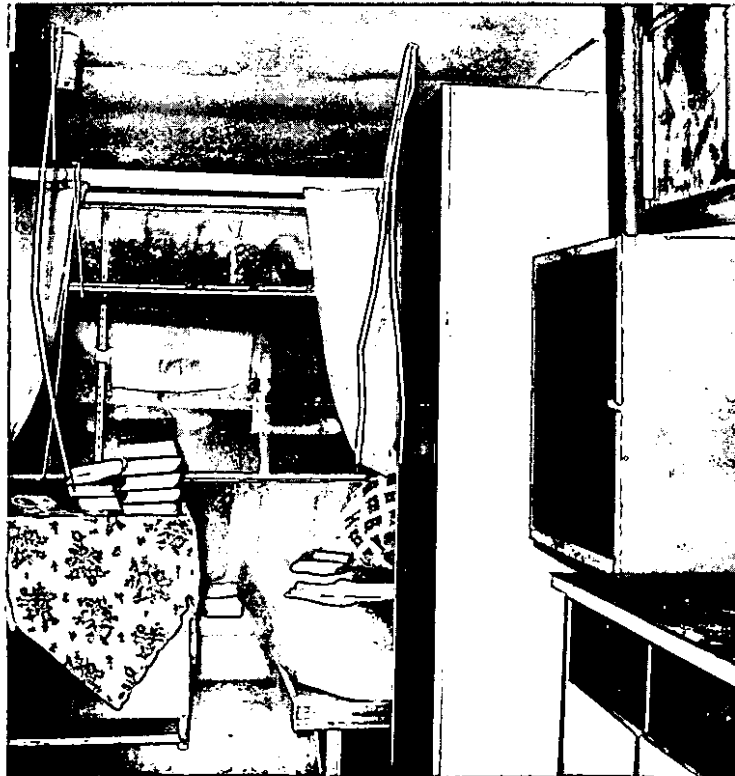
PLATE 2

INTERIOR OF CARAVANS AND FURNITURE ARRANGEMENTS
