Fire Research Note No. 855

AN INVESTIGATION INTO THE FIRE RESISTANCE
OF TIMBER DOORS

W. A. MORRIS

January 1971

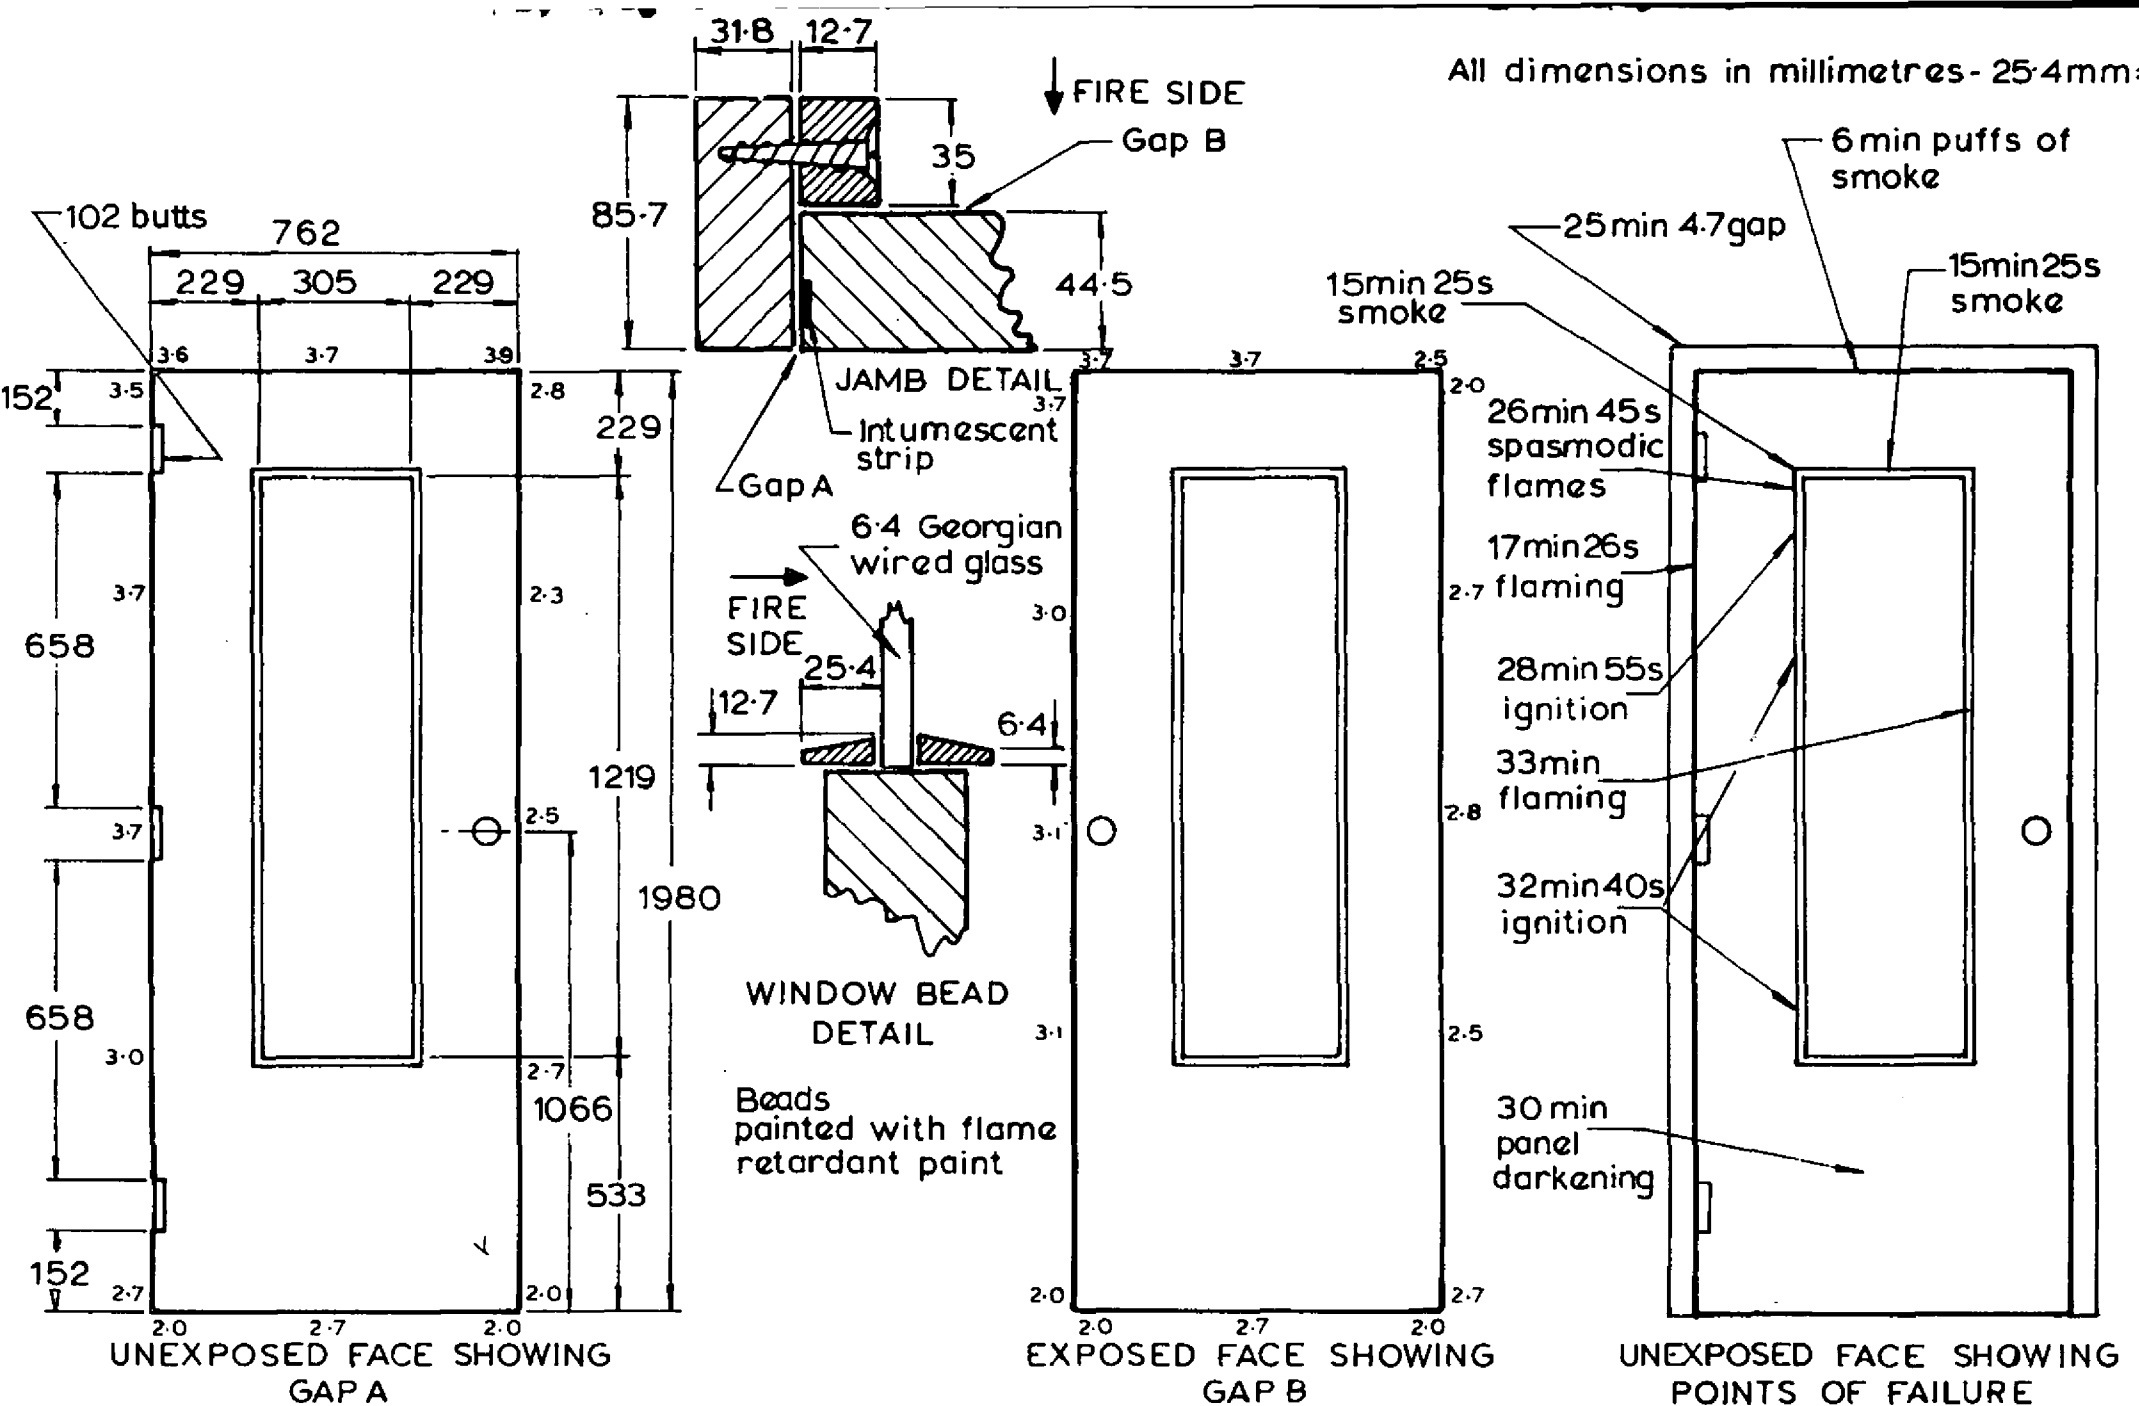
FIG. 7 DOOR TYPE C₂

The timber glazing bead of door C_2 was treated with an intumescent paint but premature failure occurred when the fire penetrated between the planted beads and the door frame. (Plate 8). It is preferable to locate the glass in a rebated frame rather than by planted beading on both sides of the glass.

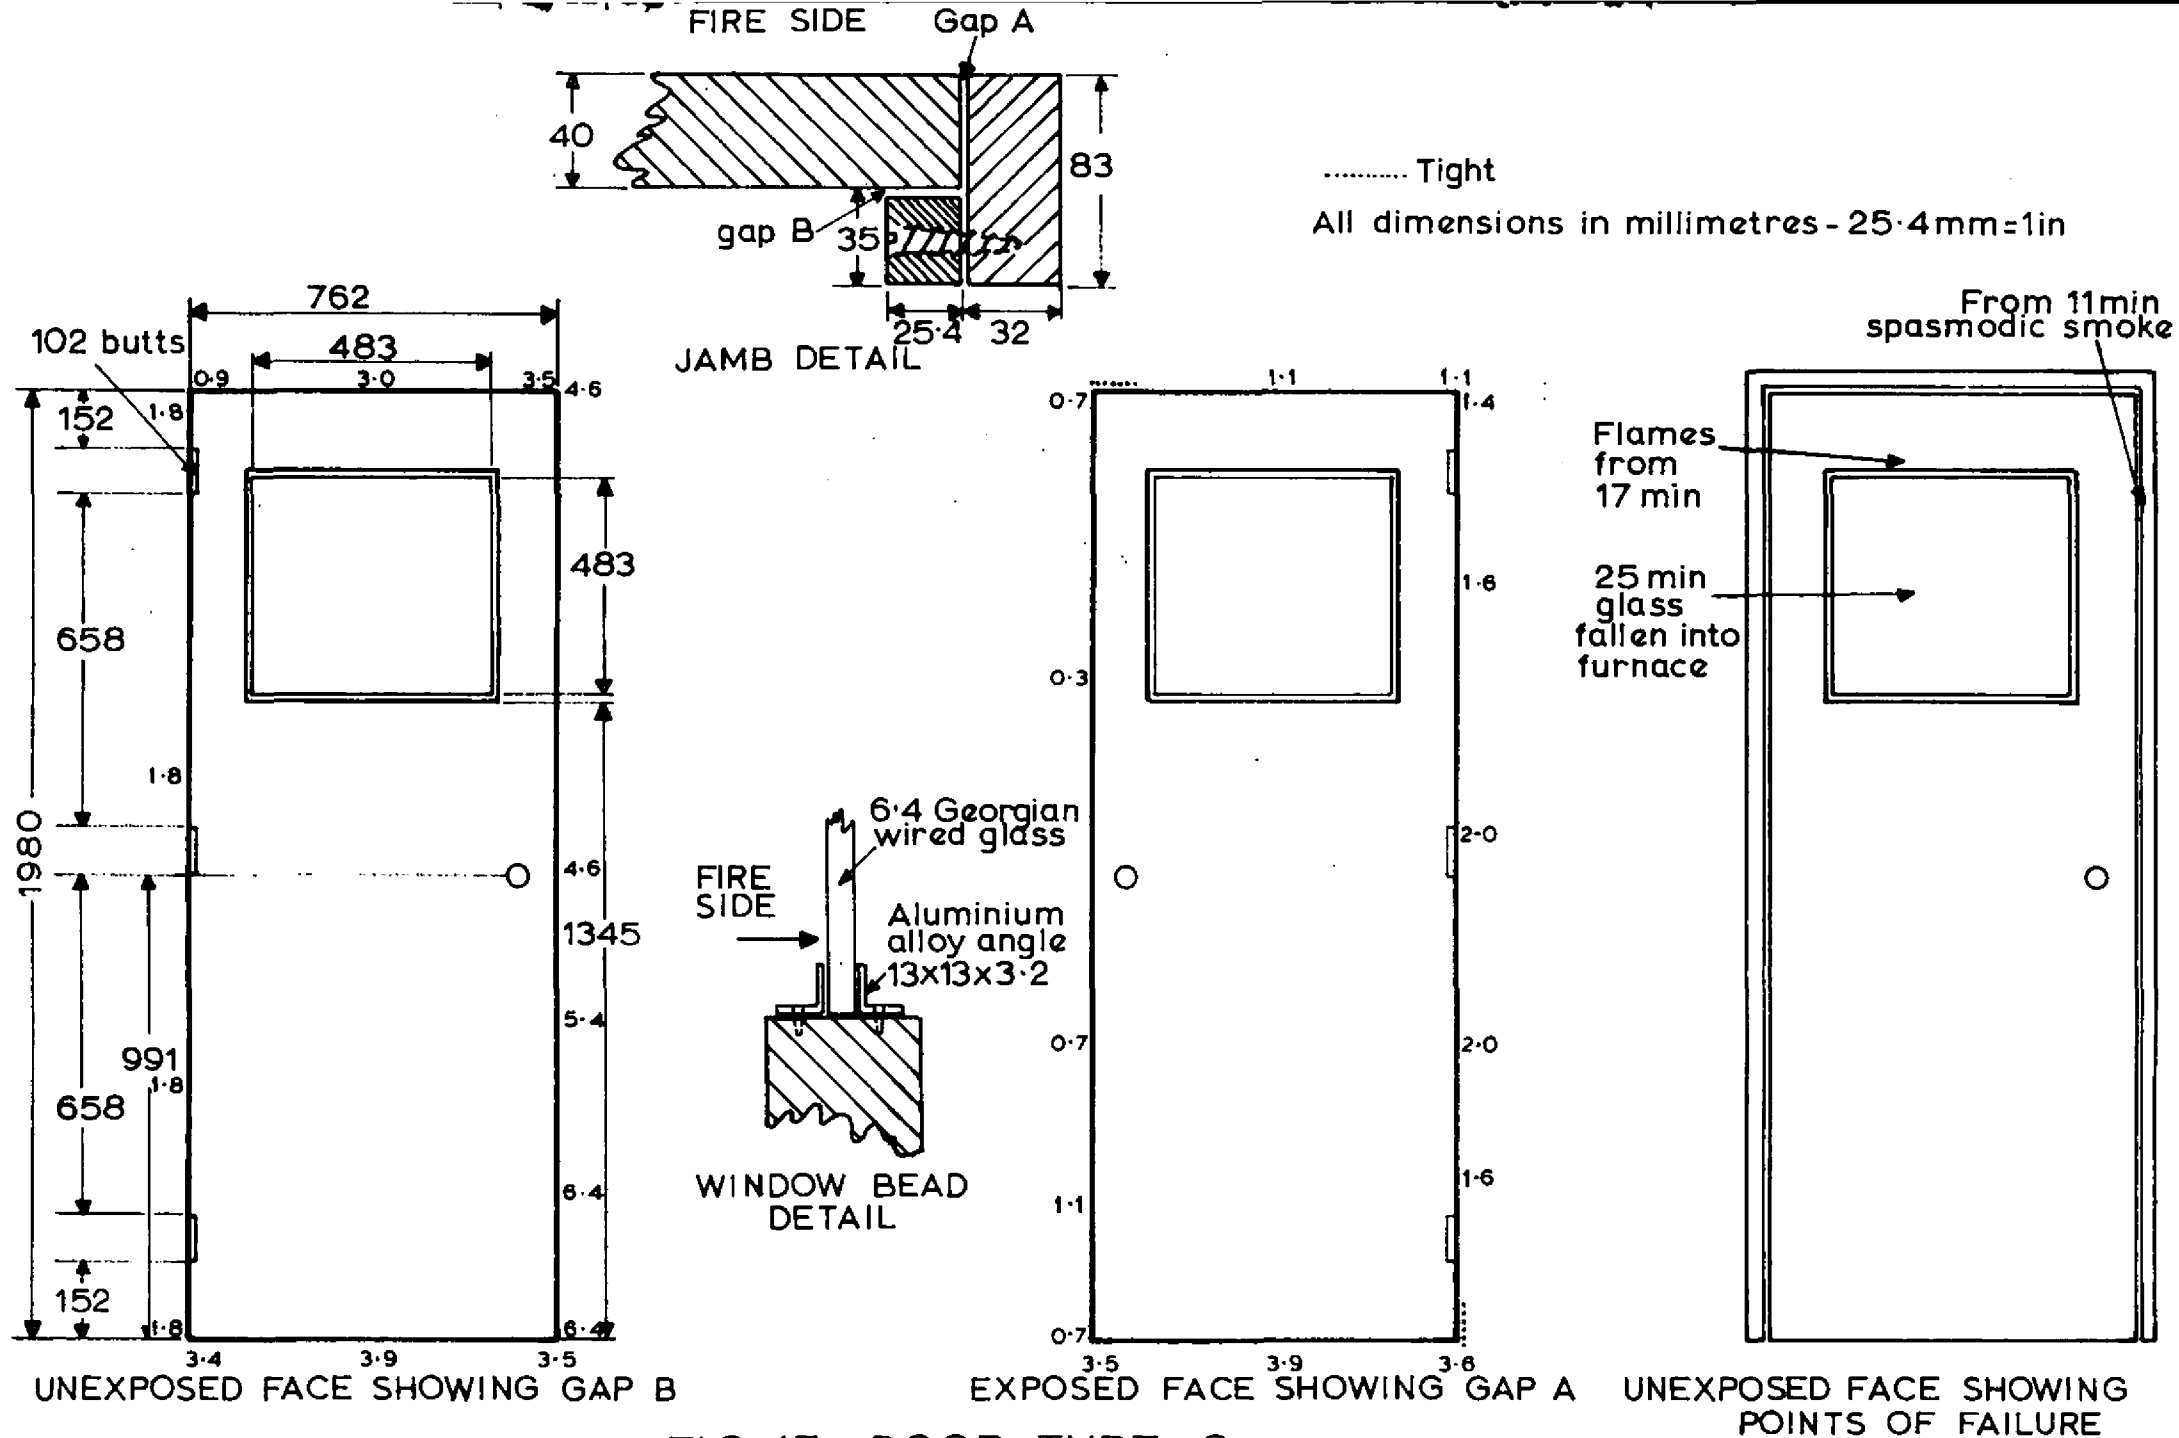
FIG.15. DOOR TYPE G2

In two tests (doors ' G_2 ' and ' H_2 ') the glazing was retained by aluminium and PVC beading. Door ' G_2 ' with the aluminium beading failed at 17 minutes the glass collapsing before the end of the test. (Plate 9).

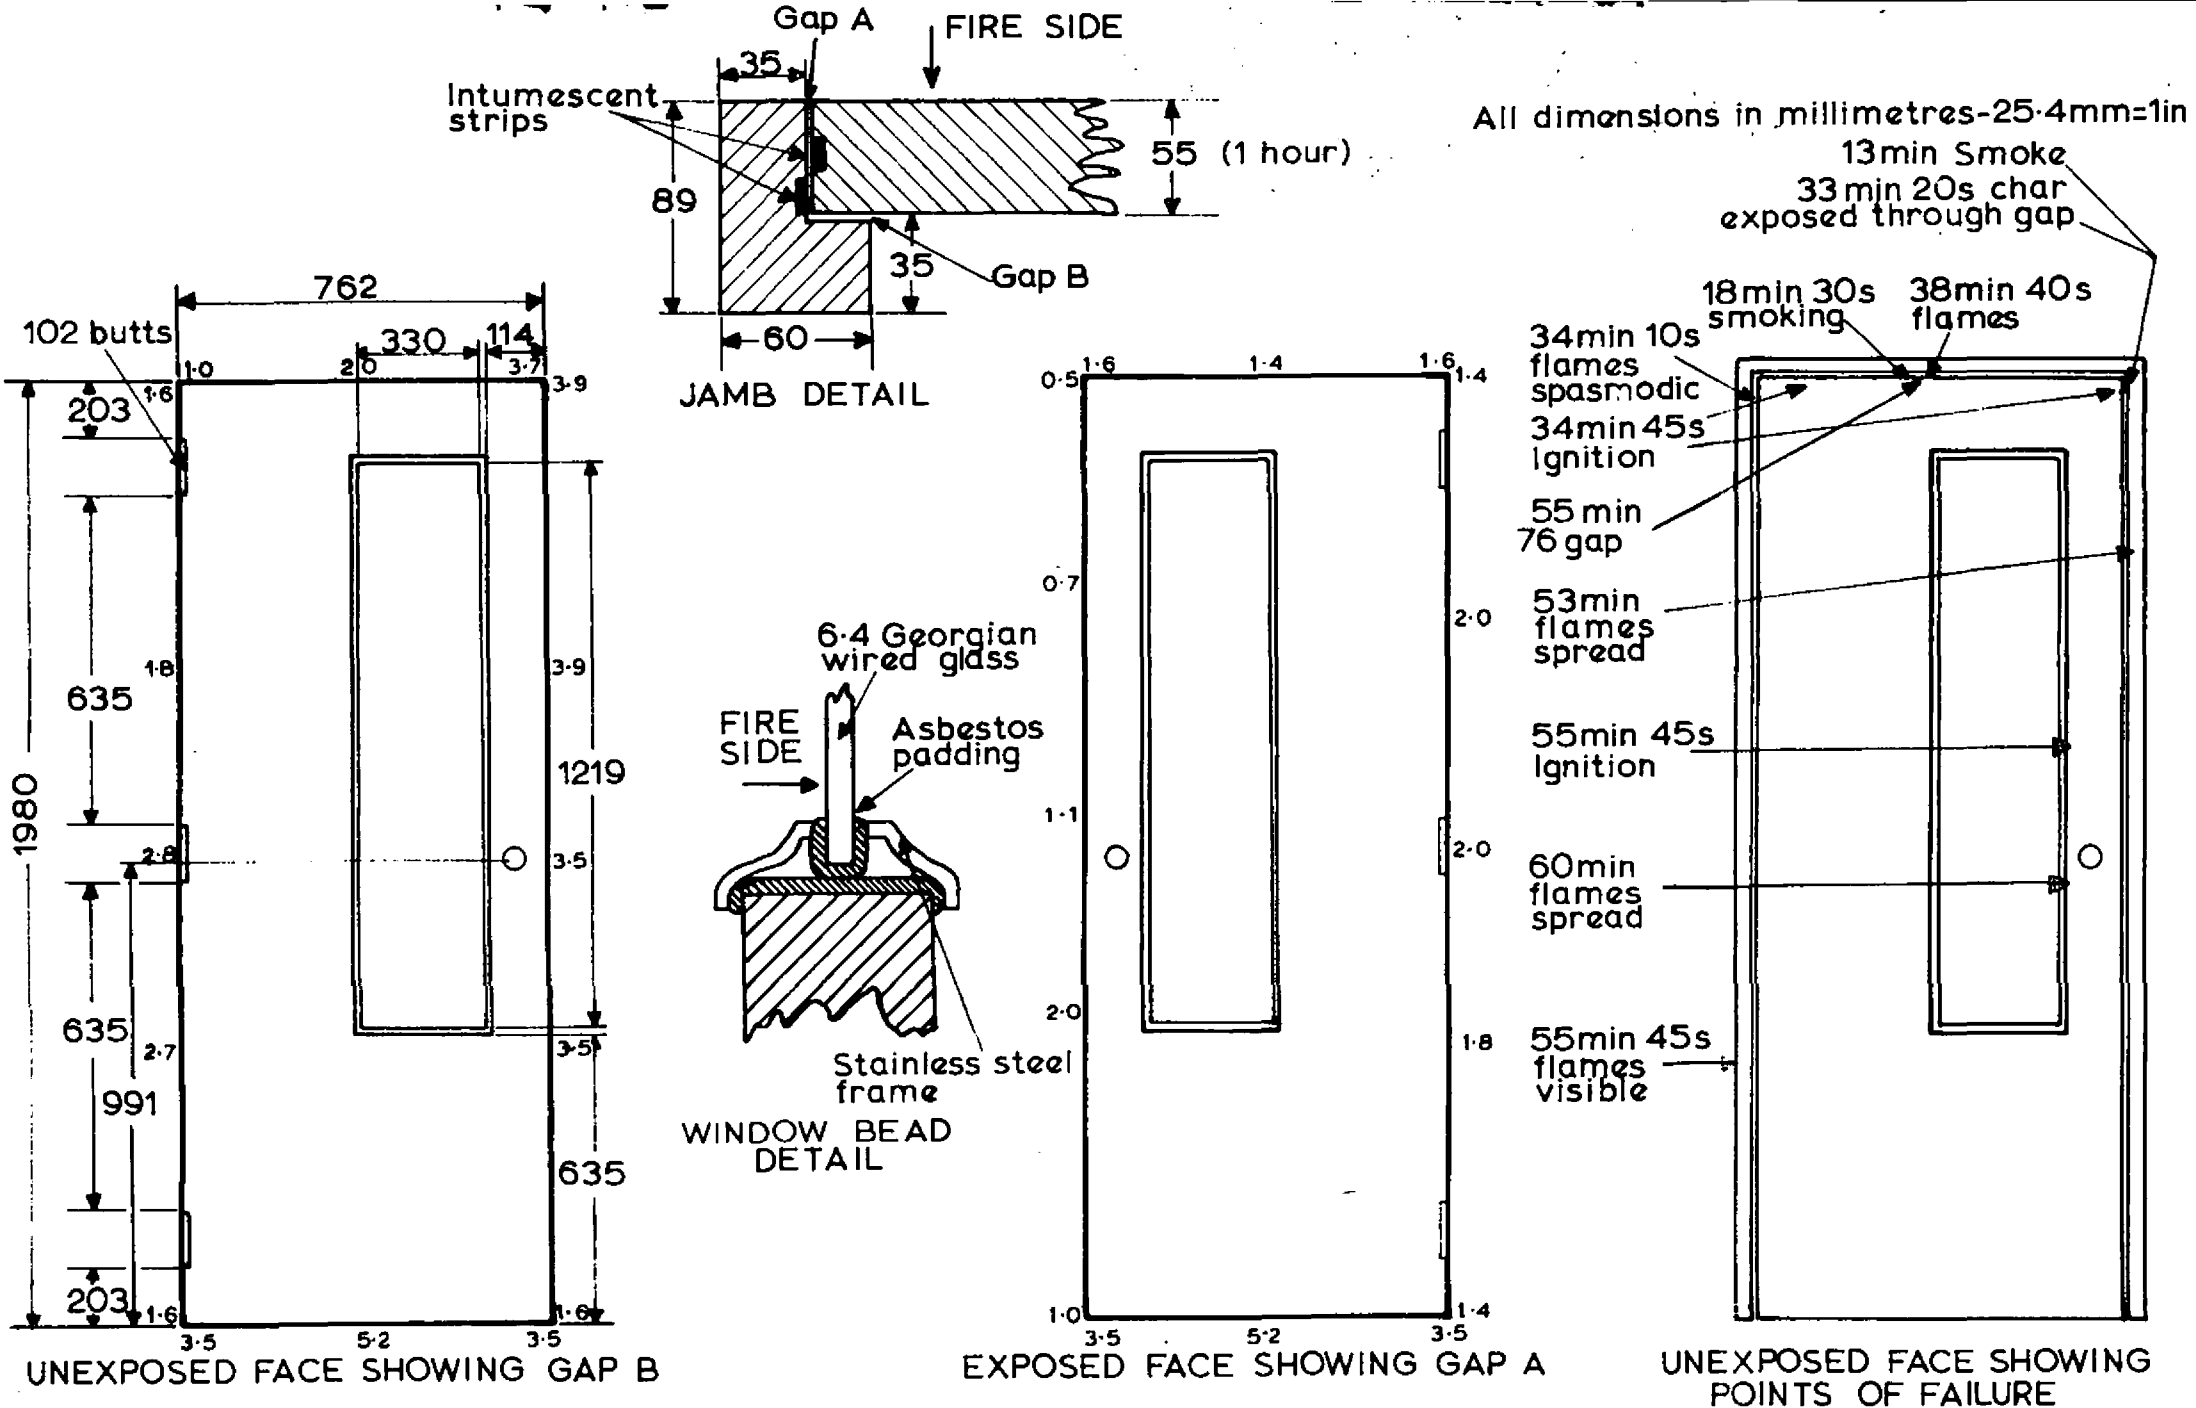
FIG. 18. DOOR TYPE I

In the case of the two 1 hour doors ('I' and 'J') the glazing was retained in position by steel beads with inserts of asbestos tape. Ignition in the vicinity of the beading occurred at 55 and 40 minutes respectively. The buckling of the metal beading was primarily responsible for flame penetration (Plate 10) and allowance for expansion would have minimised this effect. With this modification this method of fixing would appear to be adequate for 1 hour fire check doors, but to prevent ignition for 60 minutes it will be necessary to improve further the method of fixing. The use of steel beads with better insulating and masking arrangements to minimise heat transmission and to prevent the formation of gaps, or the employment of a separate framing of asbestos insulation board or similar material seem possible solutions.
