Fire Research Note No 995

EFFECTS OF DECOMPOSITION PRODUCTS OF
PVC IN FIRE ON STRUCTURAL CONCRETE

W A MORRIS and J S HOPKINSON

February 1974

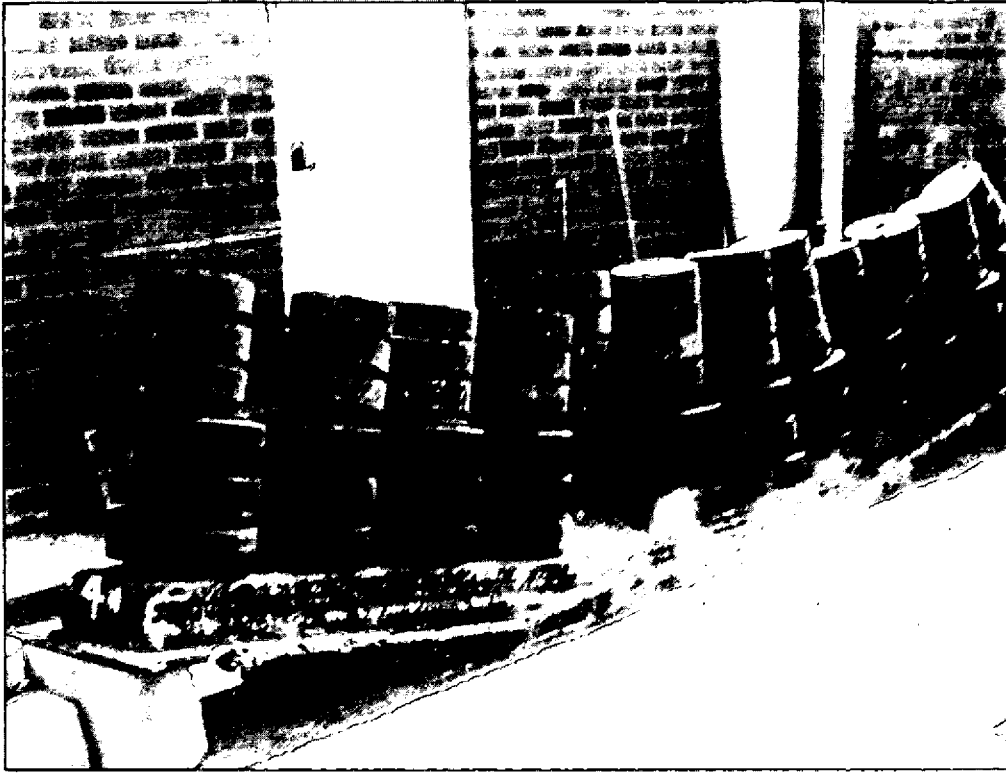
PLATE 8. ROOF UNIT SUBJECTED TO STRUCTURAL TESTING

After removal, each unit was simply supported at its ends and a uniformly distributed load consisting of cast iron weights was applied until failure occurred (Plate 8). The loads sustained by each unit at failure and the deflections produced are given in Table 1. A histogram of the failure loads is given in Fig.7 and typical load-deflection curves are shown (for Test C) in Fig.8.

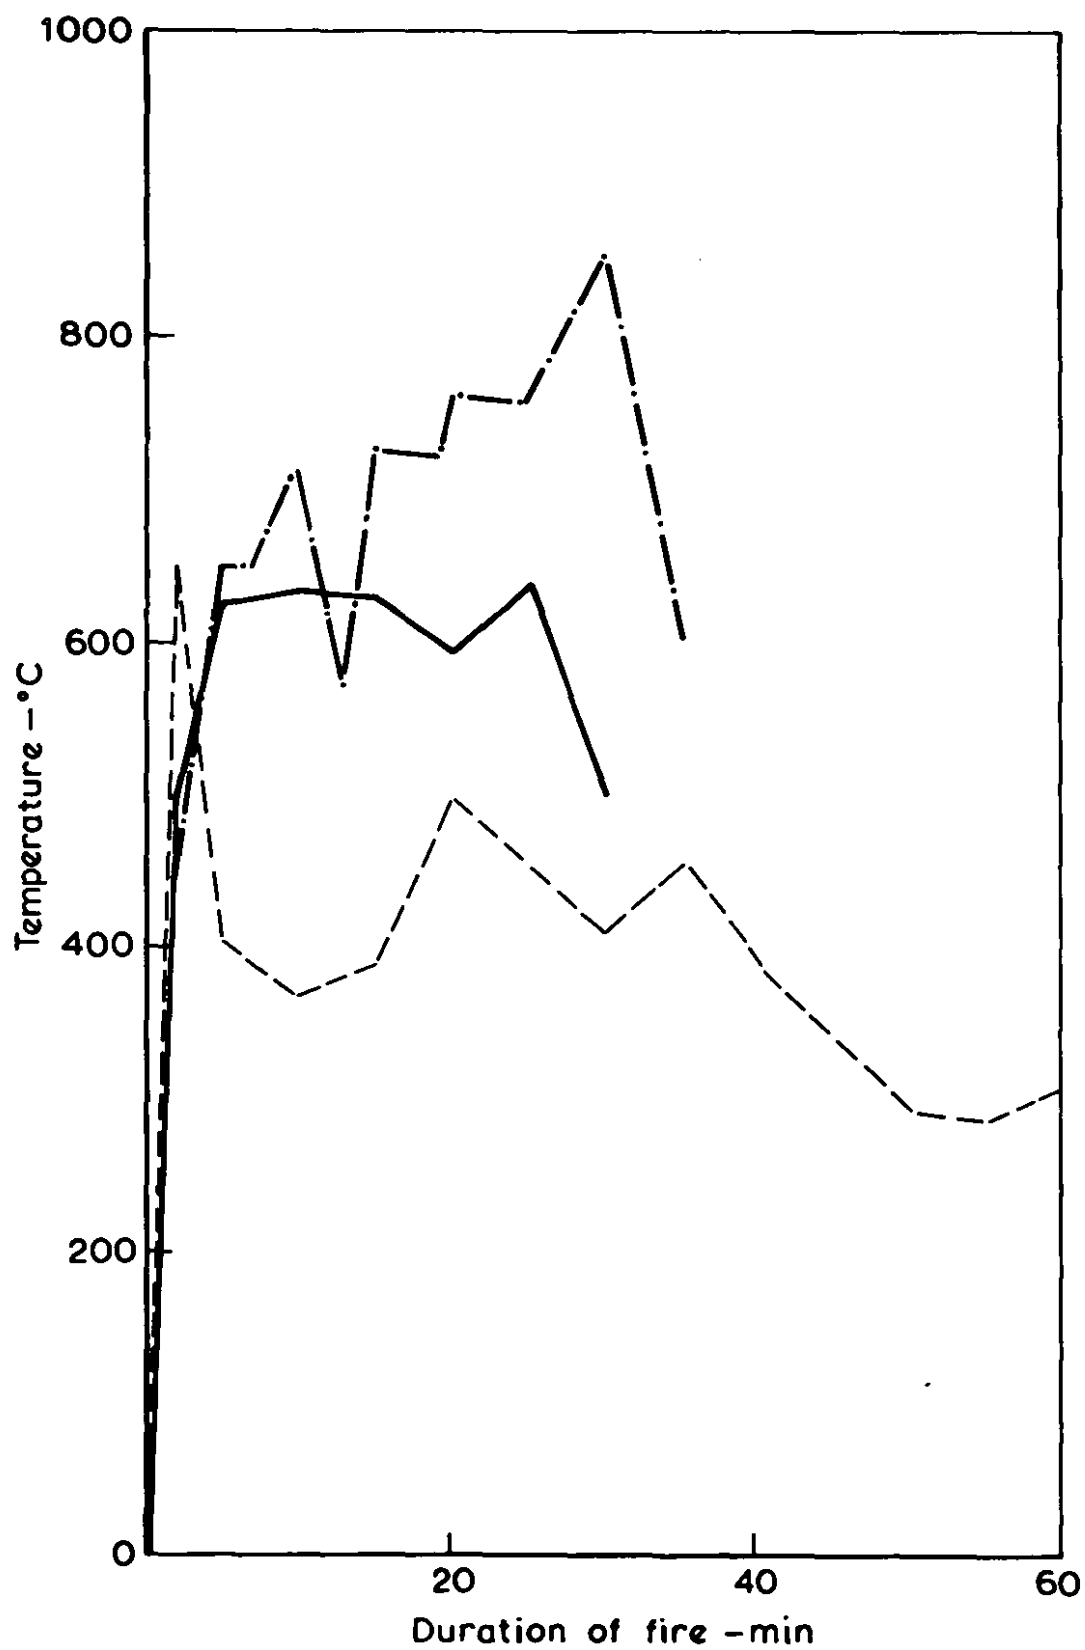
Figure 3 Mean air temperatures in the fire compartments

Figs 4 and 5, were much closer to those of the control fire in the dry and humid compartments. Figure 3 compares the temperatures in the fire compartments for the three fires. The second PVC fire was hotter than the control fire in the final stages because the total combustible content was greater.

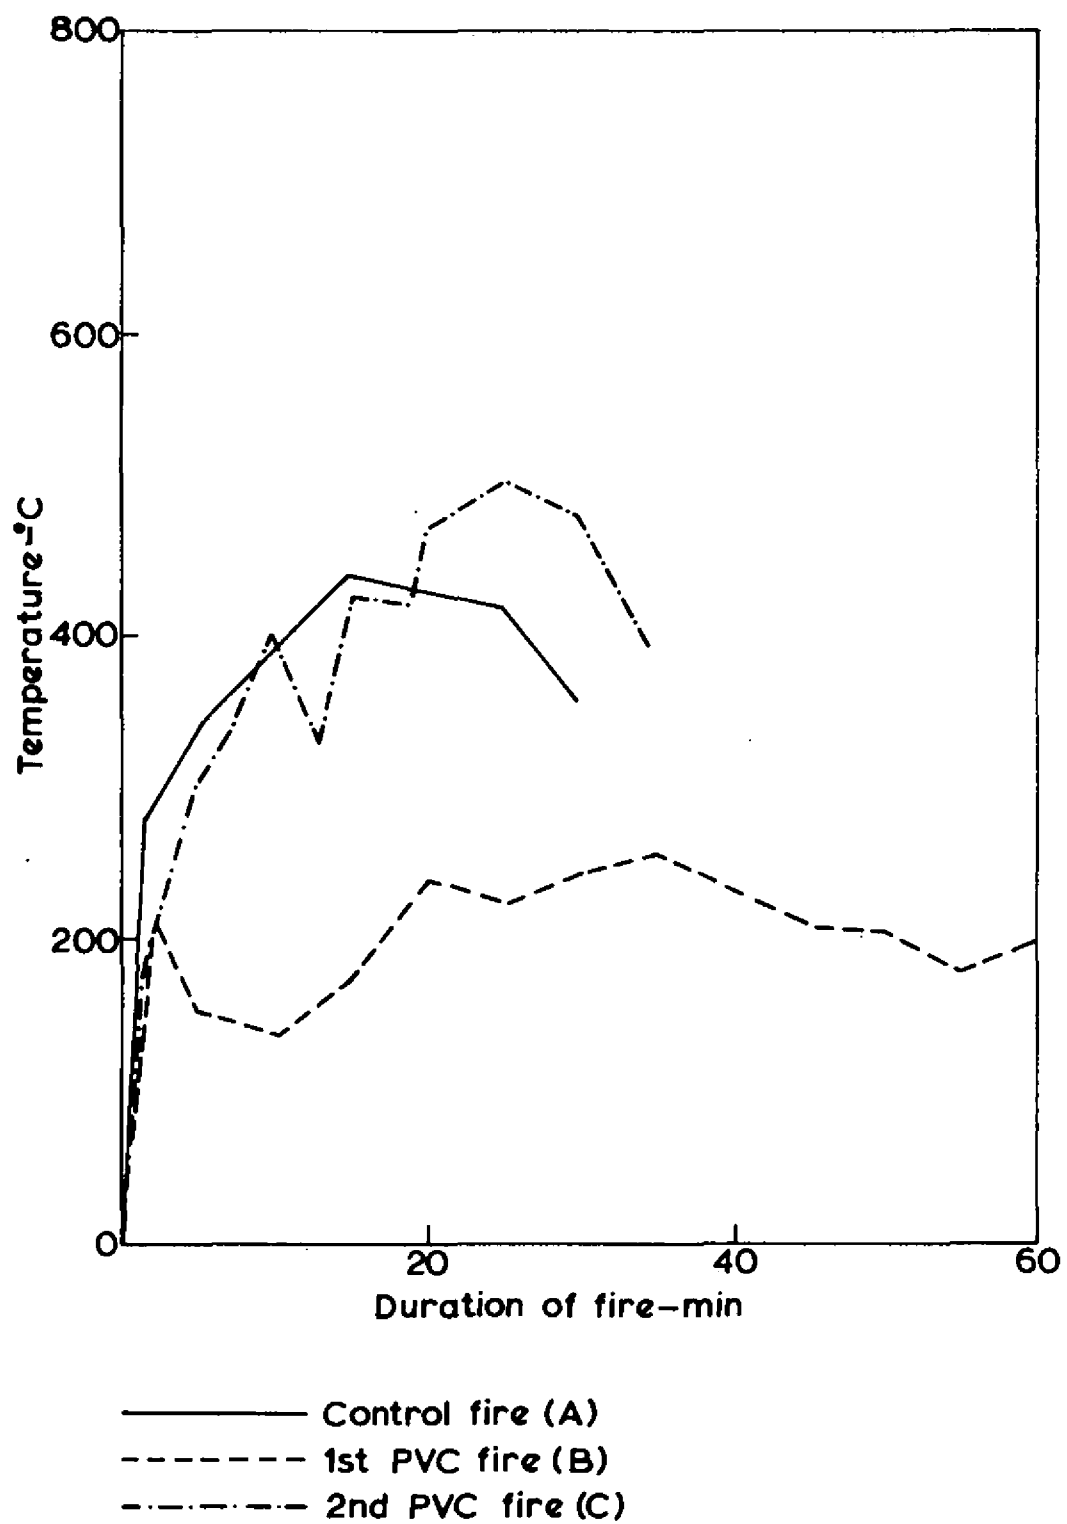
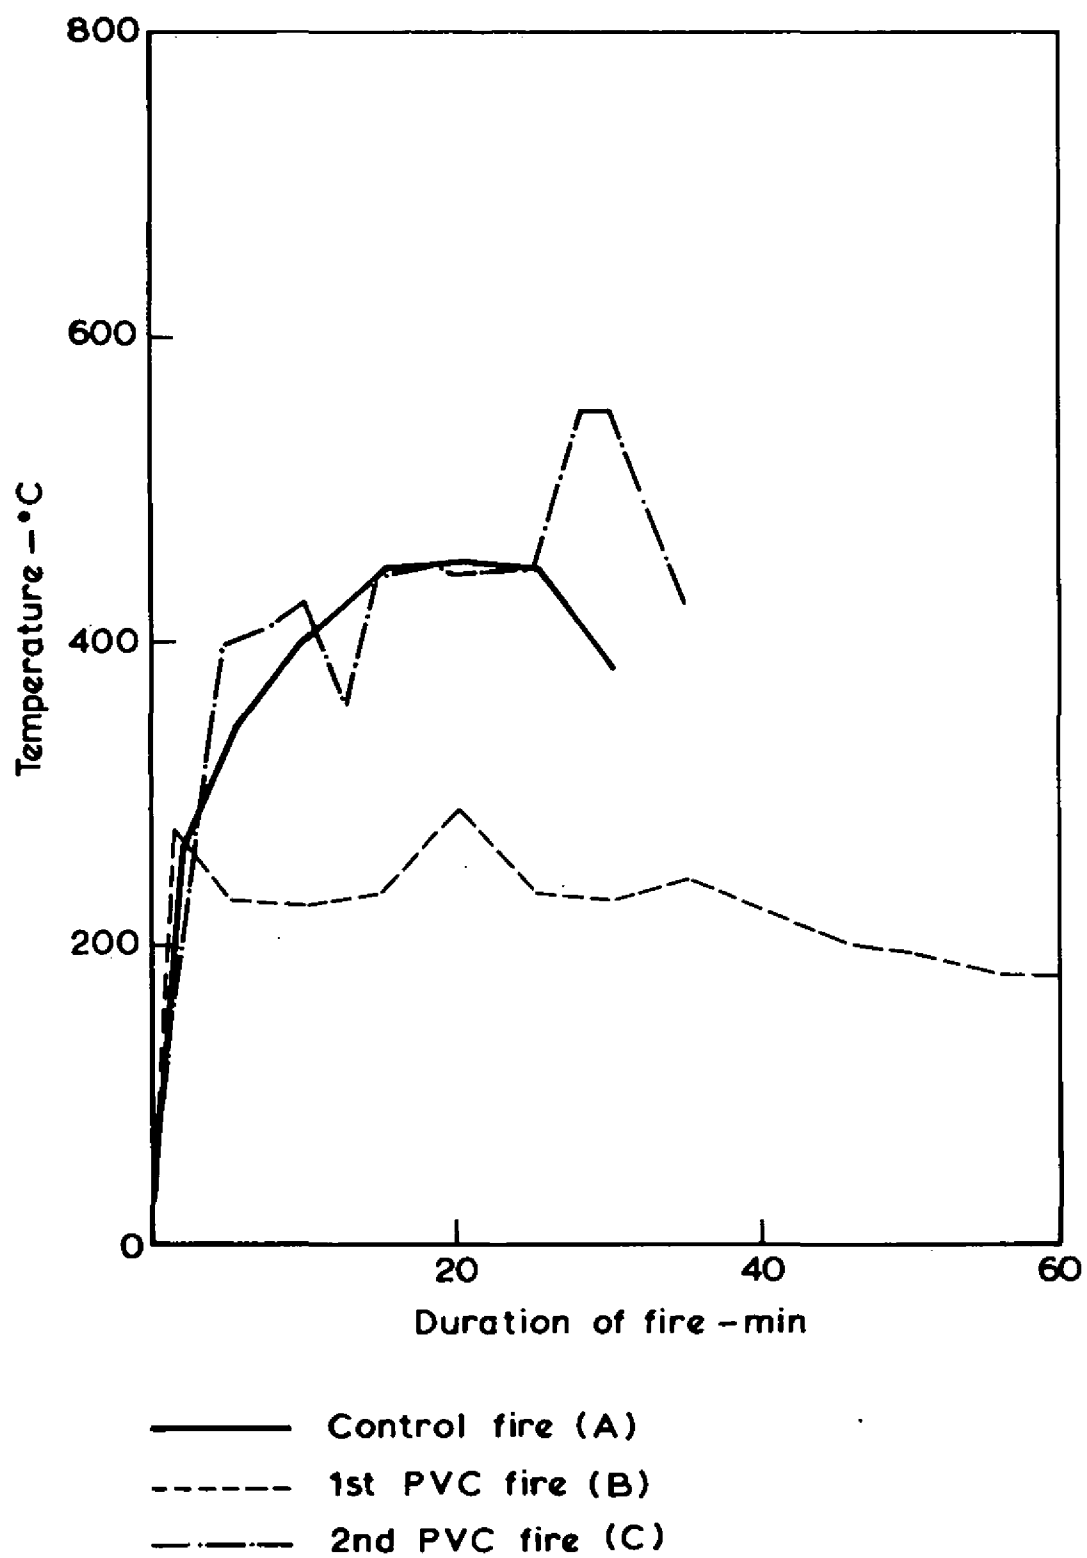
The cellulosic fire (Test A) was conducted first, and average temperatures in the fire compartment just exceeded 600°C at ceiling level. In the side compartments the temperatures reached a little over 400°C and reference to Figures 4 and 5 shows that the temperatures in the dry and humid compartments were very similar.

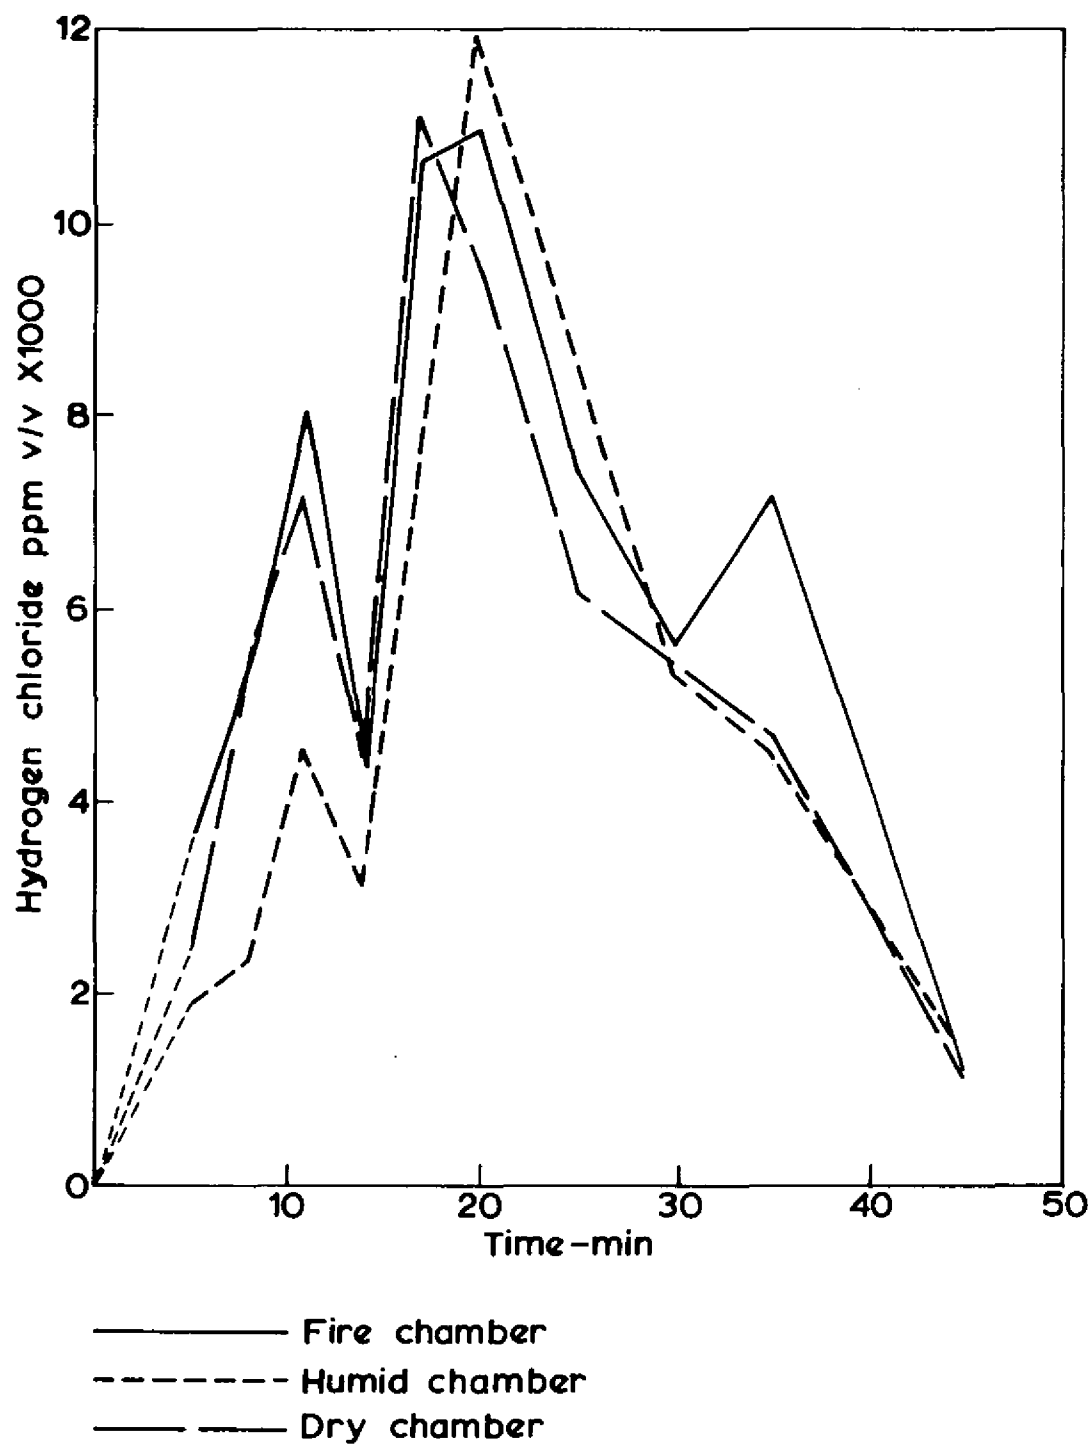
Figure 6 Hydrogen chloride concentrations
- test C

The results of the chemical analysis are given in Fig.6. In this test hydrogen chloride levels in excess of 10,000 ppm were recorded. These agree fairly well with the values recorded in the laboratory tests at RAPRA.

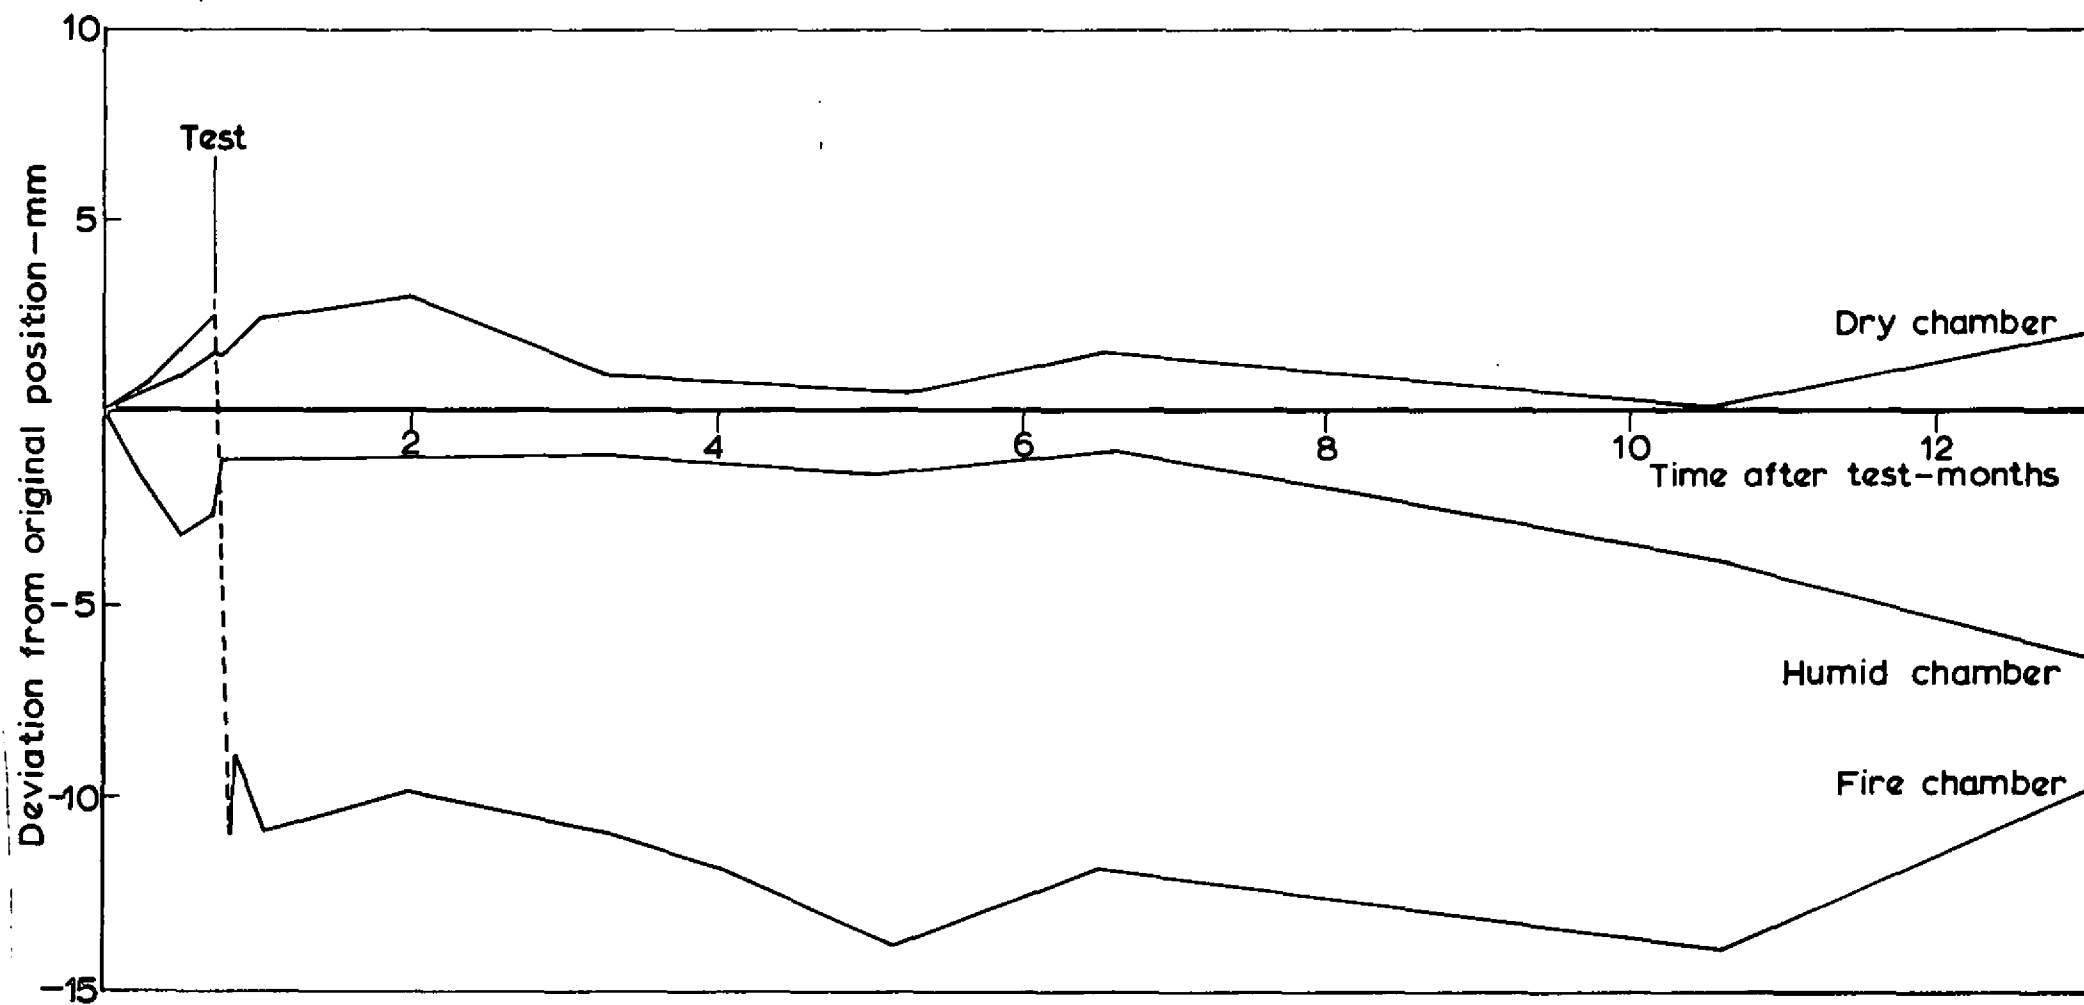
Figure 9 Deflection of prestressed units remaining on building for 13 months
- test C

Deflections of the units before and after the test but while still on the building were recorded and Fig.9 gives results from Test C for units remaining in situ for 13 months. In all three tests, the units did not deflect in the vertical direction to any significant extent before or after the fires. While they were being heated during the fires however, there was some downward deflection. In Test A, units over the fire chamber deflected downwards to a maximum of 21 mm but returned to their original position after the test. In Test B, where lower temperatures existed, a downward deflection of only 13 mm was observed and again the units returned to their original position. The maximum deflection during Test C was 63 mm and the units did not fully recover - the residual deflection at 13 months being 10 mm. The hotter fire in this test led to permanent deformation to the units (Fig.9) possibly because of some relaxation of pre-stress. As mentioned in 4.2.5 the fire chamber units suffered damage.
