Fire Performance of a Full-Scale Building Subjected to Earthquake Motions: Test Specimen, Seismic Motions and Performance of Fire Protection Systems

Jin-Kyung Kim¹, Brian J. Meacham¹, Haejun Park^{1,2}, Tara Hutchinson³ and Elide Pantoli³

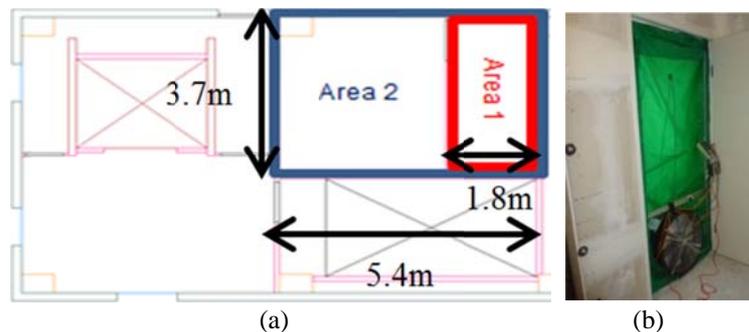
Fig. 14. Compartment integrity tests on Floor 3: (a) test areas 1 and 2 and (b) installation of blower door.

Compartment integrity tests using the blower door fan system were performed on the Northeast room area of Floor 3 following each seismic motion tests using an Infiltec E3 blower door fan. Testing was limited to the Area 1, the SBR separated by the partition wall, and Area 2, the entire SBR and LBR area combined as shown in Fig. 14a. The compartment space characteristics, such as the area and volume, were measured prior to testing. The leakage area measured after construction and prior to the first motion test served as the benchmark data to compare the degradation of the compartmentation caused by the ground motion tests.

To accurately measure the leakage area all of the window openings and ceiling vents were sealed. The door fan system was installed tightly against the door frame as shown in Fig. 14b. Pressurizing and depressurizing of the room was achieved by setting the fan to supply or extract air from the compartment configuring the equipment appropriately. The manometer was adjusted as needed to provide the fan flow and pressure values of the compartment. These values are provided by measuring the pressure differentials between the outside and inside pressures of the compartment under investigation. Several readings from the manometer were used for each test to determine the effective leakage area (ELA) at 4 Pascal [10].
