Fire Performance of Full-Scale Building Subjected to Earthquake Motions: Fire Test Program and Outcomes

ABSTRACT

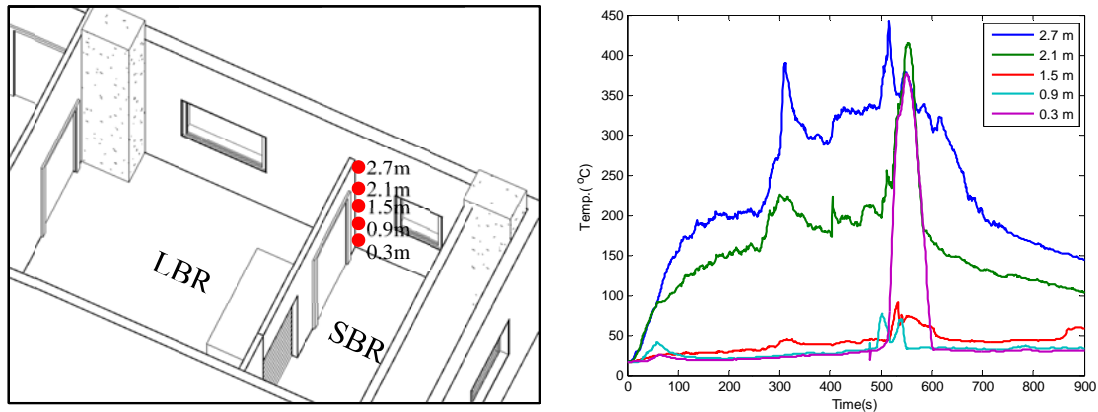
From the motion tests, about 0.025m wide gap was formed along the joint between the interior wall of balloon framing and the wall between the LBR and the SBR. In LBR-2 fire test, flame extended to SBR through this gap. The location of the gap is marked using the red circle in Fig. 10 which is taken from the northeast corner of the SBR. Although flame spread did not occur as no fuel item was located in SBR, flame extended several times to SBR with hot smoke. In conditions such as a fabric curtain being located near the gap, flame spread could have occurred as the gas temperature near the gap in SBR was over 350°C for more than 1 minute as shown in Fig. 11.

Fig. 11. Locations of thermocouples and temperature profile in LBR-2 fire test

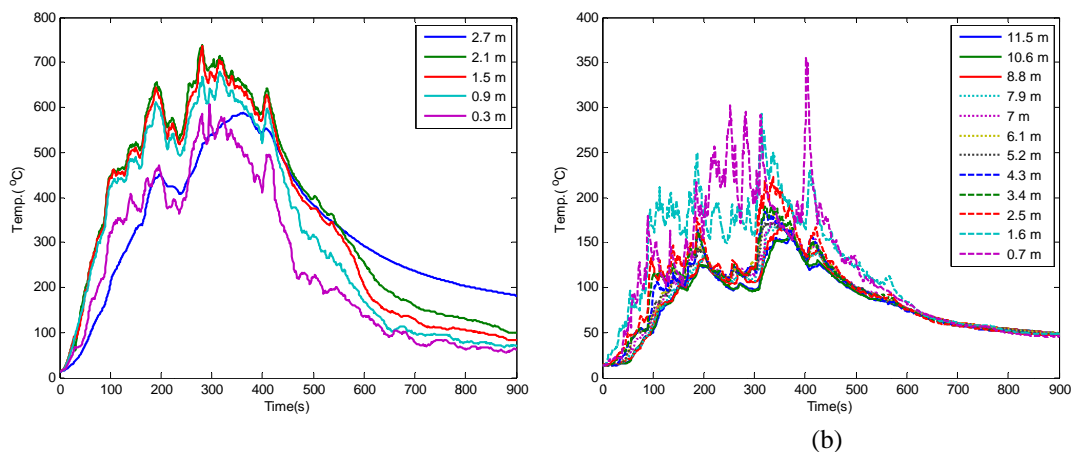
Fire and smoke spread through the elevator shaft was examined with three heptane pans placed in the elevator lobby. From the largest motion test, the elevator door and its frame in the third floor were distorted with the opening as large as 0.24m as shown in Fig. 4 (a). With partially closed window openings, gas temperatures at various heights in the elevator lobby are shown in Fig. 12 (a). A total of 12 thermocouples were located within elevator shaft to assess smoke spread and possibility of additional ignition with the top thermocouple being located 11.5 m above the 3rd floor slab. The highest temperature was recorded near the fire source, 0.7m above the 3rd floor, but over the shaft heights corresponding to the 4th and 5th floors (from 5.2m to 11.5m), relatively uniform temperatures were observed. The peak gas temperatures in this region range between 150°C and 200°C which may not be high enough to cause ignition of materials in the shaft, but near the damaged door, the temperatures range between 250°C and 300°C. This temperature range may be high enough to cause ignition with a pilot flame ignition source and large enough burning time.

Fig. 12. Gas temperatures in elevator lobby (a) and gas temperature in elevator shaft (b)
