Investigation of a Large Wooden Gymnasium Fire

- Its documentation, estimation of the fire scenario by experiments and evaluation of the structural properties of surviving timber elements

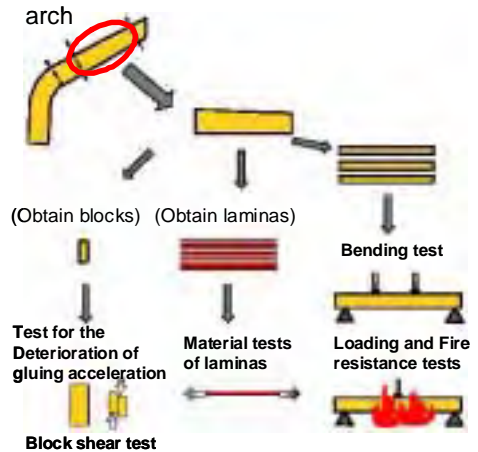
FIGURE 4 Outline of structural property tests

Structural property tests were conducted to find out how the actual fire will affect the adhesiveness, strength and fire resistance of glue-laminated timber. The tests are bending test, loading and fire resistance tests, test for the deterioration of gluing acceleration, block shear test and material tests of laminas (Figure 4).

Table 3 summarizes the results of the structural property tests of the members: although the whole building suffered from the fire, members were still self-supporting and the

deterioration of their strength was not found and there are no differences between the damaged and normal timber in these characteristics. Especially, in loading and fire resistance tests, all specimens were found to be fire resistant for more than 45 minutes. It also became clear that the fire-damaged, glue-laminated timber stayed almost as fire resistant as the normal timber and the carbonization speed of the fire-damaged, glue-laminated timber was measured to 0.56 - 0.65 mm per minute in the width direction and 0.55 - 0.71 mm per minute in the beam height direction, which indicates that there are no differences between the fire-damaged and normal timber in the carbonization speed.

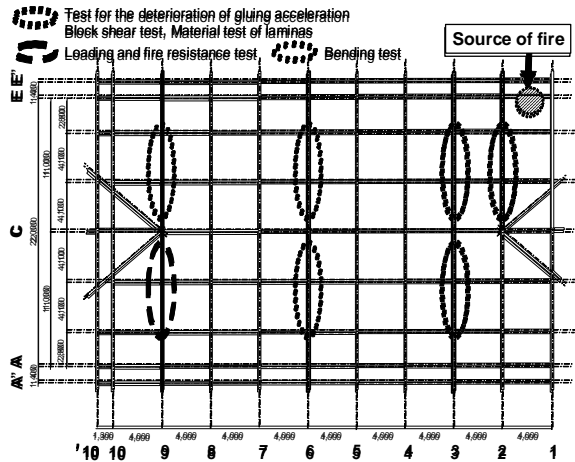
FIGURE 5 Position of the tested members

Samples of the arch members were collected when the fire-damaged building was pulled down and then transported to the Forestry and Forest Product Research Institute for investigation.
