Large Scale Fire Tests of 4 - Story Type Car Park

Part 1:

The behavior of structural frame exposed to the fire at the deepest part of the first floor

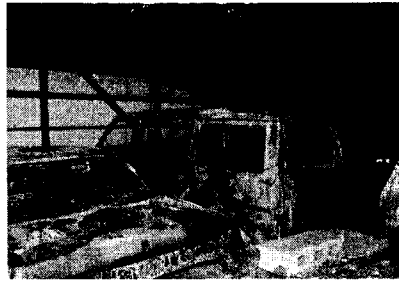
Fig.7-8 The View of Cars After Fire Extinguishment
